# **FAMILYGUARD**

## **HOME INSPECTION REPORT**

**110 S. Grant St. Kendallville, IN 46755**  
**Inspection Prepared For: Seller**

**Date of Inspection: 8/9/2023**  
**Age of House: 100+ Years**  
**Weather: Clear**

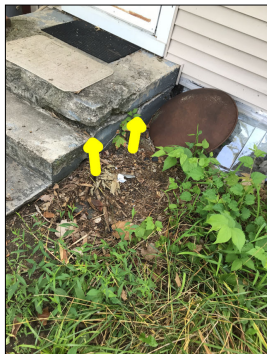
Cracks and deterioration along the service walks/steps.

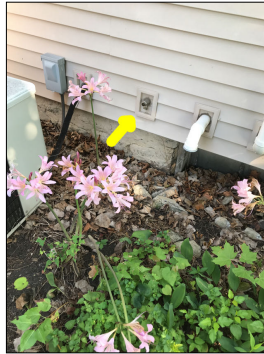
Damaged/missing handle.

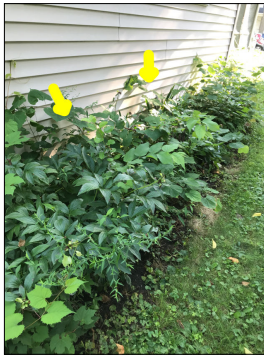
Vegetation against the siding/in proximity of the siding. This is not a recommended practice. Vegetation has the potential to harbor insects, wood destroying insects, rodents and hold moisture. Insects, wood destroying insects, rodents and moisture have the potential to create future problems for a house, such as structural damage, pest infestation and wood rot damage.

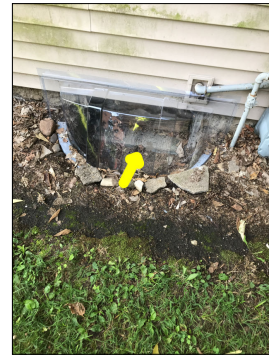
Window wells observed. Window wells can act as traps for water, thus causing excessive hydrostatic pressure against the foundation walls. Excessive hydrostatic pressure against the foundation can cause water intrusion into the house and potential foundation problems. Also, window wells can cause water intrusion from the windows.

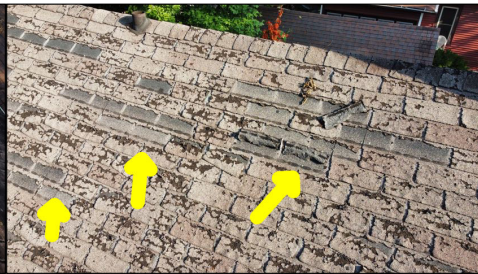
Damaged and deteriorated roof shingles.

- Damaged shingles
- Cracking
- Broken/loose tiles/shingles
- Granule loss
- Missing tabs/shingles/tiles
- Deterioration
- Recommend licensed roofer further evaluate and make necessary repairs

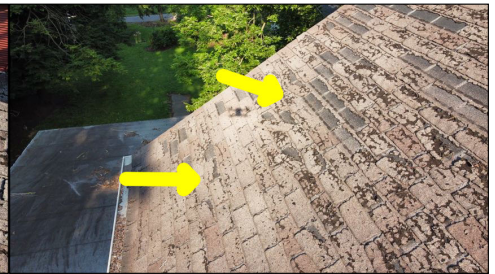
Damaged and deteriorated roof shingles.

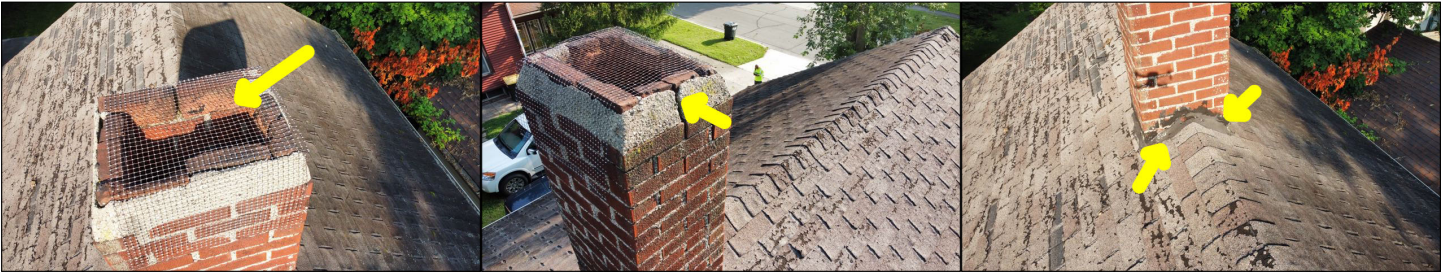
The chimney does not have a rain cap.

A rain cap keeps rain water from entering the chimney and helps keep wildlife from entering the chimney. An active or intermittent water source can cause mold growth and property damage. Wildlife can cause property damage. A rain cap also helps keep debris from entering the chimney. Debris within the chimney is a potential fire hazard as debris products are combustible. Debris can also restrict the flue from drafting properly, thus creating a safety hazard as carbon monoxide can get into the house.

Cracks along the chimney. Cracks are considered defects and potential leak points.

Unconventional and excessive application of roof sealant along the base of the chimney. This is considered abnormal and amateur craftsmanship. Amateur craftsmanship is prone to failure and leakage.

- Rain cap missing
- Cracks
- Unconventional/excessive use of sealant
- Recommend chimney professional further evaluate and make necessary repairs

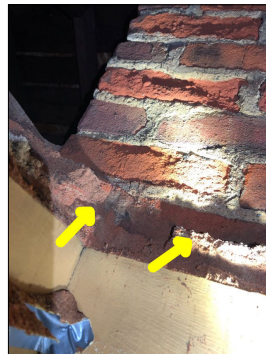
Deterioration and cracking along the brick.

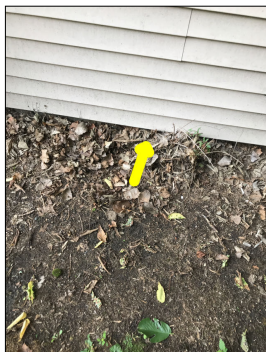
The siding is in proximity to the ground. Siding should have at least 6 to 8 inches of clearance above the ground. Maintaining proper clearances reduces access to wood structures behind the siding and helps preserve the house. The proper clearances help restrict access from wood destroying insects and/or moisture/water that might find its way behind the siding.

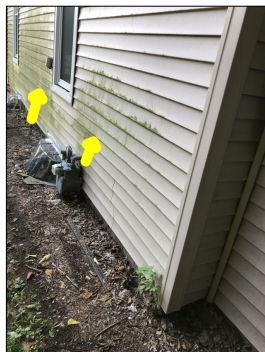
Discoloration along the siding.

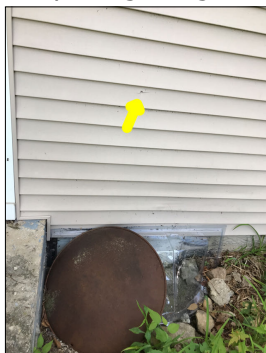
Damaged siding.

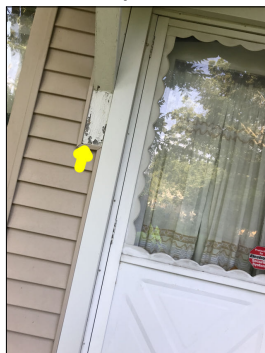
Flaking and peeling along the exterior.

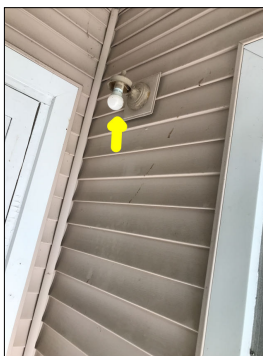
The weather protection cover/globe is missing. The lack of a proper exterior cover/globe is a potential safety hazard. Without a cover, moisture can get into the electrical wiring/components, thus causing spark, arcing and/or fire.

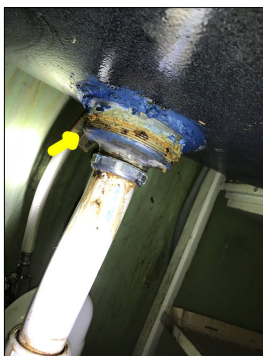
Rust/corrosion underneath the sink.

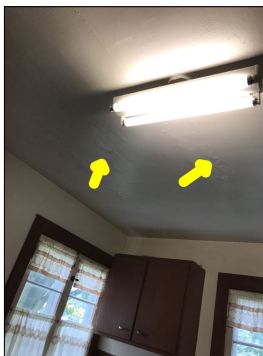
Cracks along the ceiling.

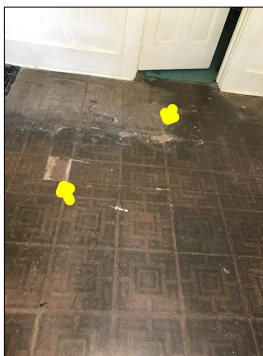
Damaged floor tiles.

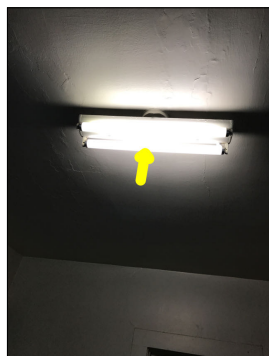
The light is noisy during operation. This is considered a defect.

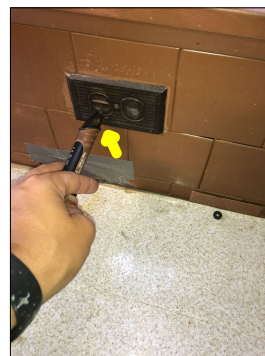
Two prong receptacles. Two prong receptacles are not grounded.

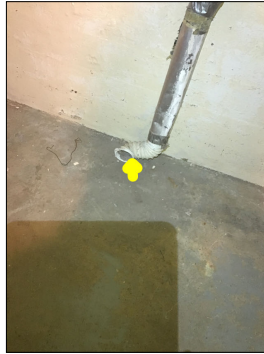
The dryer ductwork is plastic. This is not a recommended practice and is considered a safety hazard. The plastic can overheat and melt, thus creating a fire. Metal ductwork is the recommended material to use for dryer exhaust. It is also recommended for the exhaust ductwork to be insulated in non climate controlled areas, such as an attic, to prevent condensation from forming along the ductwork. An active or intermittent water source can cause mold growth and property damage.

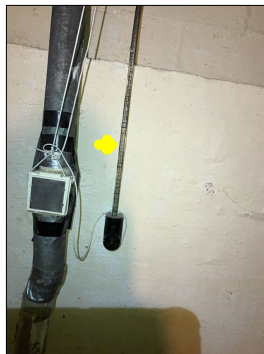
The wires are not wrapped in conduit. This is considered abnormal, amateur craftsmanship and a potential safety hazard. Wires should be wrapped in conduit to protect both humans and the electrical wiring. Wires that lack conduit can potentially get pulled, become loose, or damaged, thus creating shock hazards and/or fire hazards.

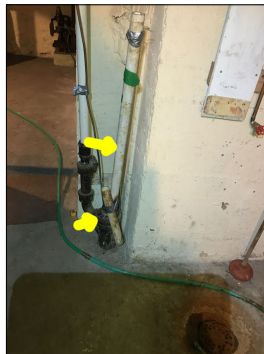
The drain line from the washing machine does not have a proper P-trap. The lack of a proper P-trap can potentially allow sewer gases into the house. Sewer gases are a potential safety hazard. Also, the drain line is not properly sealed where it goes into the cast iron pipe.

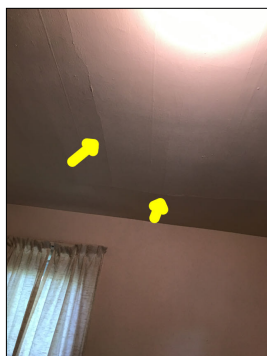
Cracks along the ceiling.

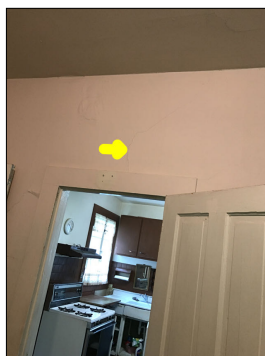
Cracks along the walls.

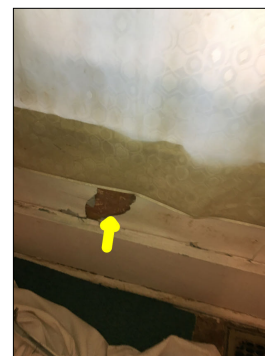
Flaking and peeling along the walls.

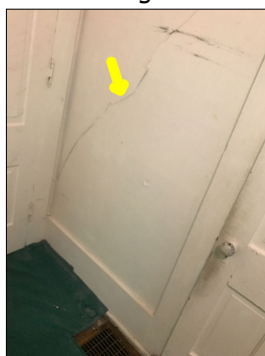
Cracks along the walls.

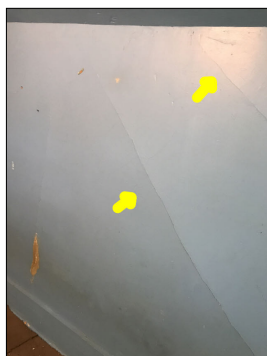
Cracks along the walls.

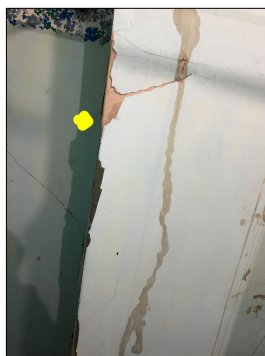
Flaking and peeling along the walls.

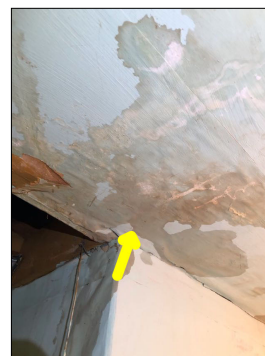
Discoloration along the ceiling and signs of previous water damage. An active or intermittent water source can cause mold growth and property damage.

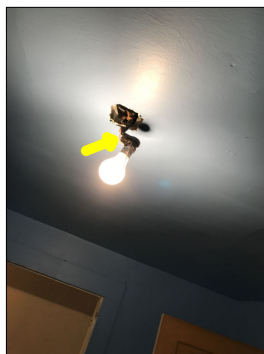
Exposed wires. This is a potential safety hazard.

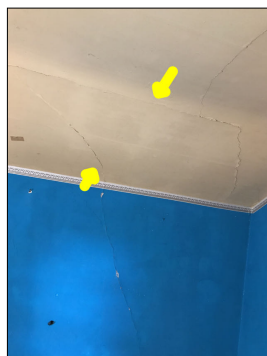
Cracks along the ceiling.

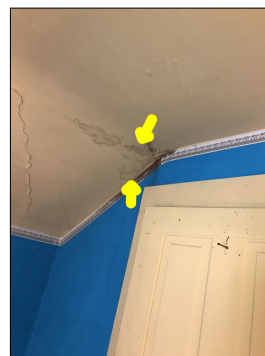
Discoloration along the ceiling and signs of previous water damage. An active or intermittent water source can cause mold growth and property damage.

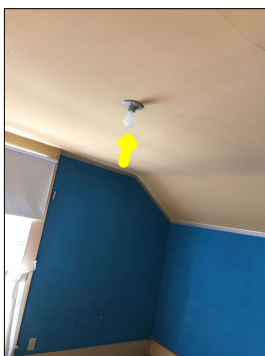
The light is inoperable, the bulb might be burned out.

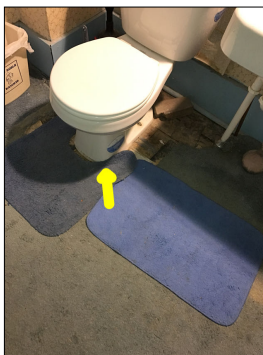
The toilet is loose. The toilet rocks back and forth. A toilet should not have any movement and be fully anchored and secured to the floor.

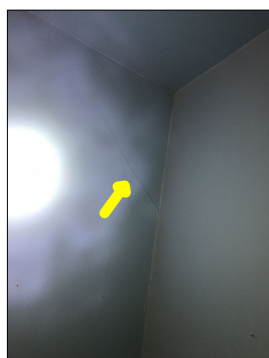
Cracks along the walls.

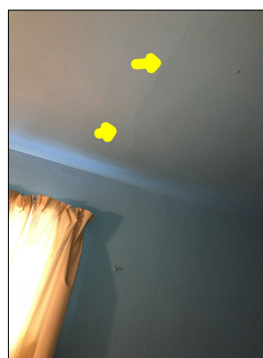
Cracks along the ceiling.

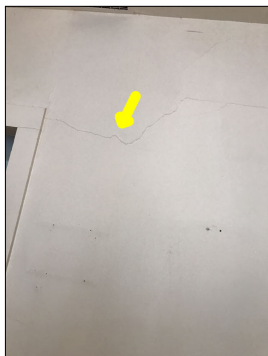
Cracks along the walls.

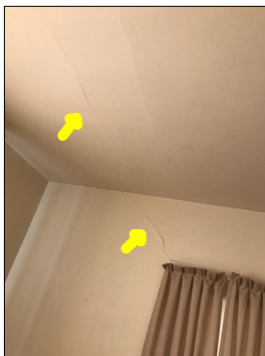
Cracks along the ceiling and walls.

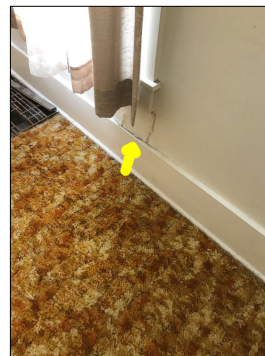
Cracks along the walls.

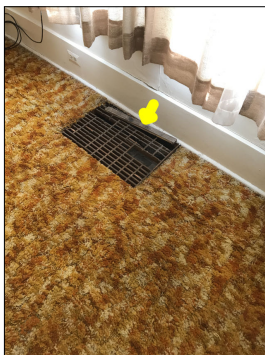
Damaged vent covers.

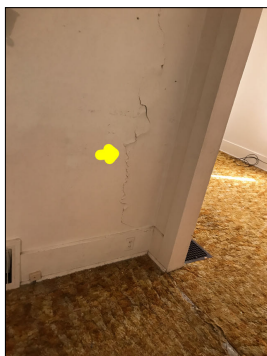
Cracks along the walls.

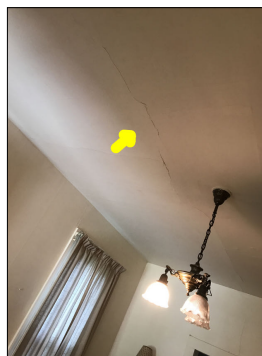
Cracks along the ceiling.

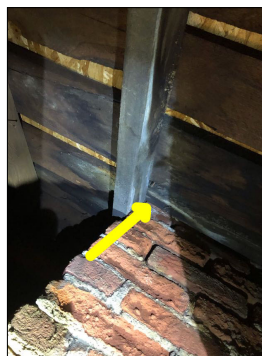
Signs of previous water damage along the sheathing. An active or intermittent water source can cause mold growth and property damage, such as wood rot damage.

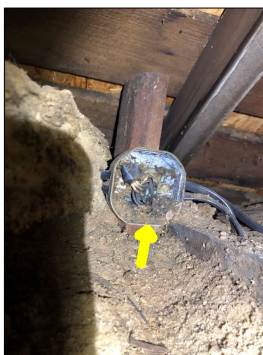
Exposed spliced wires. This is a potential safety hazard.

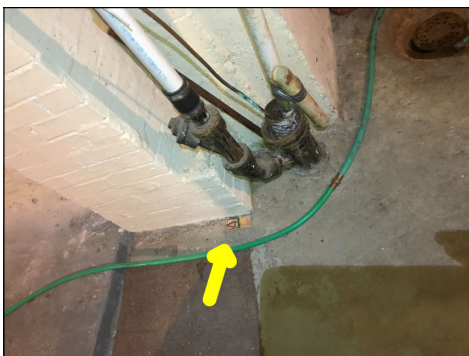
Pest control observed. Wildlife activity can cause property damage.

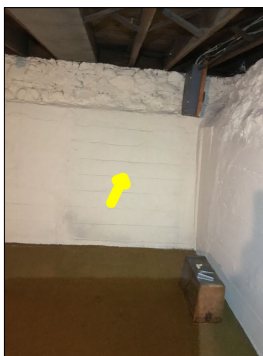
Structural modifications and repairs observed along the foundation walls.

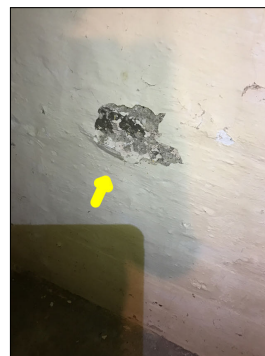
Deterioration along the foundation wall. This is considered abnormal and a defect.

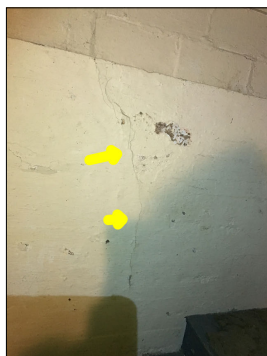
Crack along the foundation wall. Cracks are considered a defect.

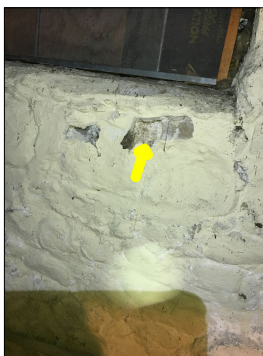
Deterioration along the foundation wall. This is considered abnormal and a defect.

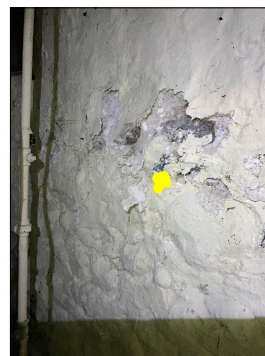
Deterioration along the foundation wall. This is considered abnormal and a defect.

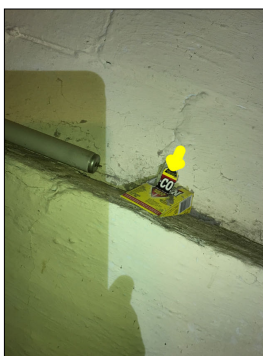
Pest control observed. Wildlife activity can cause property damage.

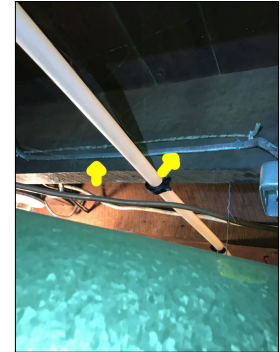
Cloth sheathing wiring observed. Cloth sheathing wiring is considered aged wiring. The cloth sheathing can become brittle due to age, thus causing wires to be exposed, which can cause spark, arcing and or fire. Also, cloth sheathing can potentially have asbestos in it. Asbestos is a potential safety hazard.

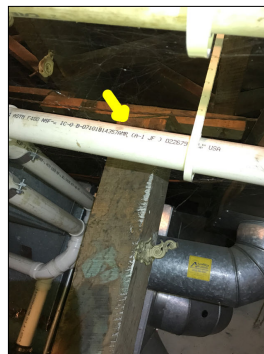
Unconventional columns supports. This is considered amateur craftsmanship. Amateur craftsmanship is prone to failure. Columns should be properly mounted/secured to the beam by bolts, tabs or be welded to the beam for proper installation and structural support.

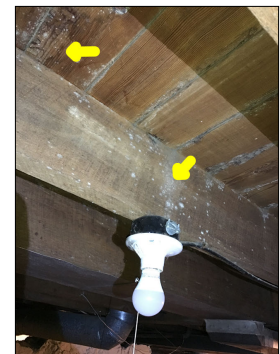
Mold like substance along the floor joists. An active or intermittent water source can cause mold growth and property damage.

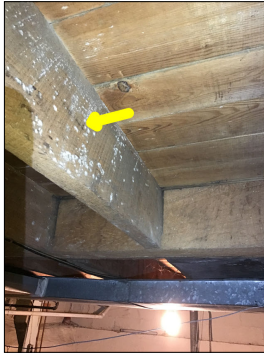
Mold like substance along the floor joists. An active or intermittent water source can cause mold growth and property damage.

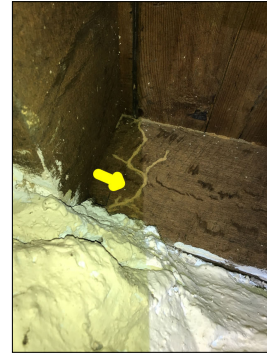
| Roof | | |
|---|---|---|
| Page 29 Item: 6 | Beams/Subfloor/Joists/Columns | <ul style="list-style-type: none"><li>• Signs of termite damage. Termites are a wood destroying insect and can cause property damage and structural damage.</li><li>• Exit holes observed. Exit holes are an indication of an infestation of powderpost beetles. Powderpost beetles are a wood destroying insect and can cause structural damage and property damage.</li></ul> |

Signs of termite damage. Termites are a wood destroying insect and can cause property damage and structural damage.

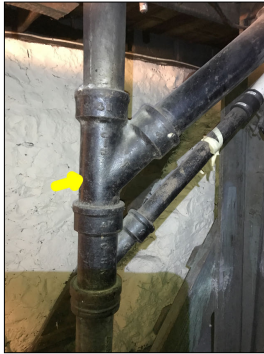
Aged cast iron drain pipes. Cast iron drain pipes no longer meet modern day plumbing standards. Cast iron pipes are prone to corroding from the inside out. Cast iron drain pipes are towards the end of their life expectancy. Repairs or replacement to cast iron drain pipes should be anticipated.

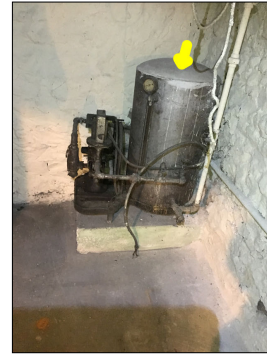
Aged pressure tank in the basement. The tank is not in service.

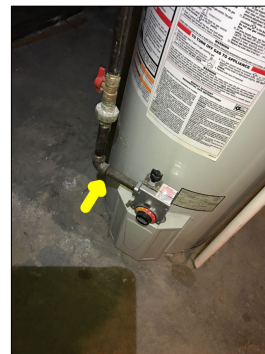
No drip leg/sediment trap. The lack of a drip leg/sediment trap can cause damage to the appliance. Sediment traps help prevent sediment, debris and moisture in the fuel line from getting into the gas valve or burner area.

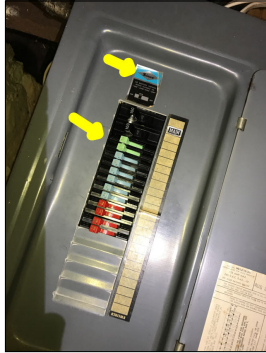
| Roof | | |
|---|---|---|
| Page 36 Item: 3 | Electrical | <ul style="list-style-type: none"><li>• The circuit breaker panel is an aged Zinsco circuit breaker panel. Zinsco circuit breaker panels no longer meet modern day electrical standards. Zinsco circuit breaker panels are considered a safety hazard. Due to their age and outdated technology, Zinsco circuit breakers are prone to not trip when experiencing an overload or overheating, thus creating arcing, spark and/or fire. Recommend replacing the Zinsco circuit breaker panel to a modern day circuit breaker panel.</li></ul> |

The circuit breaker panel is an aged Zinsco circuit breaker panel. Zinsco circuit breaker panels no longer meet modern day electrical standards.

Zinsco circuit breaker panels are considered a safety hazard. Due to their age and outdated technology, Zinsco circuit breakers are prone to not trip when experiencing an overload or overheating, thus creating arcing, spark and/or fire. Recommend replacing the Zinsco circuit breaker panel to a modern day circuit breaker panel.

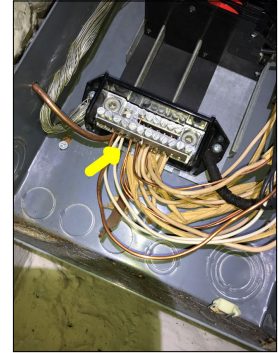
Double tapped neutral wires. Neutral wires should not share a terminal with any other wires, including ground wires. Double tapped neutrals are considered a safety hazard. Double tapped neutral wires do not allow the circuit to be isolated if the circuit needs to be worked on. Also, double tapped neutral wires under the same terminal can become loose, which could lead to arcing, overheating, spark and/or fire.

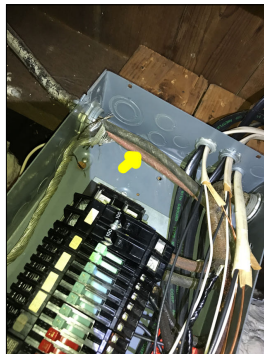
Cloth sheathing wiring observed. Cloth sheathing wiring is considered aged wiring. The cloth sheathing can become brittle due to age, thus causing wires to be exposed, which can cause spark, arcing and or fire. Also, cloth sheathing can potentially have asbestos in it. Asbestos is a potential safety hazard.

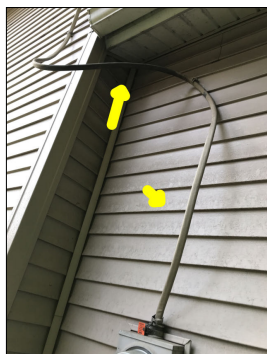
The service wires are un conventionally loose. This is considered abnormal and a potential safety hazard.

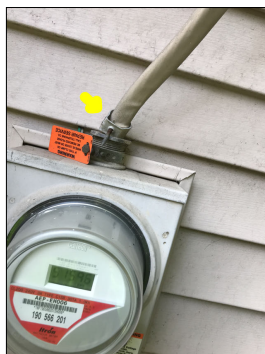
The service wires are un conventionally loose. This is considered abnormal and a potential safety hazard.

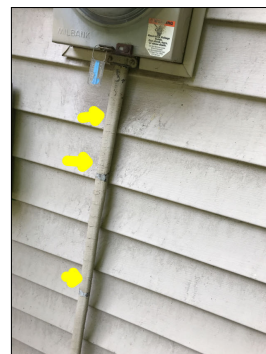
Cracking and deterioration along the sheathing of the service wires. This is a potential safety hazard.
