FAMILYGUARD

HOME INSPECTION REPORT

3633 W. State Blvd. Fort Wayne, IN 46808
Inspection Prepared For: Seller

Date of Inspection: 4/25/2024
Age of House: 57 Years
Weather: Clear

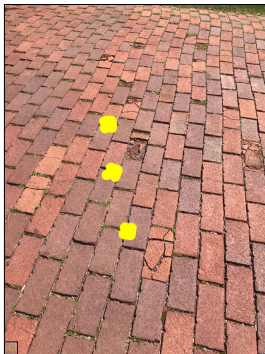
Cracks and deterioration along the driveway.

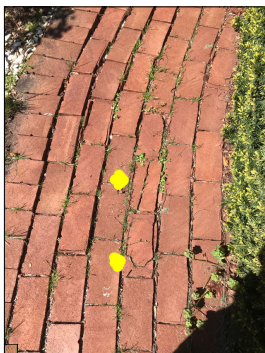
Cracks and deterioration along the service walks.

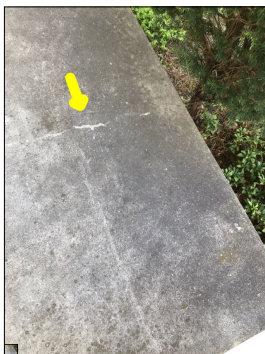
Cracks and deterioration along the porch.

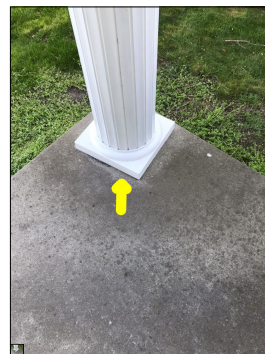
The column base is crooked compared to the other columns.

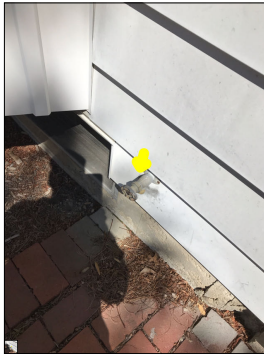
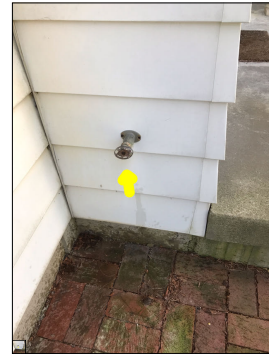
No anti-siphon/frost free valve. The lack of an anti-siphon valve can allow water back flow into the water supply lines, thus contaminating potable water. This is a potential safety hazard. The lack of a frost free valve can allow water to stay within the hose bib, which could potentially freeze during cold months and cause the pipe to rupture. This can cause property damage.

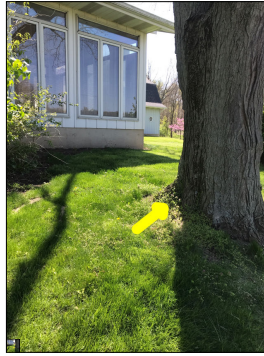
Tree adjacent to the house. Tree roots can cause foundation problems and can create structural damage to the foundation. Also, trees that are next to the house can potentially fall on the house, potentially causing bodily harm and damage to the house.

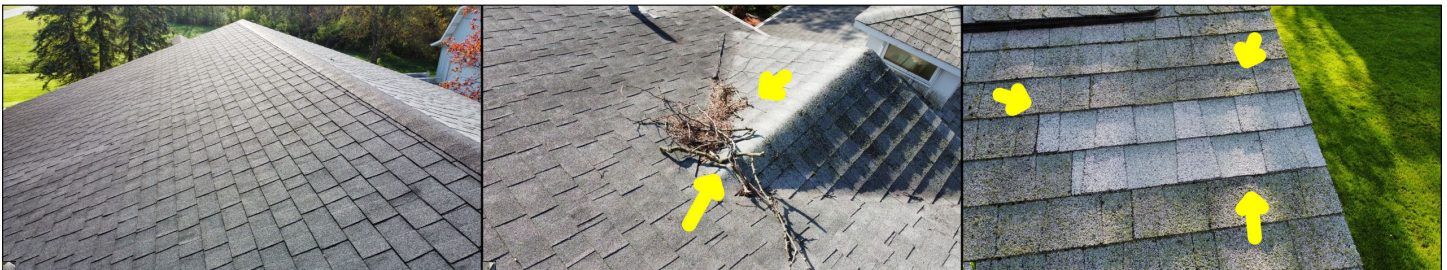
Tree branches observed along the roof. Falling tree branches can cause damage to the roof system, thus resulting in water intrusion into the attic/house.

Replacement shingles observed. This can be identified by the color contrast of roof shingles.

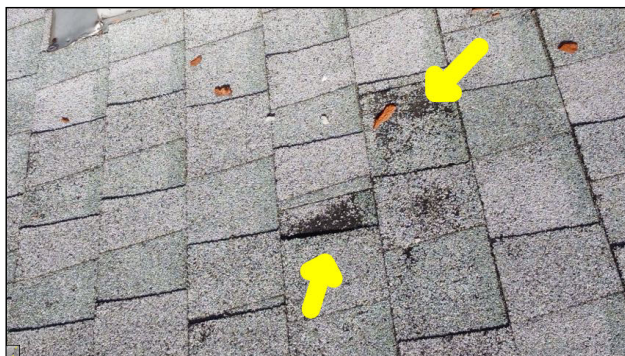
Granule loss along the roof shingles

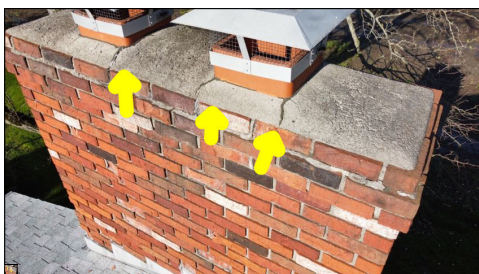
Cracks along the chimney. Cracks are considered defects and potential leak points.

- Poor ✓
- Findings:
- Recommend chimney professional further evaluate and make necessary repairs
 - Before using the fireplace, it is recommended that a licensed chimney/fireplace professional further evaluate to ensure the fireplace is in good working condition and is safe for usage.

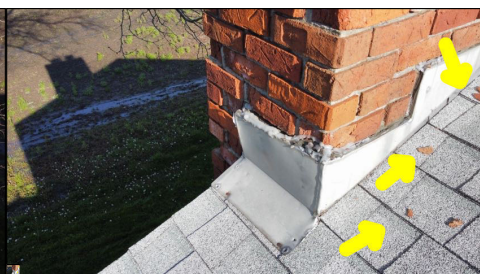
Pieces of brick from the chimney that is laying along the roof shingles. This is an indication that the chimney is deteriorating.

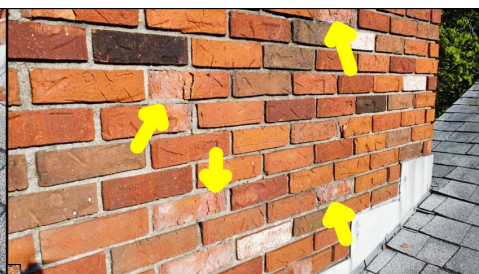
Deterioration and cracking along the chimney. Deterioration and cracks are potential leak points.

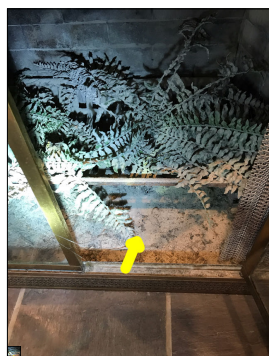
The fireplace is dirty and needs cleaning/serviced.

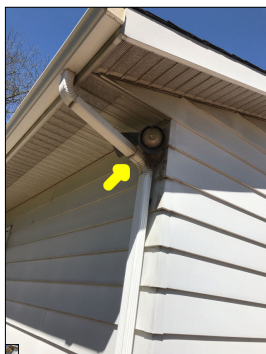
Bird's nest. Wildlife activity can cause property damage.

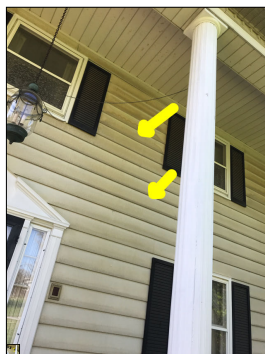
Discoloration along the siding.

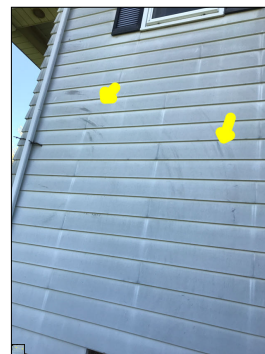
Discoloration along the siding.

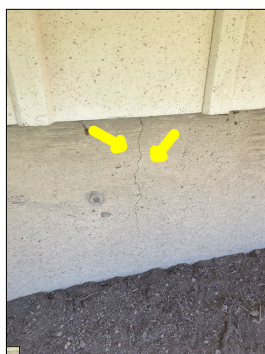
Cracks along the foundation. Cracks are considered a defect. Cracks should be repaired/sealed to prevent the intrusion of moisture, insects, wood destroying insects, mice, and radon.

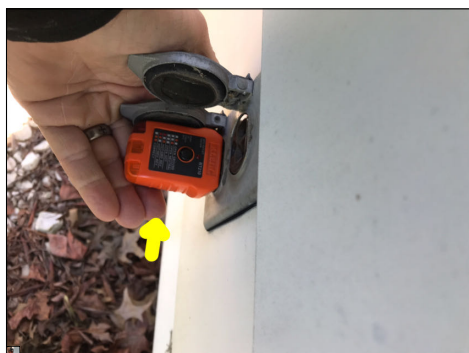
The receptacle is inoperable.

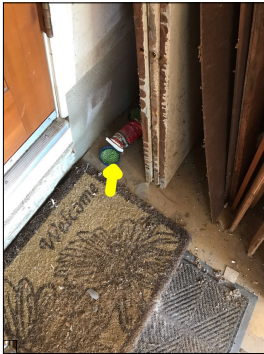
Pest control observed. Wildlife activity can cause property damage.

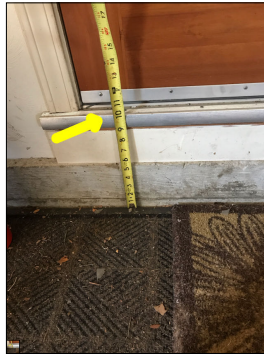
The riser/step coming into the house from the garage is unconventionally high. This is a potential trip hazard. The recommended maximum height for a riser/step is 7 inches.

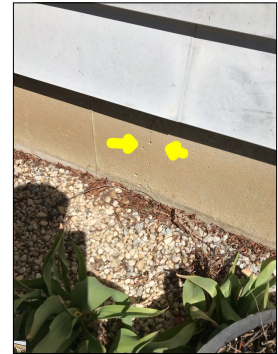
Crack along the slab. Cracks are considered a defect. Cracks should be repaired/sealed to prevent the intrusion of moisture, insects, radon, wood destroying insects, mice, etc.

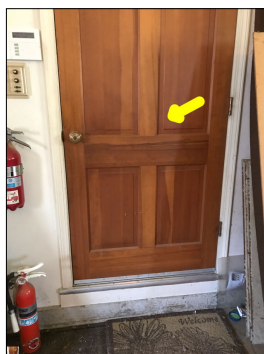
The door that separates the interior of the house from the garage does not appear to be proper fire rated door. The current door appears to be hollow. The door must be solid wood or be a metal door. The current door is a potential safety hazard.

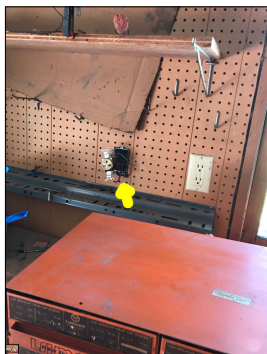
Exposed wires. This is a potential safety hazard.

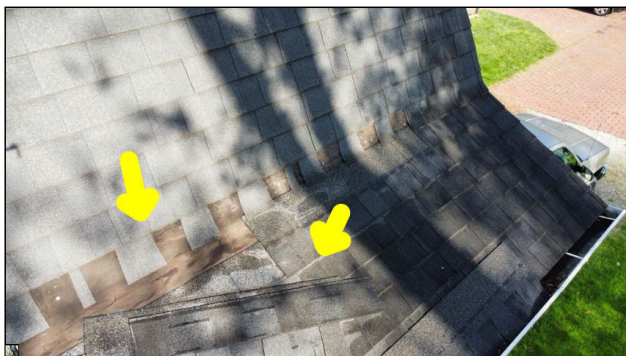
Pole Barn		
Page 14 Item: 9	Roof	• Missing/loose roof shingles.
Heating System		
Page 41 Item: 3	Heating System	• The furnace short cycles. This means the burners turn off and on repeatedly before reaching the designated desired temperature setting on the thermostat. This is considered a defect.

Missing/loose roof shingles.

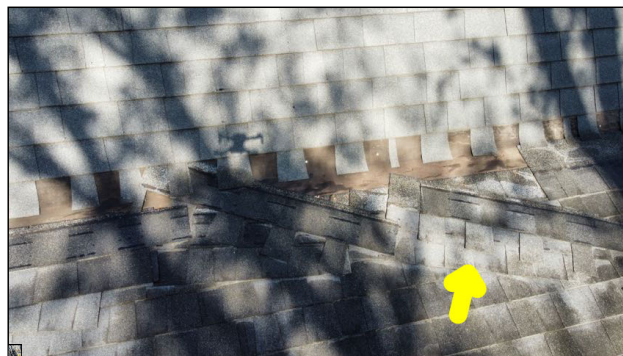
Missing/loose roof shingles.

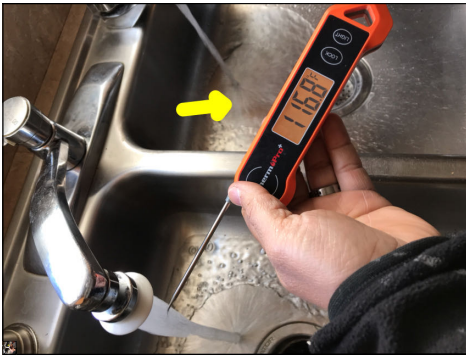
Temperature reading of the hot water during the time of the inspection. The approximate temperature of the hot water was 116 degrees Fahrenheit.

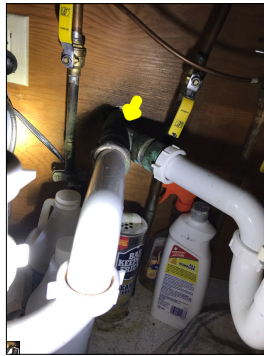
Aged copper drain pipes. Copper pipes make good water supply lines, however, they are not as effective for drain pipes. This is because copper drain pipes are thin walled, which means they are not very robust. Also, some cleaning products and house hold products are acidic which causes copper pipes to corrode. Also, urine is acidic, which can also cause copper pipes to corrode. Due to the age of copper drain pipes, repairs should be anticipated and possible replacement of copper drain pipes should be anticipated.

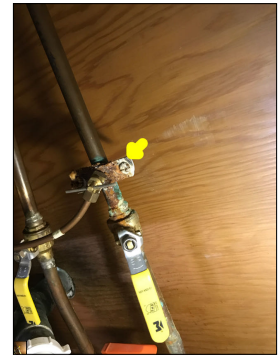
Rust/corrosion along the plumbing pipes.

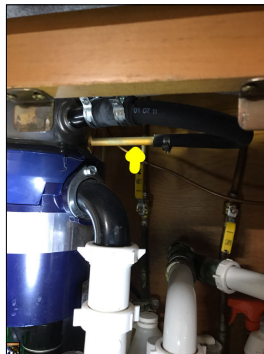
The dishwasher drain line does not have a high loop. A high loop prevents drain water from flowing into the dishwasher and contaminating the clean dishes.

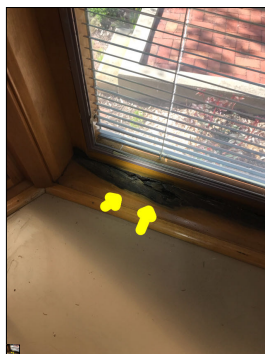
Wood rot damage along the window.

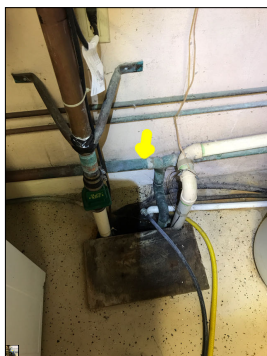
The washing machine unconventionally discharges into the floor drain/pit. This is not a recommended practice and does not meet the industry standard. The washing machine should discharge into the main drain pipes. Recommend licensed plumber further evaluate and make necessary repairs.

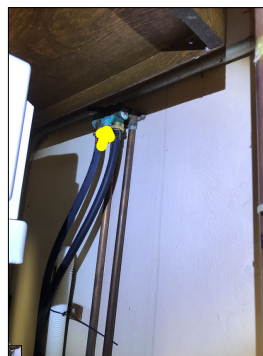
Rust/corrosion along the washer hook up lines.

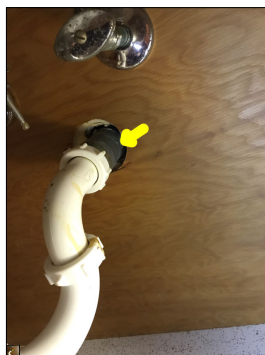
Aged copper drain pipes. Copper pipes make good water supply lines, however, they are not as effective for drain pipes. This is because copper drain pipes are thin walled, which means they are not very robust. Also, some cleaning products and house hold products are acidic which causes copper pipes to corrode. Also, urine is acidic, which can also cause copper pipes to corrode. Due to the age of copper drain pipes, repairs should be anticipated and possible replacement of copper drain pipes should be anticipated.

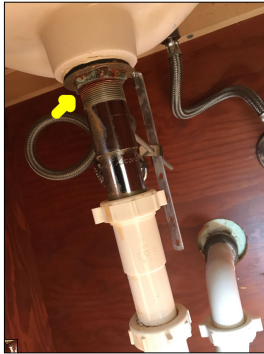
Rust/corrosion along the plumbing pipes.

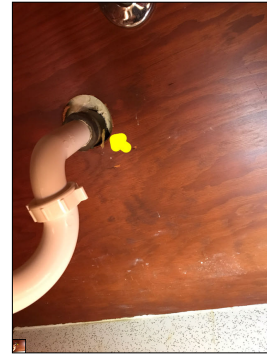
Aged copper drain pipes. Copper pipes make good water supply lines, however, they are not as effective for drain pipes. This is because copper drain pipes are thin walled, which means they are not very robust. Also, some cleaning products and house hold products are acidic which causes copper pipes to corrode. Also, urine is acidic, which can also cause copper pipes to corrode. Due to the age of copper drain pipes, repairs should be anticipated and possible replacement of copper drain pipes should be anticipated.

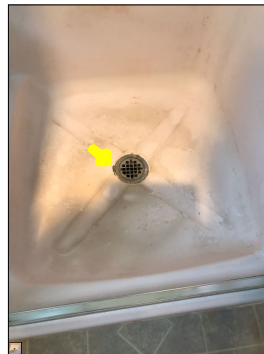
Chips along the shower. Chips are considered defects and are potential leak points.

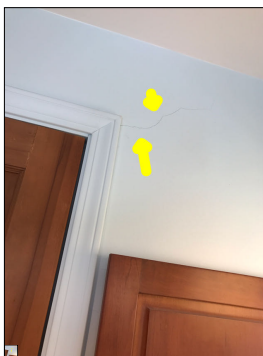
Cracks along the walls.

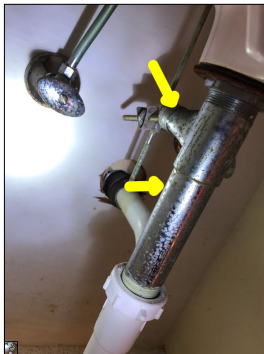
Rust/corrosion along the plumbing pipes.

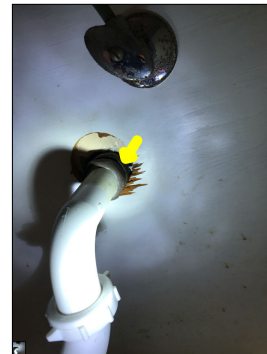
Aged copper drain pipes. Copper pipes make good water supply lines, however, they are not as effective for drain pipes. This is because copper drain pipes are thin walled, which means they are not very robust. Also, some cleaning products and house hold products are acidic which causes copper pipes to corrode. Also, urine is acidic, which can also cause copper pipes to corrode. Due to the age of copper drain pipes, repairs should be anticipated and possible replacement of copper drain pipes should be anticipated.

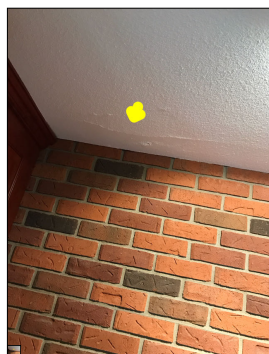
Cracks along the ceiling.

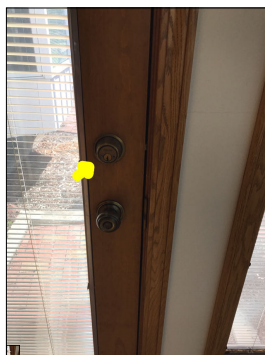
Double-keyed deadbolt lock. Double-keyed deadbolts are considered a safety hazard as they could create restricted egress.

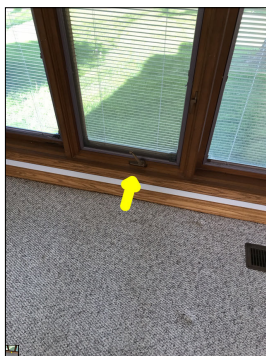
Inoperable window. The window might open with excessive force. Please note, a properly functioning window should be able to easily open.

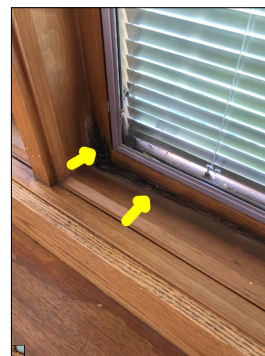
Wood rot damage along the window.

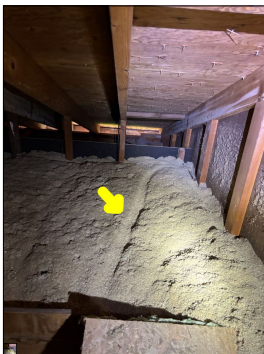
Mice/rodent tracks along the insulation. Wildlife activity can cause property damage.

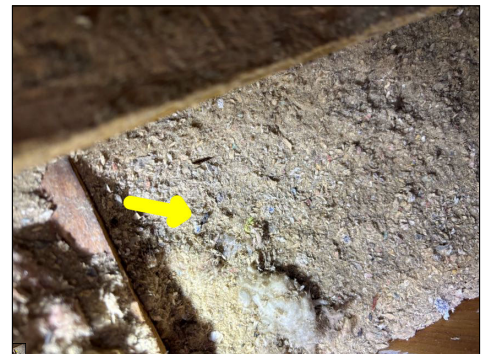
Mice/rodent droppings. Wildlife activity can cause property damage.

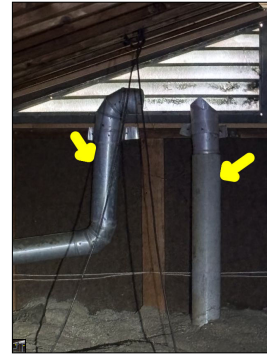
The bathroom exhaust fan vents into the attic. This is not a recommended practice. Exhaust fans venting into the attic can cause mold growth. An active or intermittent water source can cause mold growth. Exhaust fans should vent to the exterior. Exhaust fans should have their own termination and not share a termination with an attic vent, such as a roof vent or soffit. Also, the ductwork for the fan should be properly insulated so condensation does not form along it, thus potentially causing mold growth.

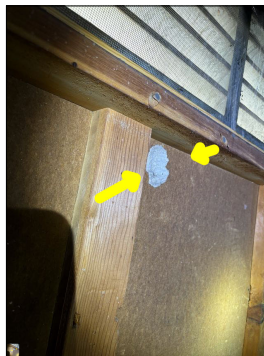
Mud dauber nests observed. Wildlife activity can cause property damage.

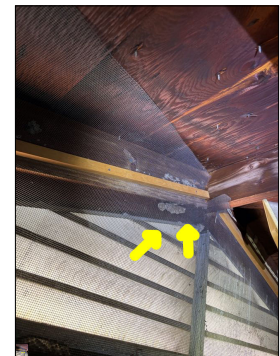
Wasp nest observed. Wildlife activity can cause property damage.

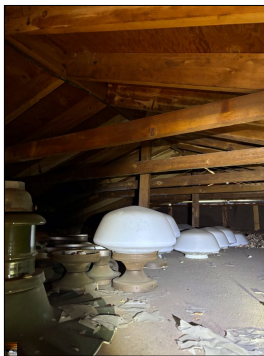
Debris and clutter within the attic. Visibility and accessibility were limited.

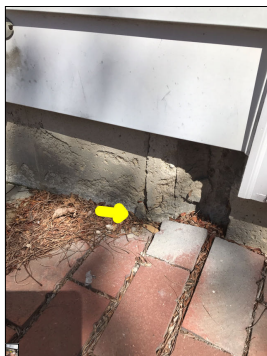
Crack along the foundation. Cracks are considered a defect. Cracks should be repaired/sealed to prevent the intrusion of moisture, insects, wood destroying insects, mice, and radon.

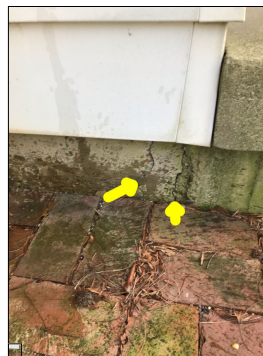
Crack along the foundation. Cracks are considered a defect. Cracks should be repaired/sealed to prevent the intrusion of moisture, insects, wood destroying insects, mice, and radon.

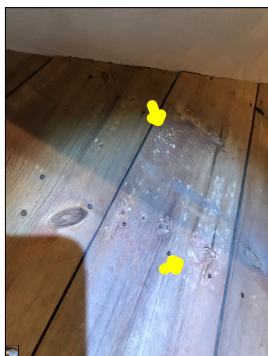
Mold like substance. An active or intermittent water source can cause mold growth and property damage.

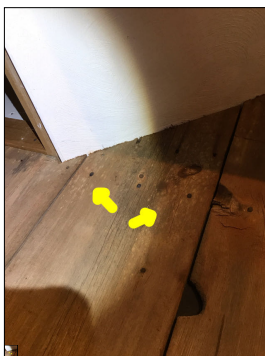
Mold like substance. An active or intermittent water source can cause mold growth and property damage.

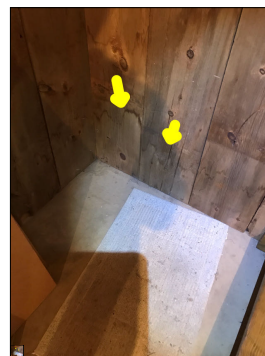
Discoloration along the wall. Discoloration along the wall is considered abnormal and a defect. An active or intermittent water source can cause discoloration, mold growth and property damage.

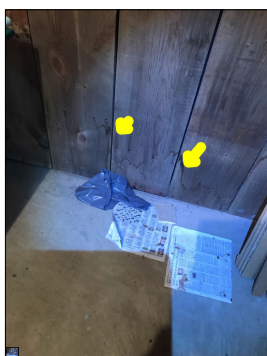
Discoloration along the wall. Discoloration along the wall is considered abnormal and a defect. An active or intermittent water source can cause discoloration, mold growth and property damage.

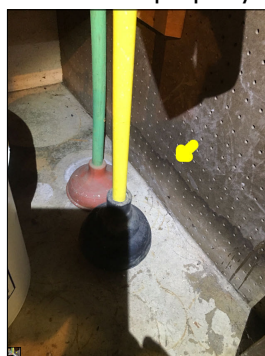
Discoloration along the wall. Discoloration along the wall is considered abnormal and a defect. An active or intermittent water source can cause discoloration, mold growth and property damage.

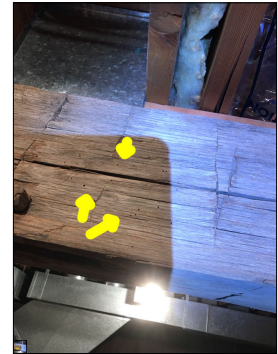
Exit holes observed. Exit holes are an indication of an infestation of powderpost beetles. Powderpost beetles are a wood destroying insect and can cause structural damage and property damage.

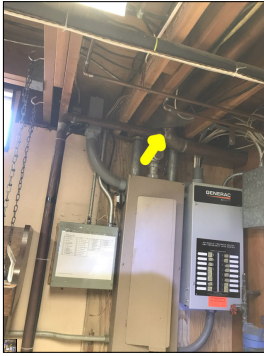
The sump pump discharges into the main drain pipes. This is not a recommended practice and does not meet the industry standard. Sump pumps should discharge to the exterior.

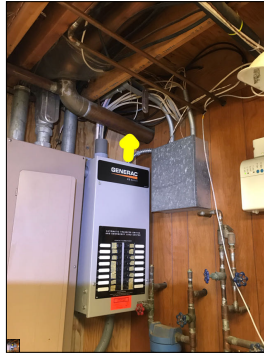
Aged copper drain pipes. Copper pipes make good water supply lines, however, they are not as effective for drain pipes. This is because copper drain pipes are thin walled, which means they are not very robust. Also, some cleaning products and house hold products are acidic which causes copper pipes to corrode. Also, urine is acidic, which can also cause copper pipes to corrode. Due to the age of copper drain pipes, repairs should be anticipated and possible replacement of copper drain pipes should be anticipated.

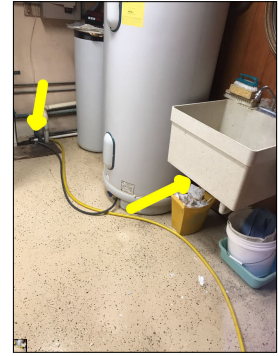
The sink unconventionally discharges into the floor drain/pit. This is not a recommended practice and does not meet the industry standard. The sink should discharge into the main drain pipes. Recommend licensed plumber further evaluate and make necessary repairs.

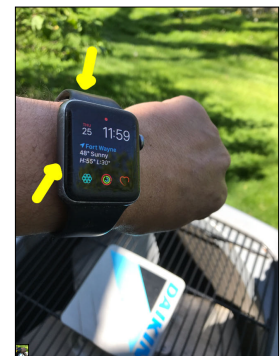
The outdoor temperature during the time of the inspection was approximately 48 degrees Fahrenheit. Due to the cold weather conditions during the time of the inspection. The performance level and working condition of the air conditioner could not be determined.

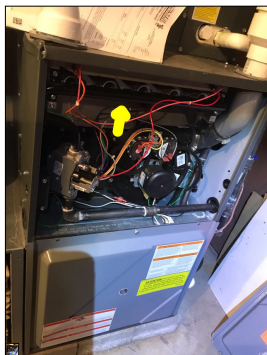
- The furnace short cycles. This means the burners turn off and on repeatedly before reaching the designated desired temperature setting on the thermostat. This is considered a defect.

The furnace short cycles. This means the burners turn off and on repeatedly before reaching the designated desired temperature setting on the thermostat. This is considered a defect.

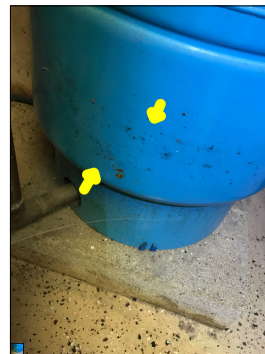
Mold like substance along the pressure tank. An active or intermittent water source can cause mold growth and property damage.

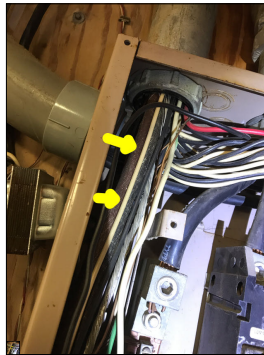
Cloth sheathing wiring observed. Cloth sheathing wiring is considered aged wiring. The cloth sheathing can become brittle due to age, thus causing wires to be exposed, which can cause spark, arcing and or fire. Also, cloth sheathing can potentially have asbestos in it. Asbestos is a potential safety hazard.

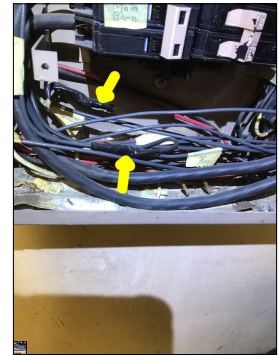
Unconventional spliced wires within the circuit breaker panel. Electrical tape is not a proper method for splicing wires.

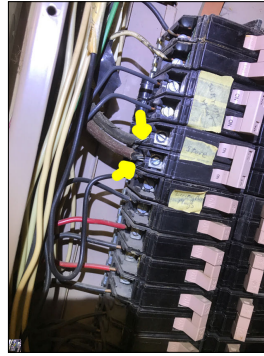
Aluminum stranded branch wire. It is required by the standards of practice to let the client know the metallic type of branch wiring. Aluminum stranded branch wire is common for current electrical wiring practices.

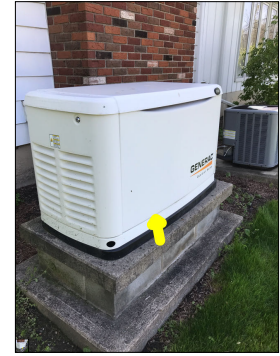
Generator observed. A home generator should have annual routine maintenance to ensure the unit is operable and is in good working condition. Recommend checking with the seller to receive proper maintenance records for annual inspections and maintenance. It is beyond the scope of a general home inspection to test and operate a home generator.

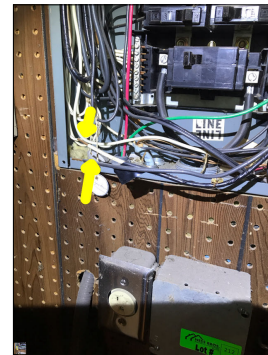
Loose/unused wires. Loose/unused wires are considered a safety hazard.
