# **FAMILYGUARD**

## **HOME INSPECTION REPORT**

**5715 W. 1200 N.-35 South Whitley, IN 46787**  
**Inspection Prepared For: Seller**

**Date of Inspection: 7/8/2024**  
**Age of House: 165 Years**  
**Weather: Clear**

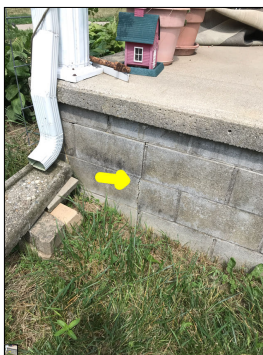
Cracks and deterioration along the porch.

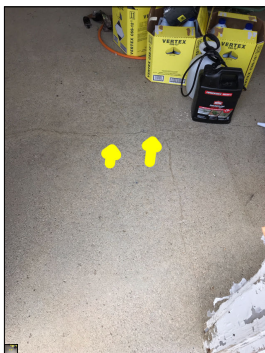
Cracks and deterioration along the patio.

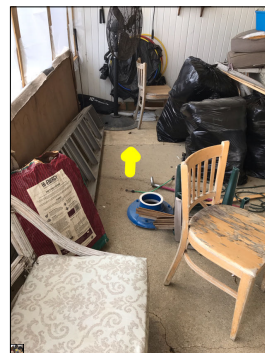
Cracks and deterioration along the patio.

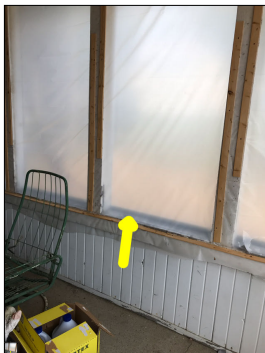
Unconventional plastic along the windows. This is considered abnormal.

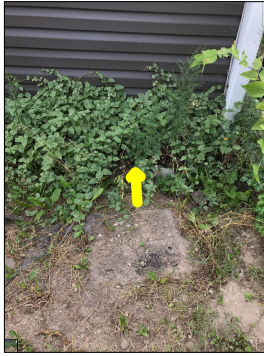
Vegetation against the siding/in proximity of the siding. This is not a recommended practice. Vegetation has the potential to harbor insects, wood destroying insects, rodents and hold moisture. Insects, wood destroying insects, rodents and moisture have the potential to create future problems for a house, such as structural damage, pest infestation and wood rot damage.

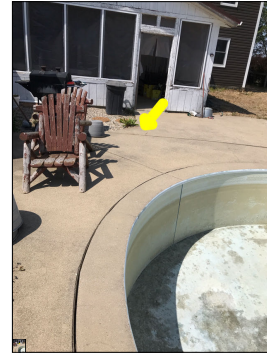
Negative sloped grade. A negative sloped grade is not a recommended practice. A negative sloped grade can cause excessive water to flow towards the house. Excessive water towards the house can cause water intrusion into the house and potential foundation problems due to excessive hydrostatic pressure.

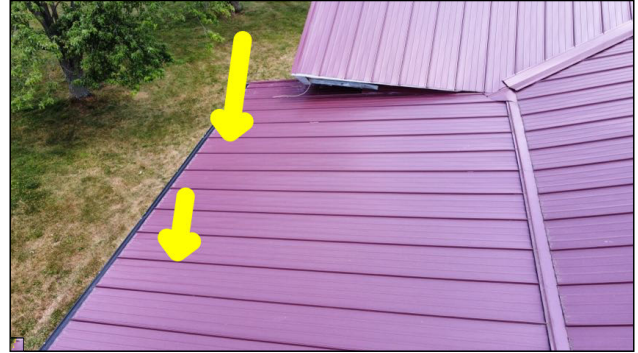
The metal roof is missing a snow/ice guard. The lack of a snow/ice guard can allow large sheets of ice and snow to slide off of the roof, thus potentially causing property damage and/or bodily harm.

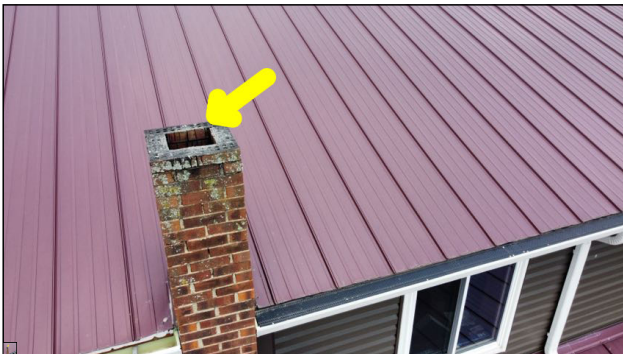
The chimney does not have a rain cap/spark arrestor. A rain cap/spark arrestor keeps rain water, small animals and pests from getting within the chimney. A spark arrestor prevents the emission of flammable debris from combustion sources. Spark arrestors help prevent surrounding objects from catching on fire, such as a tree or roof.

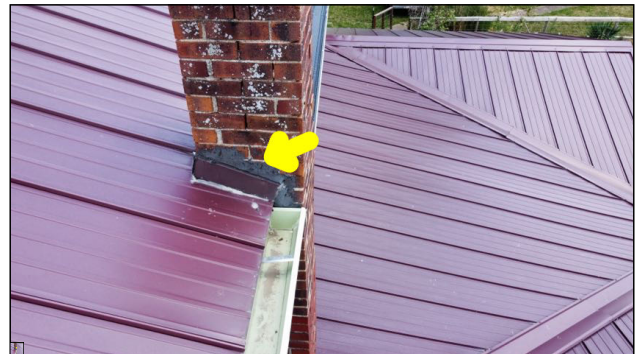
Unconventional application of roof sealant along the base of the chimney. This is considered abnormal and amateur craftsmanship. Amateur craftsmanship is prone to failure and leakage.

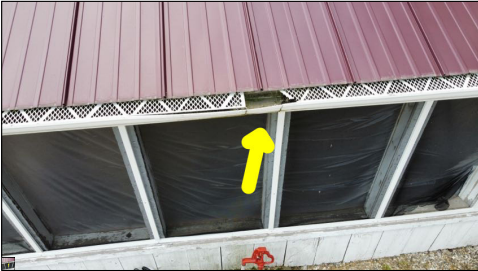
Missing section of gutter guards.

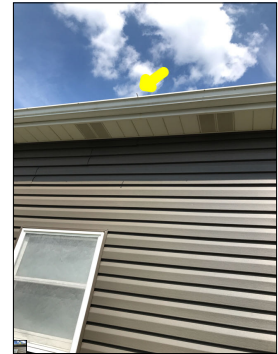
Loose gutter spikes.

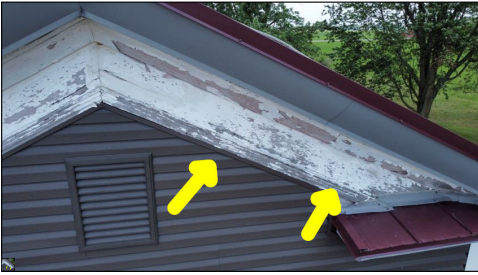
Flaking and peeling along the siding.

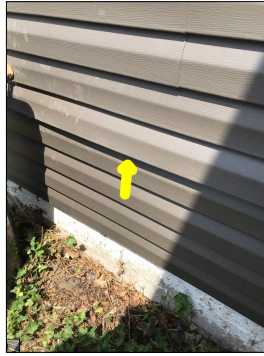
Loose/detached siding.

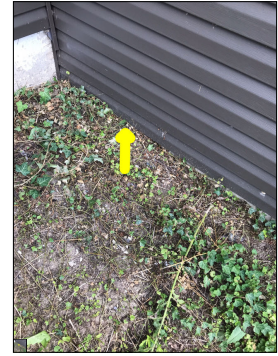
The siding is in proximity to the ground. Siding should have at least 6 to 8 inches of clearance above the ground. Maintaining proper clearances reduces access to wood structures behind the siding and helps preserve the house. The proper clearances help restrict access from wood destroying insects and/or moisture/water that might find its way behind the siding.

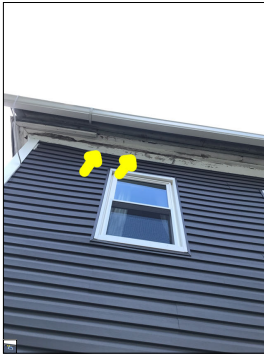
Flaking and peeling along the siding.

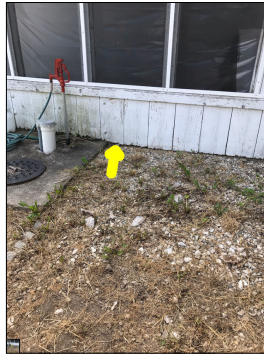
Wood rot damage.

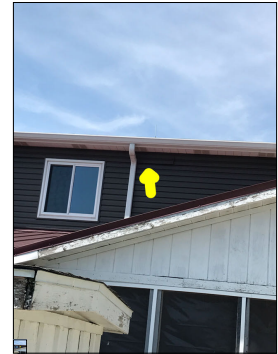
Loose/detached siding.

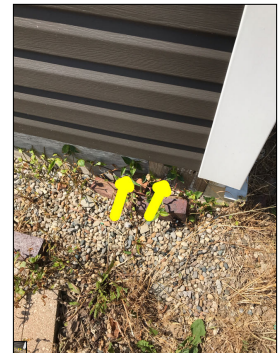
Wood to soil contact. This is not a recommended practice. Water and moisture from the soil/earth can wick up along the exterior and the water can be absorbed by interior building materials. Interior building material includes, but not limited to, drywall, insulation and framing. An active or intermittent water source can cause property damage, such as wood rot damage. Also, the wood to soil contact can enable the infestation of wood destroying insects, such as termites or powderpost beetles.

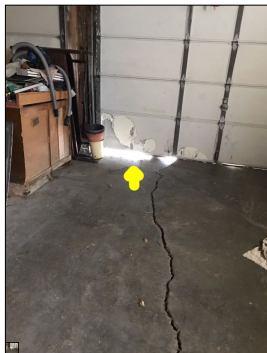
The weatherstrip is partially torn/missing along the overhead garage door. The lack of a proper weatherstrip can allow the intrusion of moisture, insects, wood destroying insects, mice and rodents into the property.

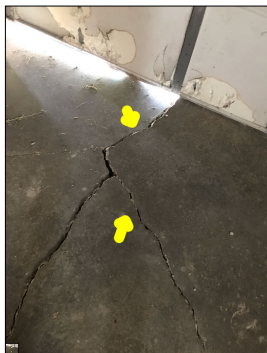
Cracks and deterioration along the floor.

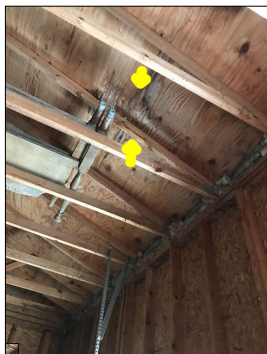
Discoloration along the ceiling and signs of previous water damage. An active or intermittent water source can cause mold growth and property damage.

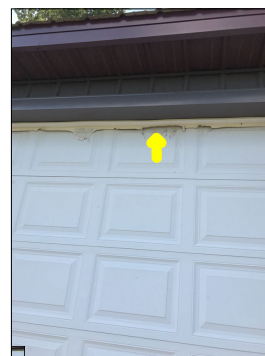
The weatherstrip is partially torn/missing along the overhead garage door. The lack of a proper weatherstrip can allow the intrusion of moisture, insects, wood destroying insects, mice and rodents into the property.

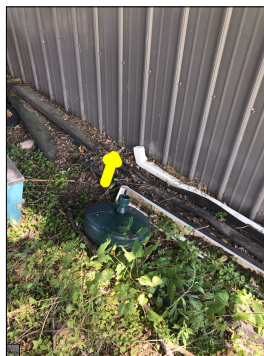
The siding is in proximity to the ground. Siding should have at least 6 to 8 inches of clearance above the ground. Maintaining proper clearances reduces access to wood structures behind the siding and helps preserve the house. The proper clearances help restrict access from wood destroying insects and/or moisture/water that might find its way behind the siding.

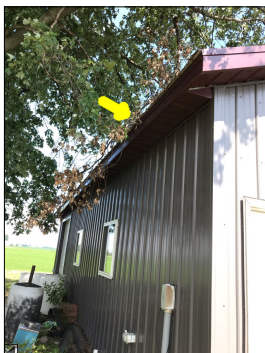
The gutter system is missing. The lack of a gutter system can allow excessive water to accumulate around the foundation. Excessive water around the foundation can cause water intrusion into the house and potential foundation problems due to excessive hydrostatic pressure.

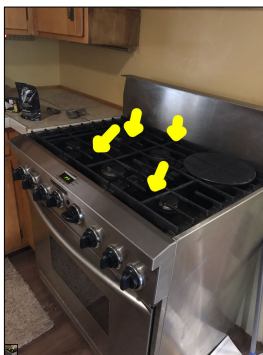
Inoperable burners. The burners do not ignite.

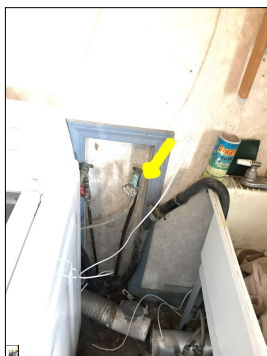
Rust/corrosion along the washer hook up lines.

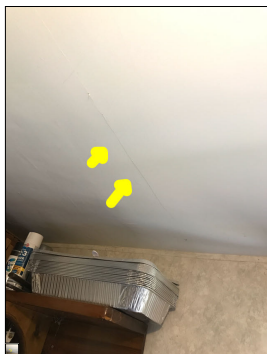
Cracks along the ceiling.

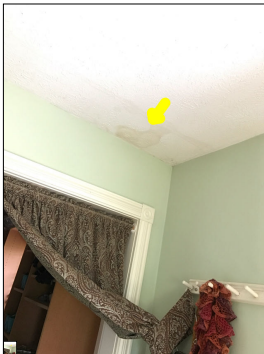
Discoloration along the ceiling and signs of previous water damage. An active or intermittent water source can cause mold growth and property damage.

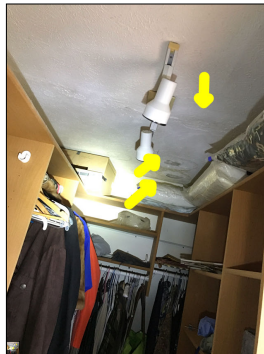
Discoloration along the ceiling and signs of previous water damage. An active or intermittent water source can cause mold growth and property damage.

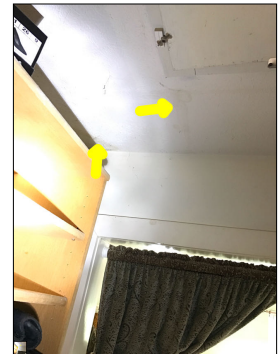
Discoloration along the ceiling and signs of previous water damage. An active or intermittent water source can cause mold growth and property damage.

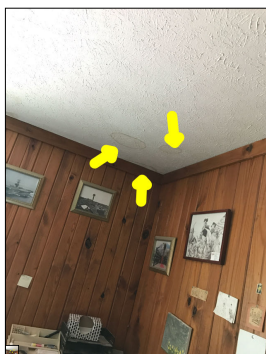
Discoloration along the ceiling and signs of previous water damage. An active or intermittent water source can cause mold growth and property damage.

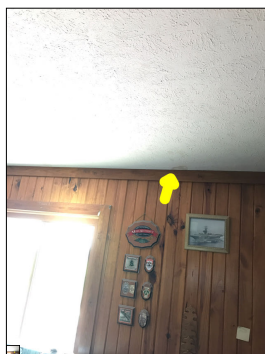
Discoloration along the ceiling and signs of previous water damage. An active or intermittent water source can cause mold growth and property damage.

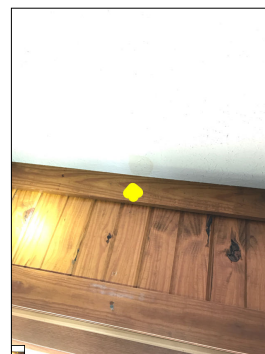
Discoloration along the ceiling and signs of previous water damage. An active or intermittent water source can cause mold growth and property damage.

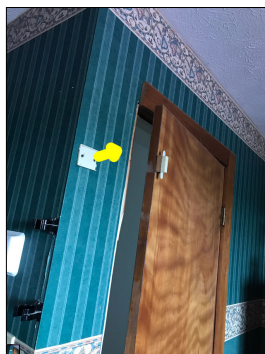
The door rubs the frame during operation. Also, missing casing along the door.

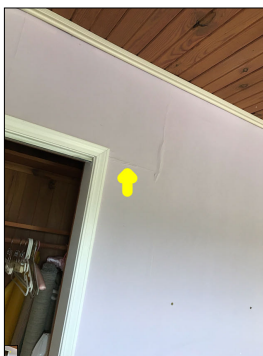
Cracks along the walls.

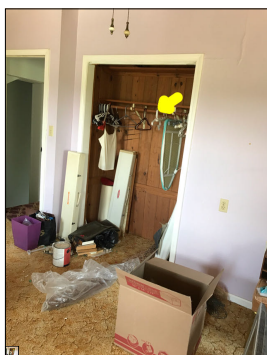
Missing door.

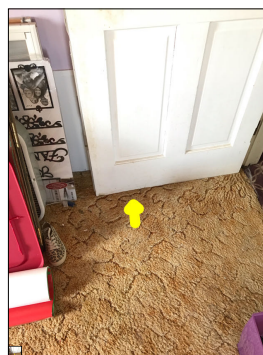
The door drags the floor during operation.

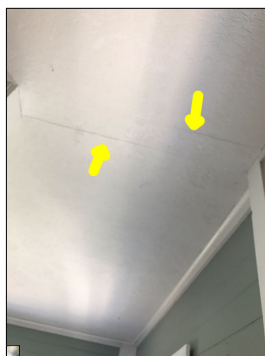
Cracks along the ceiling.

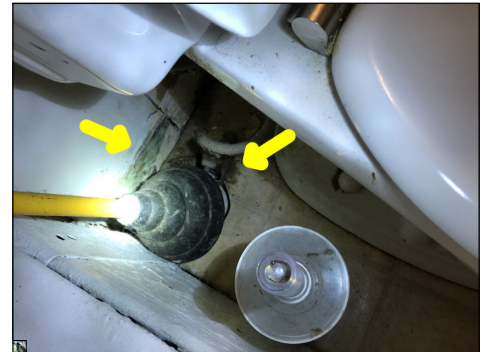
Discoloration along the wall and signs of previous water damage. An active or intermittent water source can cause mold growth and property damage.

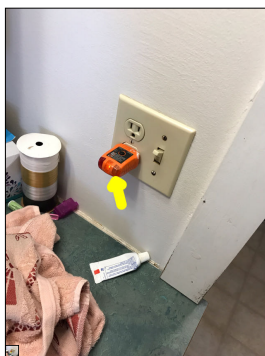
Open ground receptacles

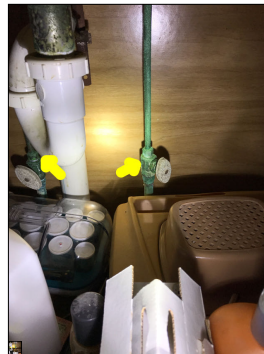
Rust/corrosion along the plumbing pipes.

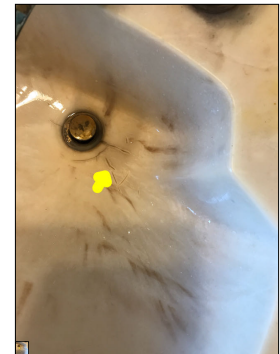
Cracks along the sink.

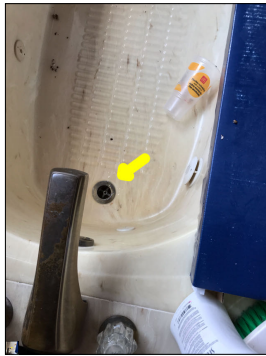
Missing drain stopper. Due to the missing drain stopper, the whirlpool jets could not be properly tested.

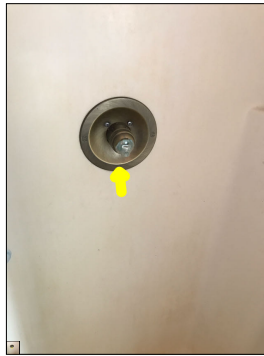
Missing handle. The lack of a handle makes it difficult to operate the showerhead.

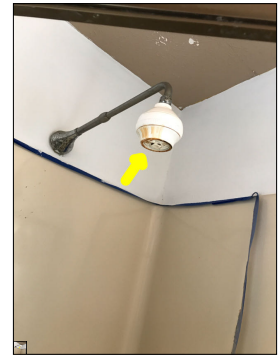
The showerhead leaks when turned off. This is considered abnormal and a defect.

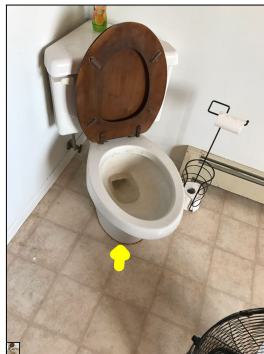
The toilet is loose. The toilet rocks back and forth. A toilet should not have any movement and be fully anchored and secured to the floor.

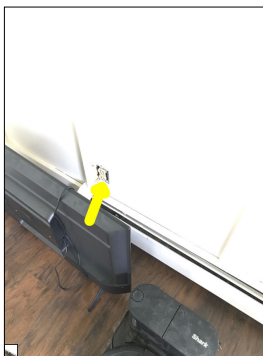
Missing receptacle covers.

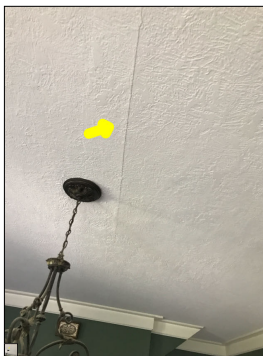
Cracks along the ceiling.

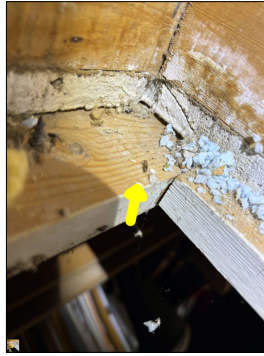
Mice/rodent droppings. Wildlife activity can cause property damage.

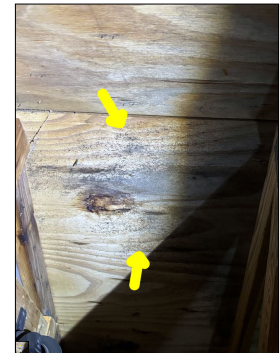
| Attic/Structure/Framing/Insulation | | |
|---|---|---|
| Page 39 Item: 6 | Sheathing/Framing | • Mold like substance along the sheathing/framing. An active or intermittent water source can cause mold growth and property damage, such as wood rot damage. |

Mold like substance along the sheathing/framing. An active or intermittent water source can cause mold growth and property damage, such as wood rot damage.

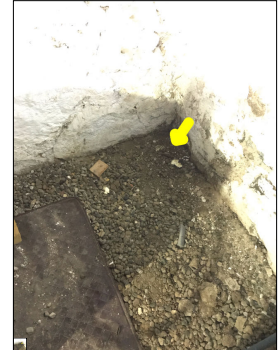
| Attic/Structure/Framing/Insulation | | |
|---|---|---|
| Page 40 Item: 3 | Foundation/Floor | • Moisture/dampness observed. This is considered a defect. An active or intermittent water source can cause mold growth and property damage. |

Moisture/dampness observed. This is considered a defect. An active or intermittent water source can cause mold growth and property damage.

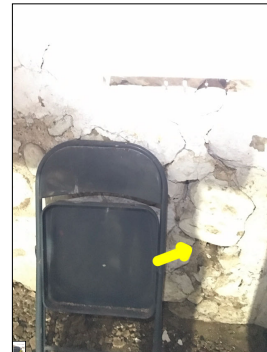
Aged field stone foundation.

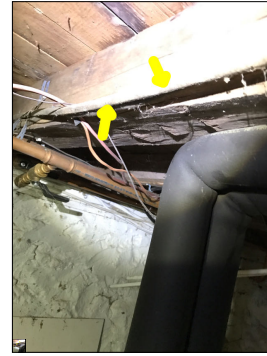
Cloth sheathing wiring observed. Cloth sheathing wiring is considered aged wiring. The cloth sheathing can become brittle due to age, thus causing wires to be exposed, which can cause spark, arcing and or fire. Also, cloth sheathing can potentially have asbestos in it. Asbestos is a potential safety hazard.

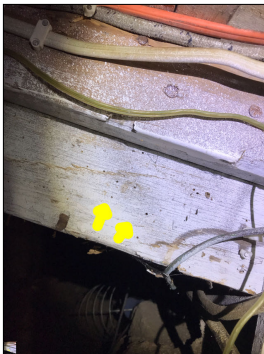
Exit holes observed. Exit holes are an indication of an infestation of powderpost beetles. Powderpost beetles are a wood destroying insect and can cause structural damage and property damage.

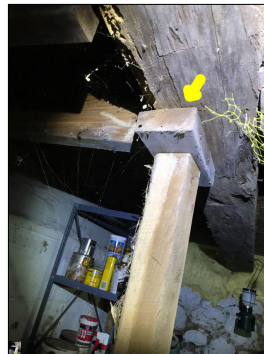
Unconventional alterations and column supports. This is considered amateur craftsmanship. Amateur craftsmanship is prone to failure.

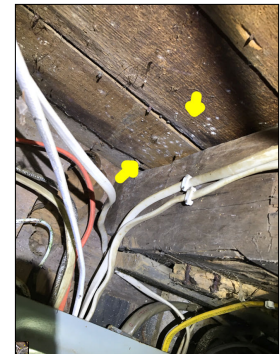
Mold like substance along the subfloor. An active or intermittent water source can cause mold growth and property damage.

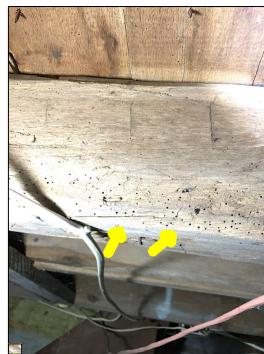
Exit holes observed. Exit holes are an indication of an infestation of powderpost beetles. Powderpost beetles are a wood destroying insect and can cause structural damage and property damage.

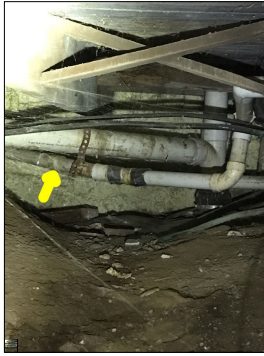
Negative sloped drain pipe. This is not a recommended practice and does not meet the industry standard. A negative sloped drain pipe can cause slow drainage and possible blockage. Also, there is some unconventional tape along the drain line. This is considered amateur craftsmanship.

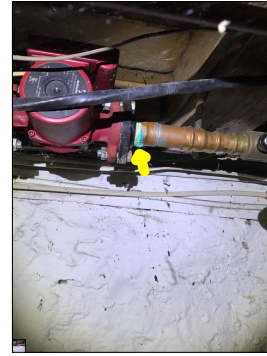
Rust and corrosion along the plumbing pipes.

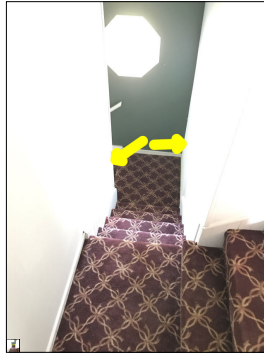
Missing handrail.

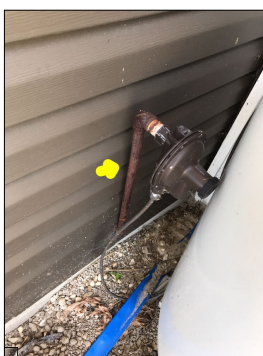
Rust and corrosion along the fuel lines. Rust and corrosion can create holes along the fuel lines, thus creating a fuel leak.

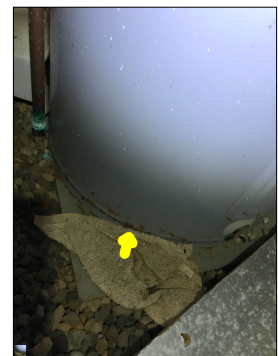
Rust and corrosion along the water heater. This is considered a defect. An active or intermittent water source can cause property damage and mold growth.

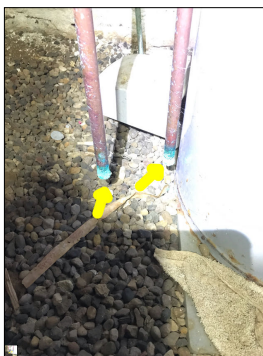
Corrosion along the end of the temperature and pressure relief valve extension. This is considered a defect and an indication that the water heater might have discharged in the past.

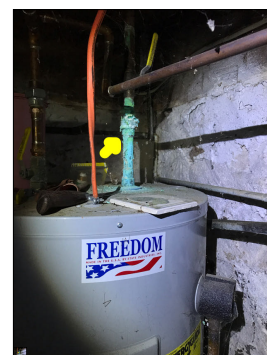
Corrosion along the water supply lines.

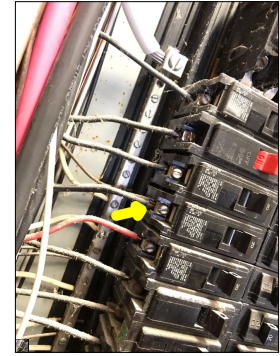
Double tapped circuit breaker. Two conductors inserted into a single circuit breaker that is rated for one conductor could become loose over time which could lead to overheating, arcing, spark and possible fire.
