FAMILYGUARD

HOME INSPECTION REPORT

623 Stratton Rd. Fort Wayne, IN 46825
Inspection Prepared For: Seller

Date of Inspection: 9/11/2024
Age of House: 41 Years
Weather: Clear

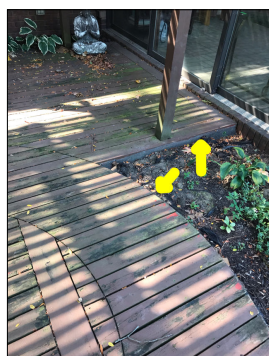
The deck has wood to soil contact. This is not a recommended practice. Water and moisture from the soil/earth can wick up along the deck and the water can be absorbed by the deck. An active or intermittent water source can cause property damage, such as wood rot damage. Also, the wood to soil contact can enable the infestation of wood destroying insects, such as termites or powderpost beetles.

- Recommend refinishing

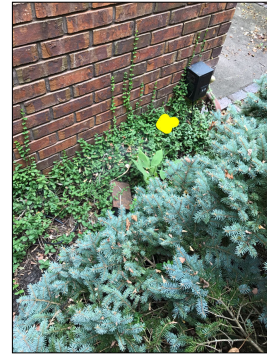
Vegetation against the siding/in proximity of the siding. This is not a recommended practice. Vegetation has the potential to harbor insects, wood destroying insects, rodents and hold moisture. Insects, wood destroying insects, rodents and moisture have the potential to create future problems for a house, such as structural damage, pest infestation and wood rot damage.

- Trim back trees/shrubberies
- Remove wood/leaves/debris from around house

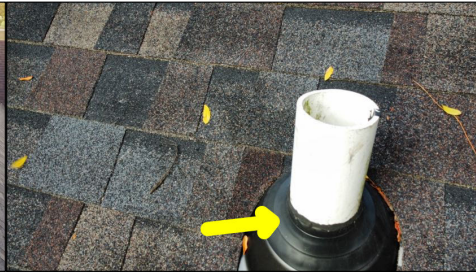
Unconventional application of roof sealant along the rubber flashing. Rubber flashing is designed to be caulkless. This is considered amateur craftsmanship. Most roof sealants are petroleum based. A petroleum based product can cause the rubber flashing to prematurely deteriorate, thus creating a leak point.

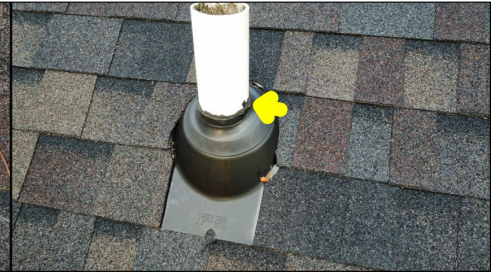
Unconventional application of roof sealant along the rubber flashing. Rubber flashing is designed to be caulkless. This is considered amateur craftsmanship. Most roof sealants are petroleum based. A petroleum based product can cause the rubber flashing to prematurely deteriorate, thus creating a leak point.

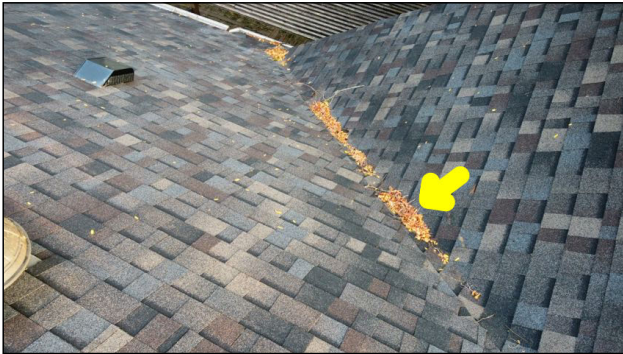
Debris along the roof. Excessive debris along the roof can restrict the ability of the roof to shed water, thus creating potential leak points.

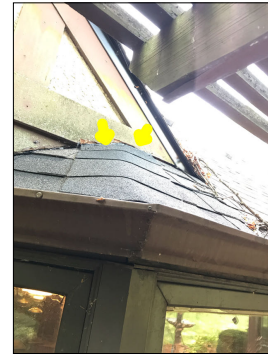
Unconventional application of sealant along the roof. This is considered abnormal and amateur craftsmanship. Amateur craftsmanship is prone to failure and leakage.

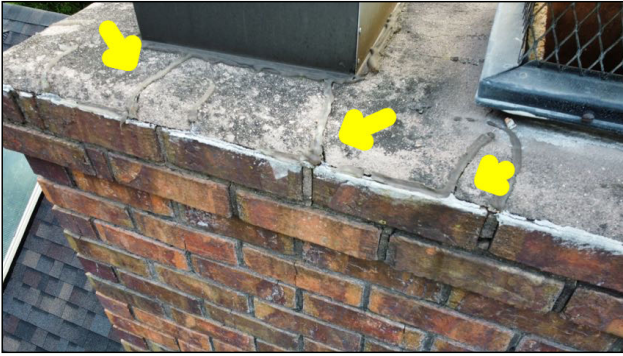
Cracks along the chimney. Cracks are considered defects and potential leak points.

- Needs cleaning/serviced
- Before using the fireplace, it is recommended that a licensed chimney/fireplace professional further evaluate to ensure the fireplace is in good working condition and is safe for usage.

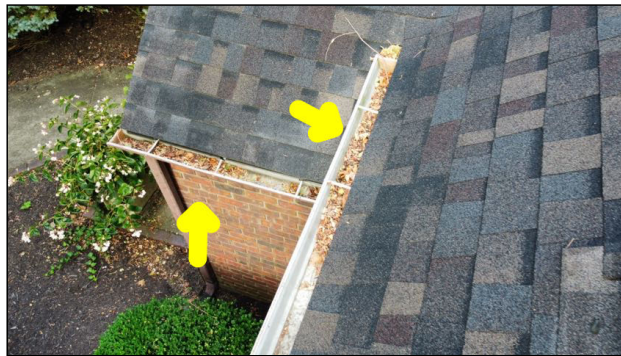
The gutter system is dirty and needs to be cleaned. A dirty gutter system can cause excessive water to accumulate around the house, thus potentially causing water intrusion into the house or potential foundation problems due to excessive hydrostatic pressure. Also, a dirty gutter system can cause excessive water to flow along the siding which could allow water to get behind the siding. An active or intermittent water intrusion source can cause mold growth and property damage.

- Need to be cleaned

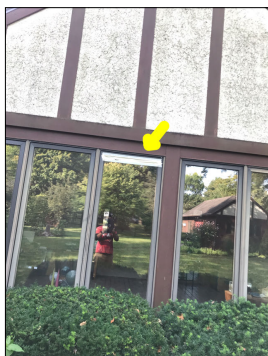
Unconventional tape along the window.

- Recommend general contractor further evaluate and make necessary repairs

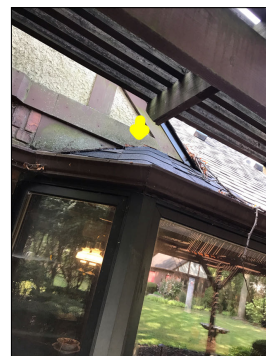
Damaged siding.

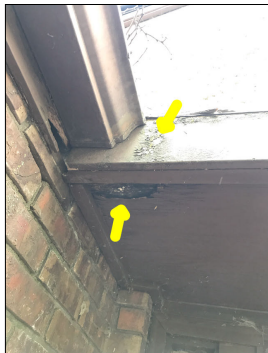
Wood rot damage.

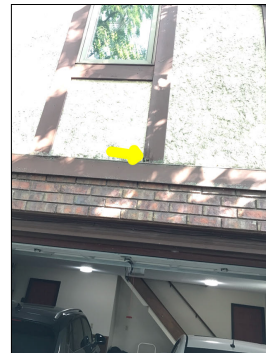
Wood rot damage.

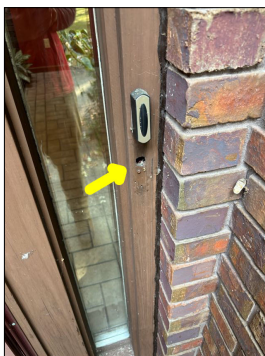
Hole along the siding.

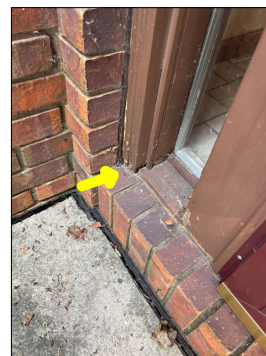
Wood rot damage.

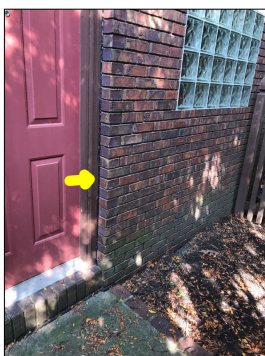
Unconventional application of caulk along the brick. This is considered abnormal and amateur craftsmanship.

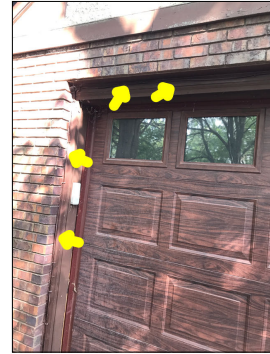
Unconventional cables routed along the overhead garage door. This is considered abnormal and amateur craftsmanship.

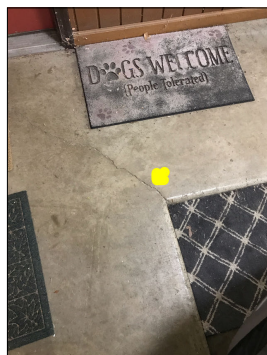
Cracks and deterioration along the floor.

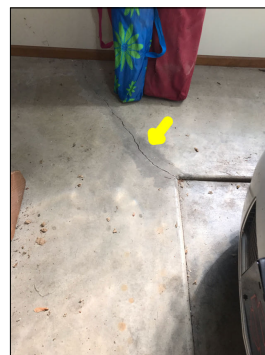
Cracks and deterioration along the floor.

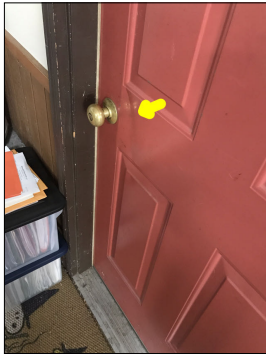
Damage/dents along the door.

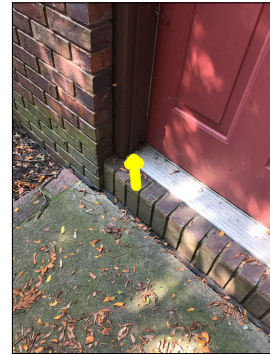
Wood rot damage along the service door.

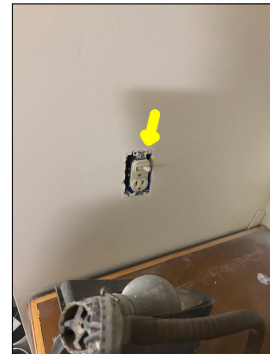
Missing receptacle cover.

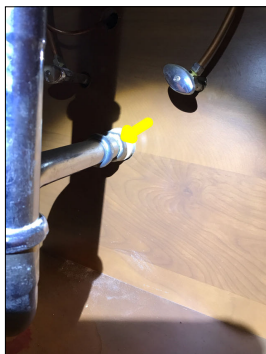
Rust/corrosion along the plumbing pipes. This is underneath the sink in the living room.

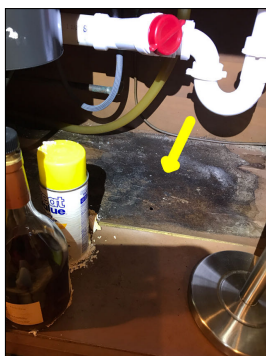
Signs of previous water damage underneath the sink and a mold like substance. An active or intermittent water source can cause mold growth and property damage, such as wood rot damage.

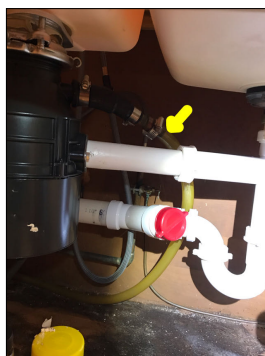
The dishwasher drain line does not have a high loop. A high loop prevents drain water from flowing into the dishwasher and contaminating the clean dishes.

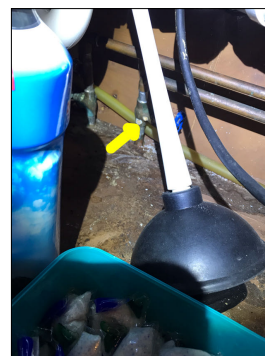
Rust/corrosion along the plumbing pipes.

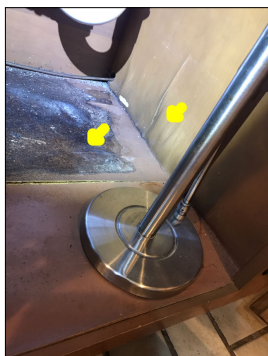
Signs of previous water damage underneath the sink and a mold like substance. An active or intermittent water source can cause mold growth and property damage, such as wood rot damage.

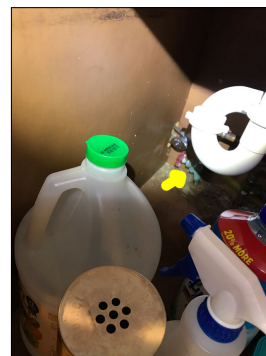
Rust/corrosion along the plumbing pipes.

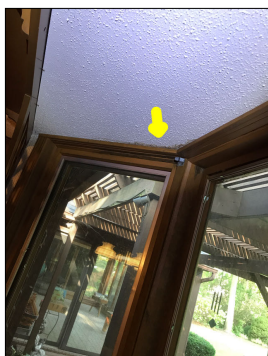
Discoloration along the ceiling. Discoloration along the ceiling is considered abnormal and a defect. An active or intermittent water source can cause discoloration, mold growth and property damage.

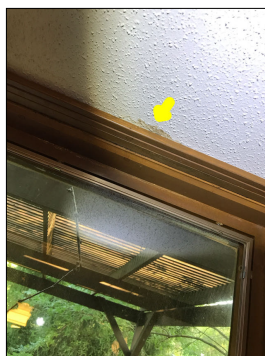
Discoloration along the ceiling. Discoloration along the ceiling is considered abnormal and a defect. An active or intermittent water source can cause discoloration, mold growth and property damage.

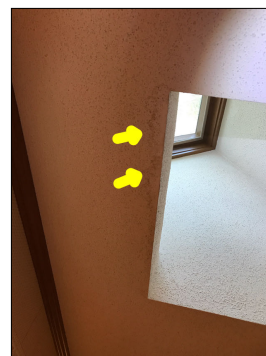
Discoloration along the ceiling. Discoloration along the ceiling is considered abnormal and a defect. An active or intermittent water source can cause discoloration, mold growth and property damage.

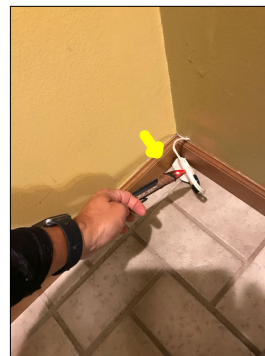
Exposed wires/unconventional wires sticking out from the wall. This is a potential safety hazard.

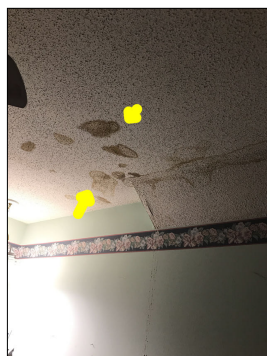
Discoloration along the ceiling. Discoloration along the ceiling is considered abnormal and a defect. An active or intermittent water source can cause discoloration, mold growth and property damage.

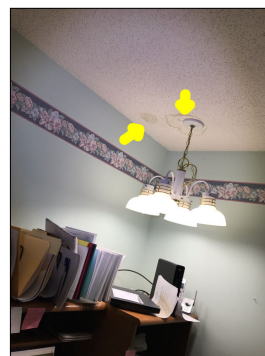
Discoloration along the ceiling. Discoloration along the ceiling is considered abnormal and a defect. An active or intermittent water source can cause discoloration, mold growth and property damage.

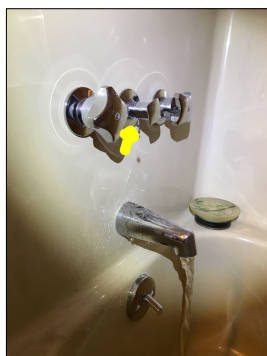
The faucet/handle leaks during operation. This can cause water to leak behind the shower/bath wall. An active or intermittent water source can cause property damage and mold growth.

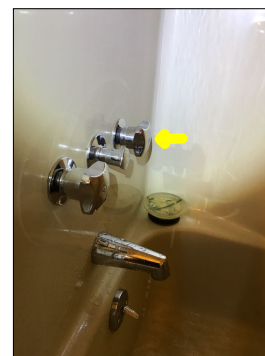
The cold handle is stuck, therefore, making it inoperable. It might move with excessive force.

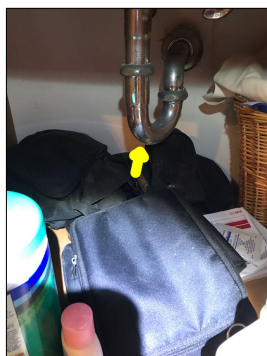
Rust/corrosion along the plumbing pipes.

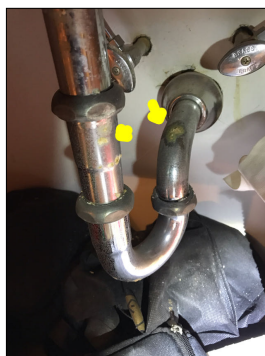
Rust/corrosion along the plumbing pipes.

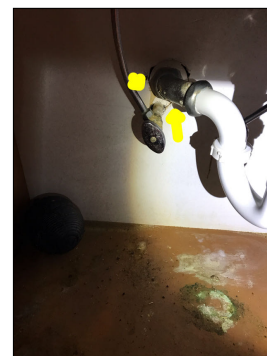
Rust/corrosion along the plumbing pipes.

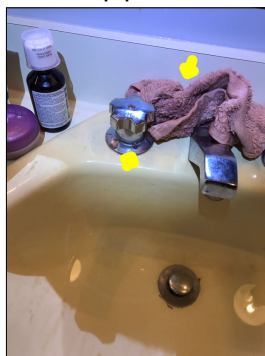
The faucet leaks during operation. A leaking faucet has the potential to leak underneath the sink. An active or intermittent water source can cause property damage and mold growth.

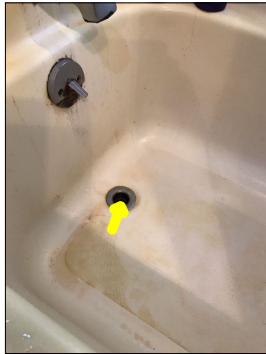
The drain is missing a grate/screen. The lack of a grate/screen over the drain can allow debris down the drain, thus potentially creating slow drainage or blockage.

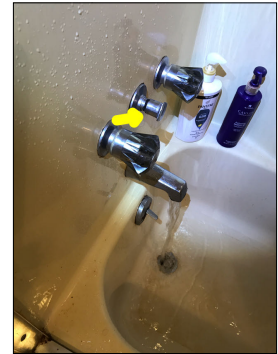
The faucet/handle leaks during operation. This can cause water to leak behind the shower/bath wall. An active or intermittent water source can cause property damage and mold growth.

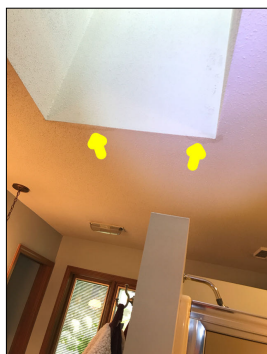
Discoloration along the ceiling and signs of previous water damage. An active or intermittent water source can cause mold growth and property damage.

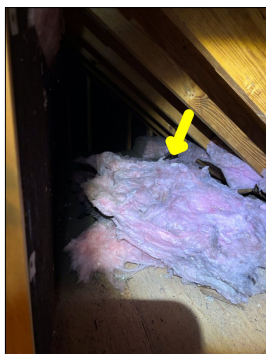
Displaced insulation. Displaced insulation is considered abnormal and a defect.

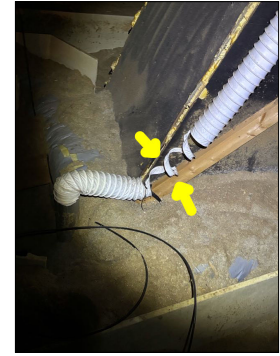
Deterioration along the ductwork, thus causing the bathroom exhaust fan to vent into the attic. This is not a recommended practice. Exhaust fans venting into the attic can cause mold growth. An active or intermittent water source can cause mold growth. Exhaust fans should vent to the exterior. Exhaust fans should have their own termination and not share a termination with an attic vent, such as a roof vent or soffit. Also, the ductwork for the fan should be properly insulated so condensation does not form along it, thus potentially causing mold growth.

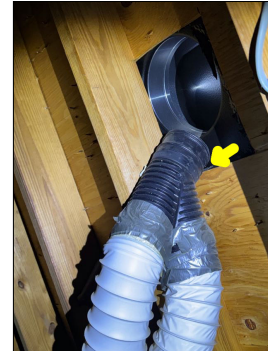
The bathroom exhaust fan vents into the attic. This is not a recommended practice. Exhaust fans venting into the attic can cause mold growth. An active or intermittent water source can cause mold growth. Exhaust fans should vent to the exterior. Exhaust fans should have their own termination and not share a termination with an attic vent, such as a roof vent or soffit. Also, the ductwork for the fan should be properly insulated so condensation does not form along it, thus potentially causing mold growth.

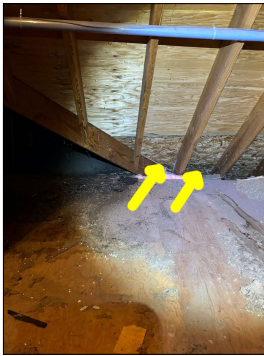
Areas of replaced sheathing. This is an indication that the original sheathing was defective. Normally, due to an intermittent or active water source.

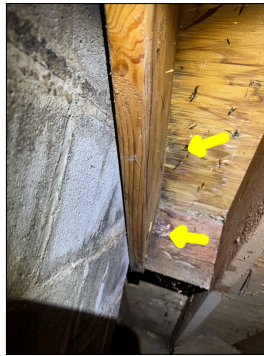
Discoloration along the sheathing. An active or intermittent water source can cause discoloration, mold growth and property damage. This is adjacent to the chimney. No moisture detected in this area on the day of the inspection.

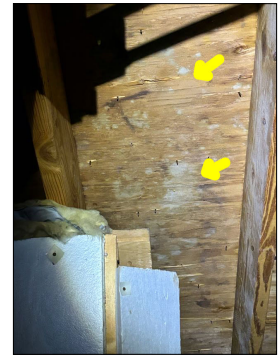
Discoloration along the sheathing. An active or intermittent water source can cause discoloration, mold growth and property damage.

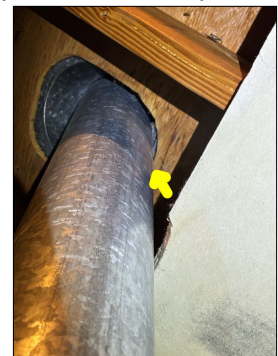
The flue is against the sheathing. This is a potential safety hazard. There should be at minimum a 1 inch clearance around the flue from all combustible materials. Wood is a combustible material.

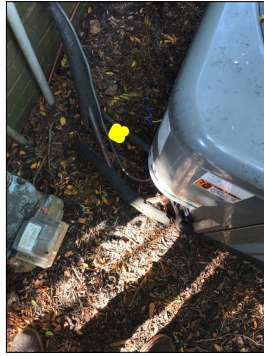
The insulation to the suction line is torn/missing. The insulation on the suction line is important so the refrigerant in the line does not absorb additional heat. The hotter the refrigerant, the harder the condenser has to work, thus shortening the life of the condenser.

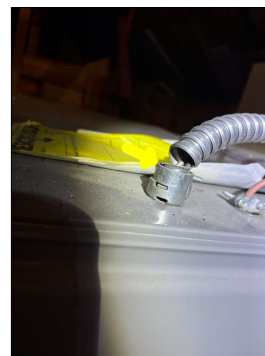
Exposed wires and the conduit is damaged. The metal edge of the conduit could damage the wires, thus potentially causing spark, arcing, and/or fire.

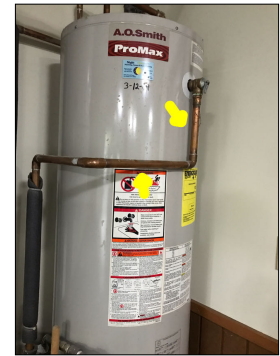
The temperature and pressure relief valve extension has bends along it and is not straight. Temperature and pressure relief valves should be straight and within 6 inches of the floor. The lack of a proper extension is a potential safety hazard.

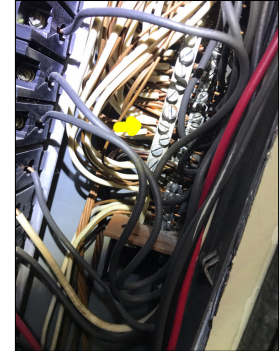
Double tapped neutral wires. Neutral wires should not share a terminal with any other wires, including ground wires. Double tapped neutrals are considered a safety hazard. Double tapped neutral wires do not allow the circuit to be isolated if the circuit needs to be worked on. Also, double tapped neutral wires under the same terminal can become loose, which could lead to arcing, overheating, spark and/or fire.

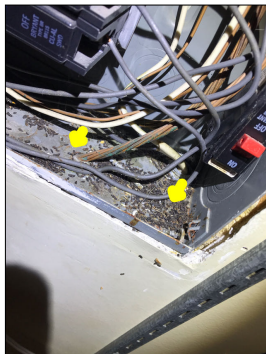
Mice/rodent droppings within the electrical panel. Wildlife activity can cause property damage.

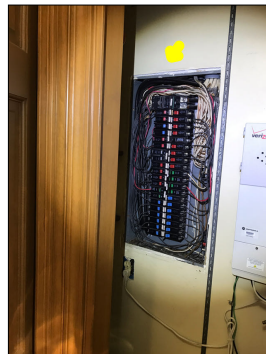
Inadequate clearance around the circuit breaker panel. The lack of proper clearance is a potential safety hazard. Circuit breaker panels should have at minimum, 3 feet depth measured from front edge of the panel, 30 inches minimum width or width of equipment if > 30 inches, working space height of 6 feet, 6 inches or height of equipment, whichever is greater. Required working space must extend to the ground, panel door must be operable to at least 90 degrees.

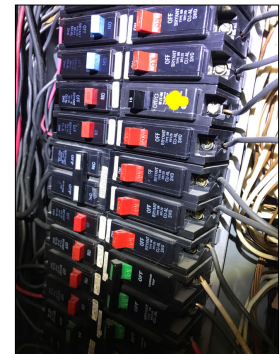
Electrical panel/circuit breaker manufacturer mismatch within the circuit breaker panel. The defect is because not all busbars are the same size and have the same dimensions. A circuit breaker from another manufacturer might not properly fit the busbar, thus creating a poor/loose connection.

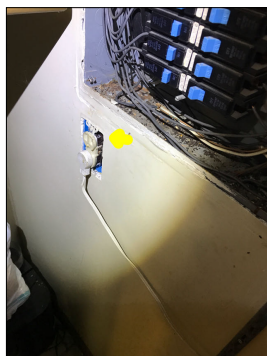
Missing receptacle cover.

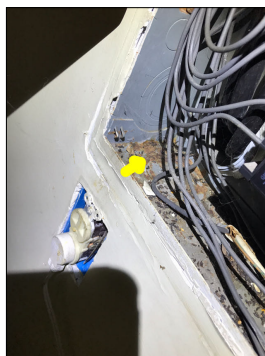
Rust and corrosion within the circuit breaker panel. This is considered abnormal and a potential safety hazard. An active or intermittent water source can cause rust and corrosion.

Rusted/corroded terminals and connections increase resistance in the circuit that can cause overheating, thus causing arcing, spark and/or fire. Some areas of rust and corrosion may not be visible and could be concealed behind breakers, wires, etc.

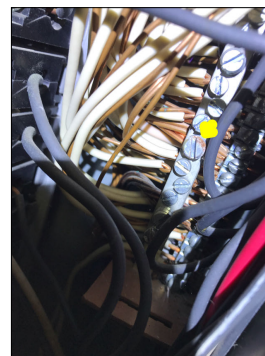
Rust and corrosion within the circuit breaker panel. This is considered abnormal and a potential safety hazard. An active or intermittent water source can cause rust and corrosion.

Rusted/corroded terminals and connections increase resistance in the circuit that can cause overheating, thus causing arcing, spark and/or fire. Some areas of rust and corrosion may not be visible and could be concealed behind breakers, wires, etc.

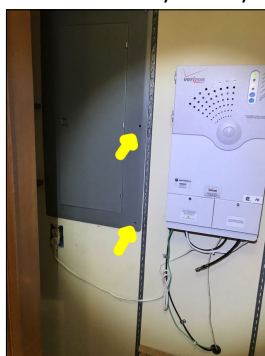
Missing screws.
