FAMILYGUARD

HOME INSPECTION REPORT

305 E. Highland St. Albion, IN 46701
Inspection Prepared For: Seller

Date of Inspection: 9/17/2025
Age of House: 175 Years
Weather: Clear

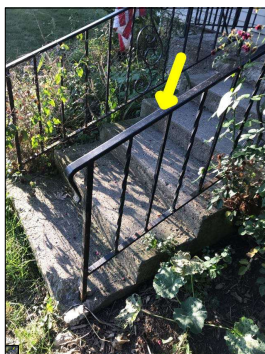
Loose handrails.

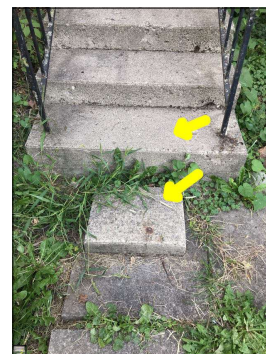
Uneven steps.

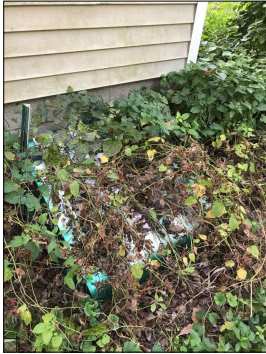
Vegetation against the siding/in proximity of the siding. This is not a recommended practice. Vegetation has the potential to harbor insects, wood destroying insects, rodents and hold moisture. Insects, wood destroying insects, rodents and moisture have the potential to create future problems for a house, such as structural damage, pest infestation and wood rot damage.

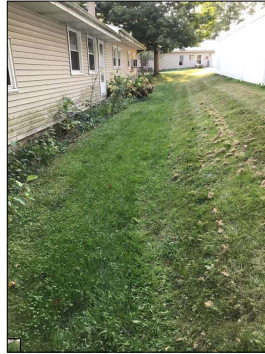
Negative sloped grade. A negative sloped grade is not a recommended practice. A negative sloped grade can cause excessive water to flow towards the house. Excessive water towards the house can cause water intrusion into the house and potential foundation problems due to excessive hydrostatic pressure.

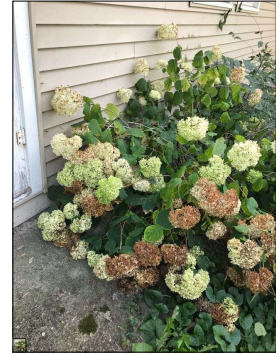
Vegetation against the siding/in proximity of the siding. This is not a recommended practice. Vegetation has the potential to harbor insects, wood destroying insects, rodents and hold moisture. Insects, wood destroying insects, rodents and moisture have the potential to create future problems for a house, such as structural damage, pest infestation and wood rot damage.

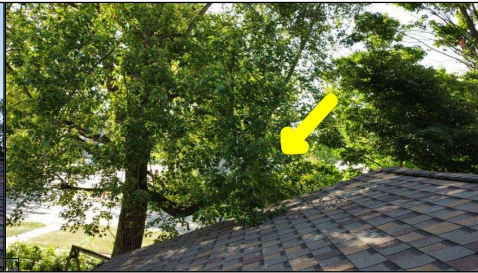
Tree branches observed along the roof. Falling tree branches can cause damage to the roof system, thus resulting in water intrusion into the attic/house.

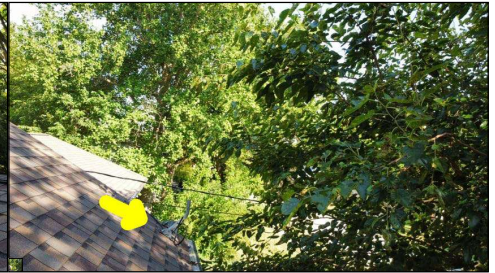
Dish mounted to the roof. While mounting a dish to a roof is a common practice, it is not a recommended practice due to the anchor bolts that penetrate the roof shingles, underlayment and sheathing, thus creating a potential leak point.

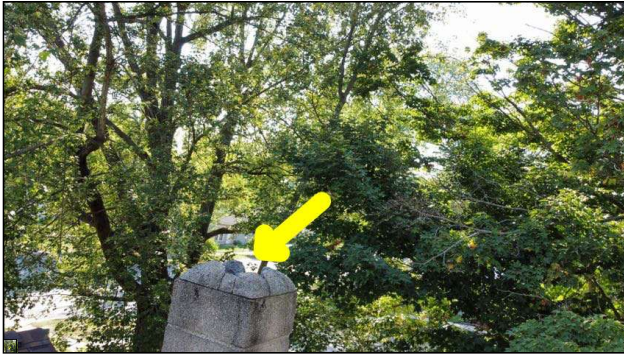
The chimney does not have a rain cap/spark arrestor. A rain cap/spark arrestor keeps rain water, small animals and pests from getting within the chimney. A spark arrestor prevents the emission of flammable debris from combustion sources. Spark arrestors help prevent surrounding objects from catching on fire, such as a tree or roof.

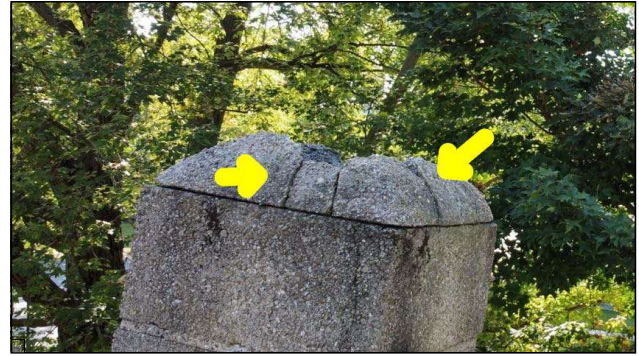
Cracks along the chimney. Cracks are considered defects and potential leak points.

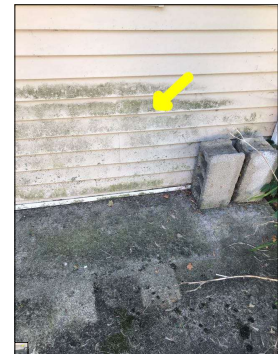
Discoloration along the siding.

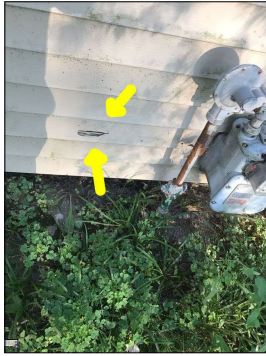
Damaged siding.

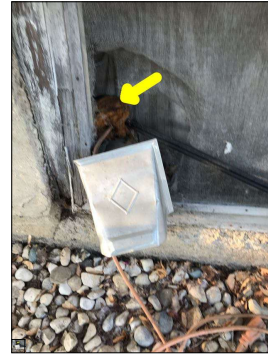
Exposed foam spray along the exterior of the house. This is considered amateur craftsmanship. Foam spray is not rated for exterior use. Amateur craftsmanship is prone to failure and leakage. This installation of the dryer vent is unconventionally.

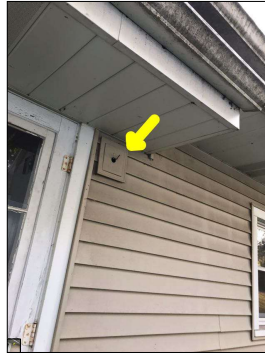
Exposed wires. This is a potential safety hazard.

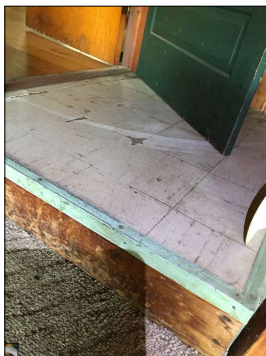
9" X 9" floor tiles. These tiles are potentially asbestos based tiles. Asbestos based products are considered a potential health/safety hazard.

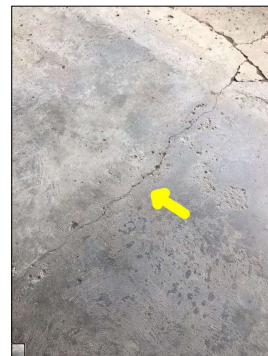
Cracks and deterioration along the floor.

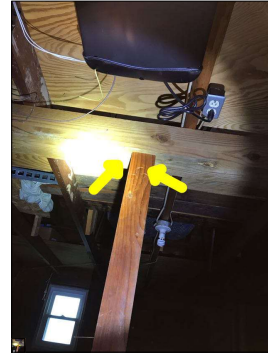
The column does not have bolts/fasteners to the beam. This is considered abnormal. Bolts/fasteners brace the column to the beam to ensure and maintain structural integrity and to prevent the column from experiencing lateral movement. The lack of proper bolts/fasteners is considered amateur craftsmanship. Amateur craftsmanship is prone to failure.

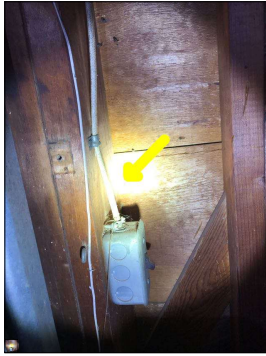
The wires are not wrapped in conduit. This is considered abnormal, amateur craftsmanship and a potential safety hazard. Wires should be wrapped in conduit to protect both humans and the electrical wiring. Wires that lack conduit can potentially get pulled, become loose, or damaged, thus creating shock hazards and/or fire hazards.

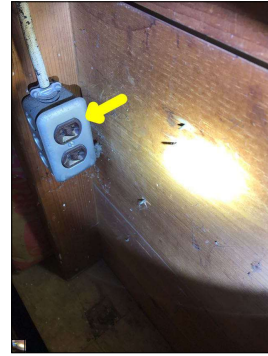
Two prong receptacles. Two prong receptacles are not grounded.

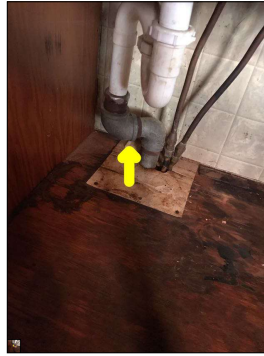
Aged galvanized water lines/pipes. Galvanized pipes no longer meet modern day plumbing standards. Galvanized pipes are prone to corroding from the inside out. Galvanized pipes are towards the end of their life expectancy. Repairs or replacement to galvanized pipes should be anticipated.

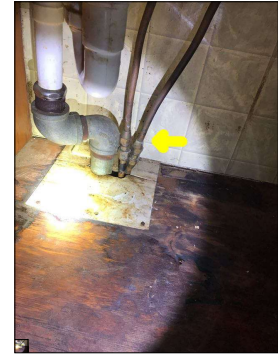
There are no water shut off valves underneath the sink.

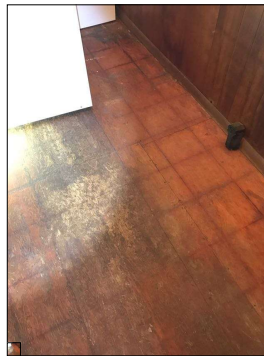
Unfinished floor/missing floor coverings.

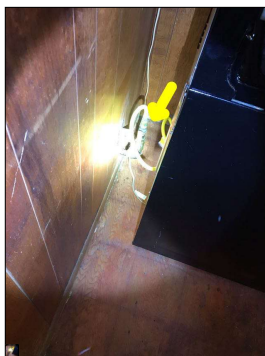
No anti-tip bracket. This is a potential safety hazard.

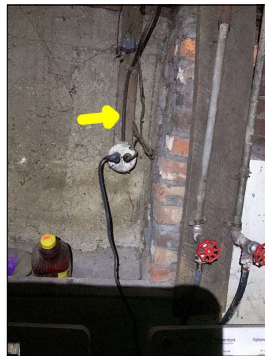
Cloth sheathing wiring observed. Cloth sheathing wiring is considered aged wiring. The cloth sheathing can become brittle due to age, thus causing wires to be exposed, which can cause spark, arcing and or fire. Also, cloth sheathing can potentially have asbestos in it. Asbestos is a potential safety hazard.

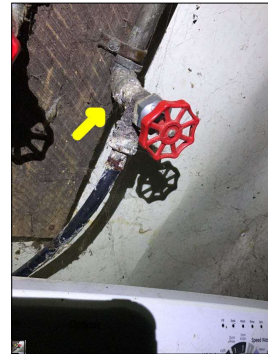
Rust/corrosion along the washer hook up lines.

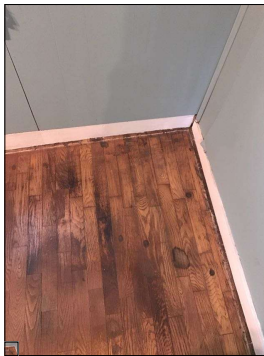
The floor slopes. This is considered abnormal and a defect.

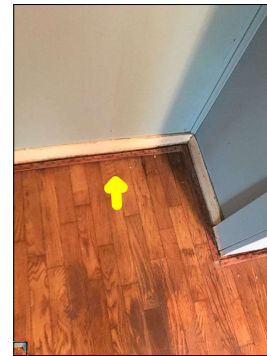
Exposed tack strip.

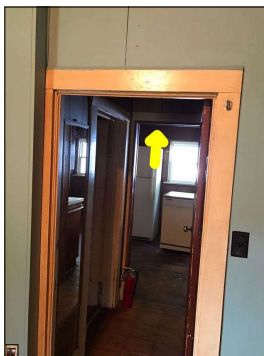
Low overhead clearance. This is a potential safety hazard.

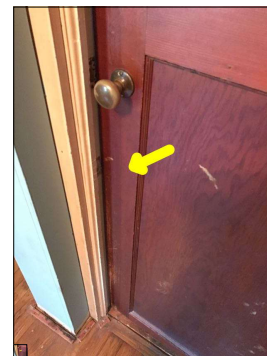
The door rubs the frame during operation.

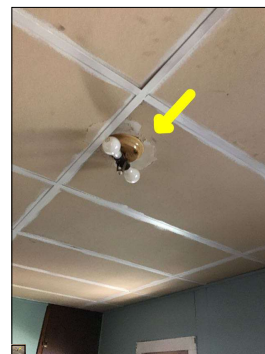
The ceiling light is missing its globe/cover.

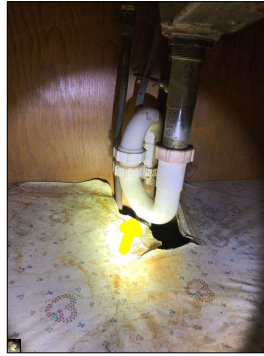
S-trap underneath the sink. S-traps no longer meet modern day plumbing standards. S-traps have the potential to siphon and become dry, thus creating the potential to allow sewer gases into the house. S-traps have the potential to make a knocking/gurgling sound when draining.

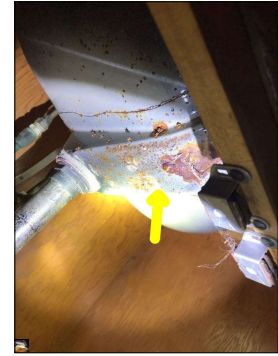
Rust/corrosion along the bottom of the sink.

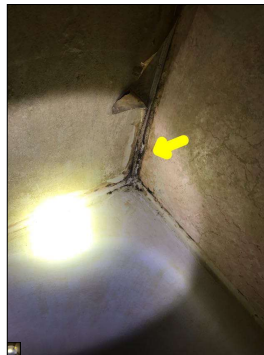
Mold like substance.

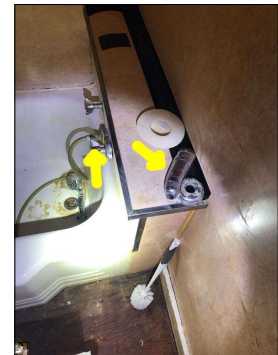
The faucet has been replaced with a spray hose. This is considered abnormal. Also, this is a safety hazard as the spray hose could get submerged in bathtub water, thus potentially contaminating drinking water due to dirty bathtub water gaining access to water supply lines.

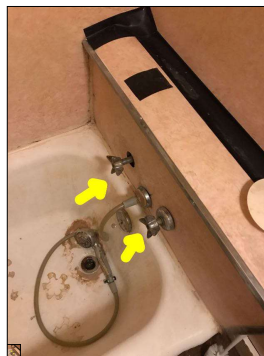
Inoperable spray hose. Opening the handles/valves did not call for water.

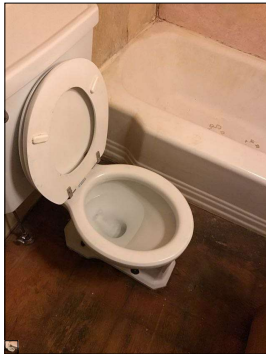
The toilet continuously calls for water. This is considered abnormal and a defect.

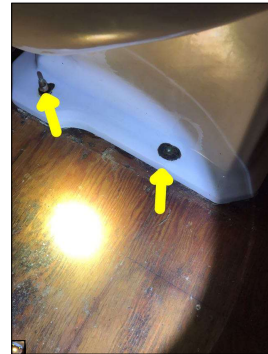
Rust and corrosion along the toilet anchor bolts. This is considered a defect and the rust and corrosion can cause the toilet to become loose and potentially leak.

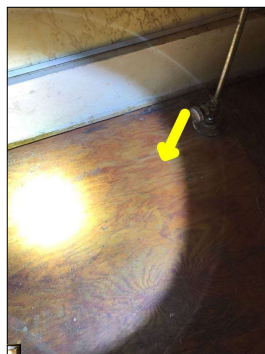
Unfinished floor/missing floor coverings.

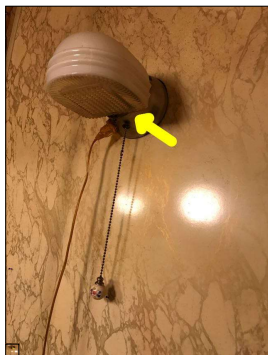
The light is inoperable.

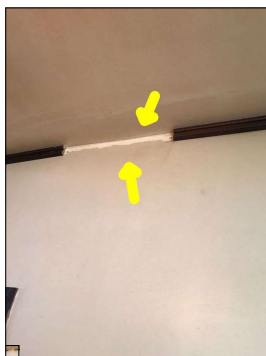
Missing trim sections.

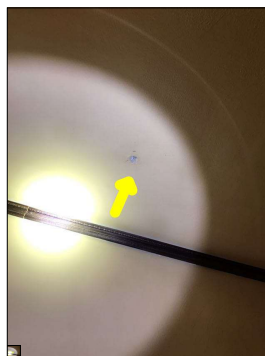
Holes/damage along the ceiling.

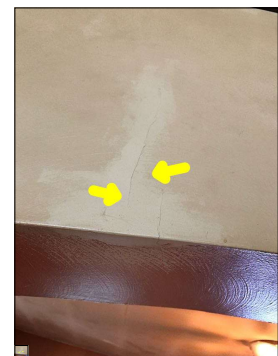
Cracks along the walls.

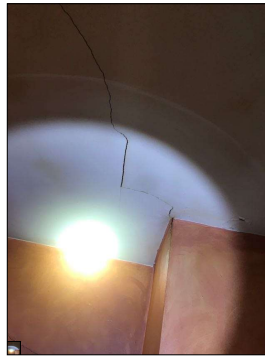
Cracks along the ceiling.

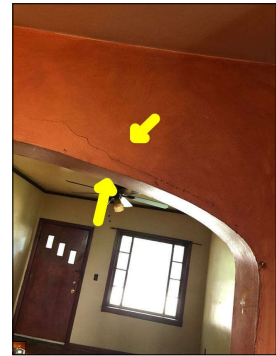
Cracks along the walls.

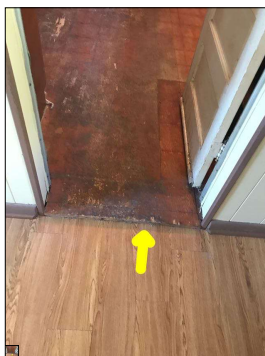
Uneven surfaces along the floor. Uneven surfaces are a potential trip hazard.

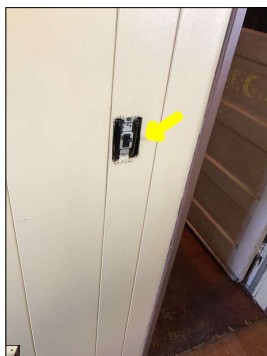
Missing switch and receptacle covers.

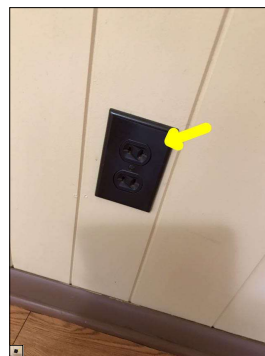
Two prong receptacles. Two prong receptacles are not grounded.

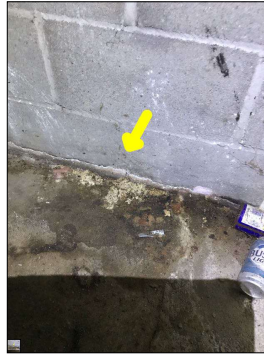
Discoloration observed. Discoloration is considered abnormal and a defect. Discoloration can be caused by an intermittent or active water source. An active or intermittent water source can cause mold growth and property damage.

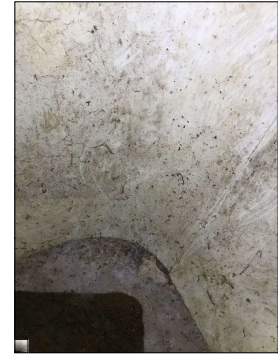
Mold like substance. An active or intermittent water source can cause mold growth and property damage.

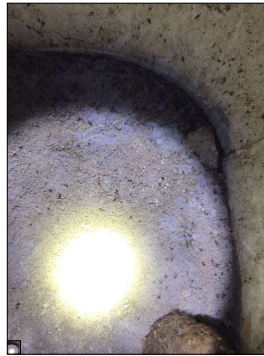
Mice/rodent droppings observed. Wildlife activity can cause property damage.

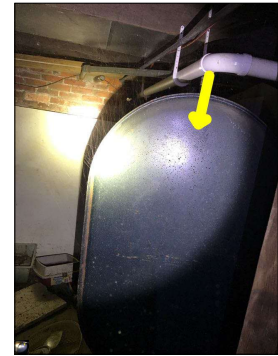
Aged oil tank observed in the basement.

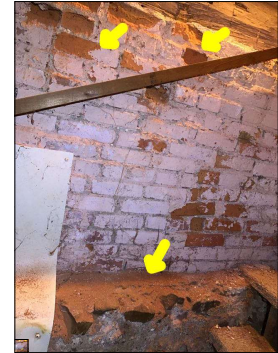
Deterioration along the foundation wall. This is considered abnormal and a defect

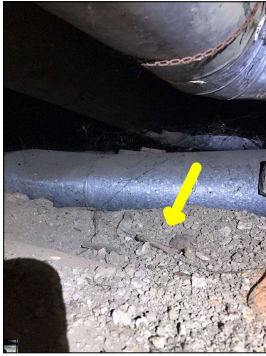
Dirt floor observed within the crawl space. Dirt floors are not recommended. A dirt floor can allow the intrusion of moisture, insects, wood destroying insects, radon, mice, and rodents. An active or intermittent water source can cause mold growth and property damage, such as wood rot damage. It is recommended that dirt floors be properly encapsulated.

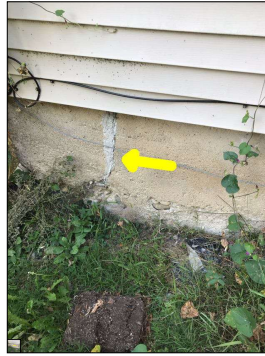
Crack along the foundation. Cracks are considered a defect. Cracks should be repaired/sealed to prevent the intrusion of moisture, insects, wood destroying insects, mice, and radon.

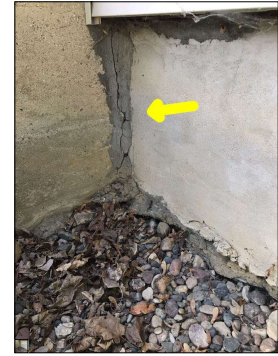
Crack along the foundation. Cracks are considered a defect. Cracks should be repaired/sealed to prevent the intrusion of moisture, insects, wood destroying insects, mice, and radon.

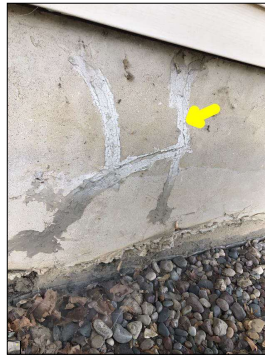
Crack along the foundation. Cracks are considered a defect. Cracks should be repaired/sealed to prevent the intrusion of moisture, insects, wood destroying insects, mice, and radon.

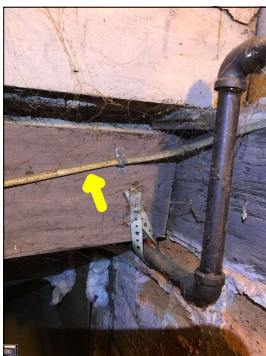
Cloth sheathing wiring observed. Cloth sheathing wiring is considered aged wiring. The cloth sheathing can become brittle due to age, thus causing wires to be exposed, which can cause spark, arcing and or fire. Also, cloth sheathing can potentially have asbestos in it. Asbestos is a potential safety hazard.

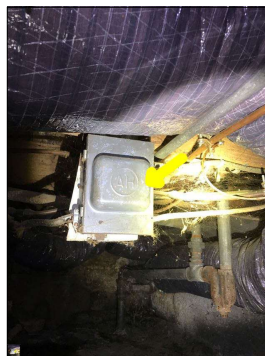
Aged fuse panel. Fuse panels no longer meet modern day electrical standards and are considered a safety hazard due to their age. Recommend upgrading from the fuse panel to a modern day electrical panel.

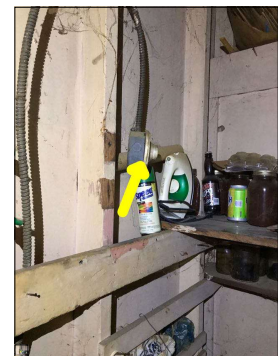
Loose electrical components. This is a potential safety hazard.

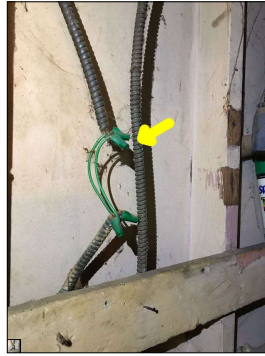
Exposed wires. This is a potential safety hazard.

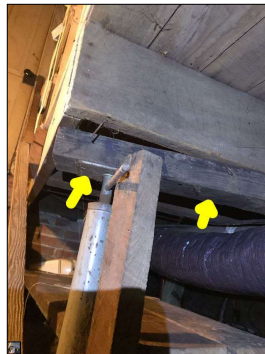
Unconventional alterations and column supports. This is considered amateur craftsmanship. Amateur craftsmanship is prone to failure.

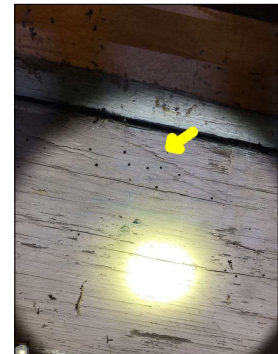
| Basement | | |
|---|---|---|
| Page 29 Item: 5 | Beams/Subfloor/Joints/Columns | • Exit holes observed. Exit holes are an indication of an infestation of powderpost beetles. Powderpost beetles are a wood destroying insect and can cause structural damage and property damage. |

Exit holes observed. Exit holes are an indication of an infestation of powderpost beetles. Powderpost beetles are a wood destroying insect and can cause structural damage and property damage.

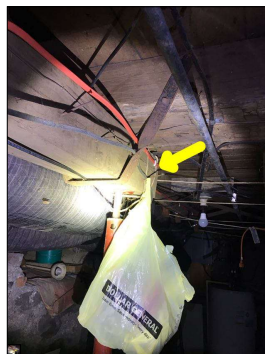
Unconventional alterations and column supports. This is considered amateur craftsmanship. Amateur craftsmanship is prone to failure.

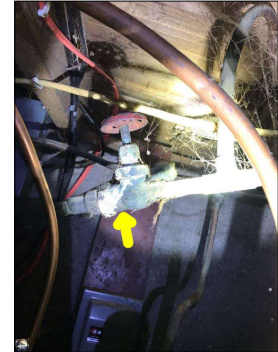
Rust and corrosion along the plumbing pipes.

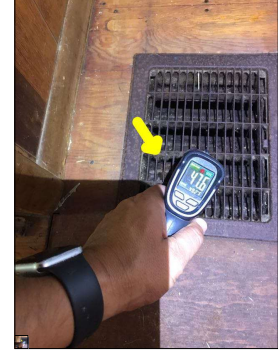
The photo identifies the temperature of the supply air while the air conditioner was in operation. The approximate temperature of the supply air was 47 degrees Fahrenheit.

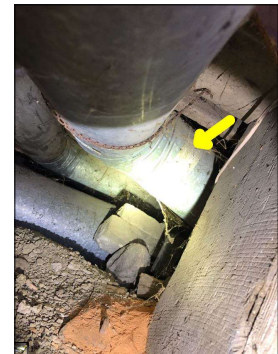
Potential asbestos based tape along the ductwork. Asbestos is a potential safety hazard.

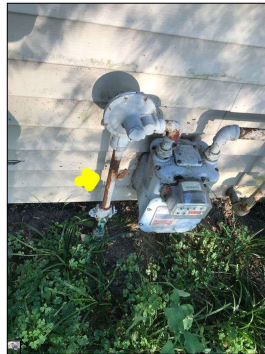
Rust and corrosion along the fuel lines. Rust and corrosion can create holes along the fuel lines, thus creating a fuel leak.

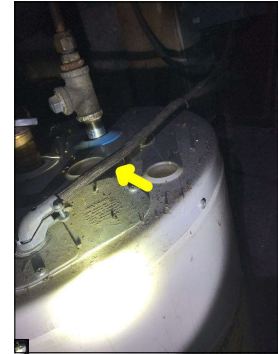
The wires are not wrapped in conduit. This is considered abnormal, amateur craftsmanship and a potential safety hazard. Wires should be wrapped in conduit to protect both humans and the electrical wiring. Wires that lack conduit can potentially get pulled, become loose, or damaged, thus creating shock hazards and/or fire hazards.

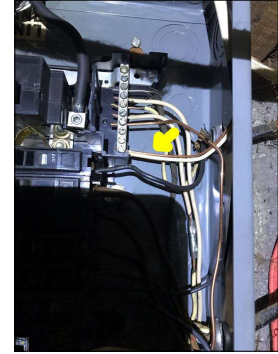
Double tapped neutral wires. Neutral wires should not share a terminal with any other wires, including ground wires. Double tapped neutrals are considered a safety hazard. Double tapped neutral wires do not allow the circuit to be isolated if the circuit needs to be worked on. Also, double tapped neutral wires under the same terminal can become loose, which could lead to arcing, overheating, spark and/or fire.

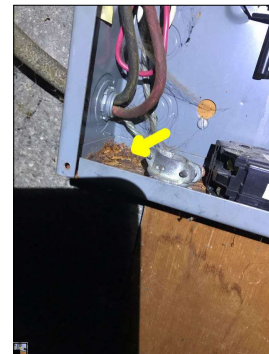
Rust and corrosion within the circuit breaker panel. This is considered abnormal and a potential safety hazard. An active or intermittent water source can cause rust and corrosion. Rusted/corroded terminals and connections increase resistance in the circuit that can cause overheating, thus causing arcing, spark and/or fire. Some areas of rust and corrosion may not be visible and could be concealed behind breakers, wires, etc.
