# **FAMILYGUARD**

## **HOME INSPECTION REPORT**

**6407 Maumee Rd. Fort Wayne, IN 46803**  
**Inspection Prepared For: Seller**

**Date of Inspection: 12/4/2024**  
**Age of House: 79 Years**  
**Weather: Overcast & Cold**

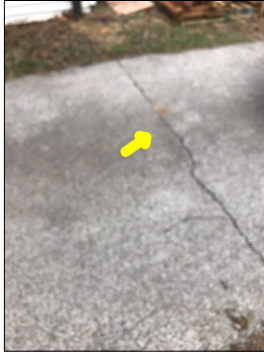
Cracks and deterioration along the driveway.

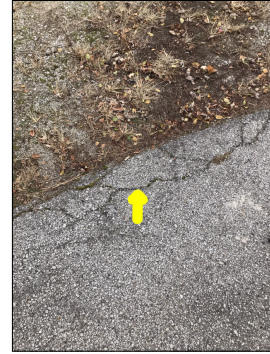
Cracks and deterioration along the driveway.

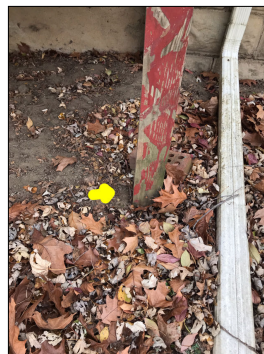
The deck has wood to soil contact. This is not a recommended practice. Water and moisture from the soil/earth can wick up along the deck and the water can be absorbed by the deck. An active or intermittent water source can cause property damage, such as wood rot damage. Also, the wood to soil contact can enable the infestation of wood destroying insects, such as termites or powderpost beetles.

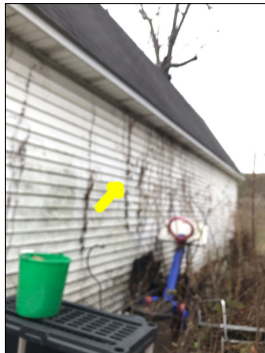
Vegetation against the siding/in proximity of the siding. This is not a recommended practice. Vegetation has the potential to harbor insects, wood destroying insects, rodents and hold moisture. Insects, wood destroying insects, rodents and moisture have the potential to create future problems for a house, such as structural damage, pest infestation and wood rot damage.

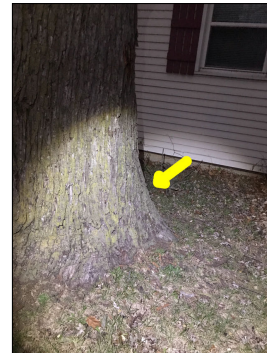
Tree adjacent to the house. Tree roots can cause foundation problems and can create structural damage to the foundation. Also, trees that are next to the house can potentially fall on the house, potentially causing bodily harm and damage to the house.

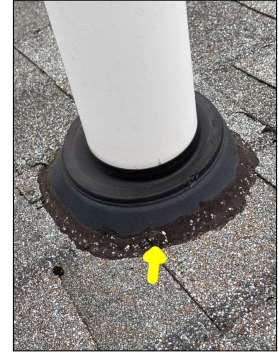
Unconventional application of roof sealant along the rubber flashing.  
Rubber flashing is designed to be caulkless. This is considered amateur craftsmanship. Most roof sealants are petroleum based. A petroleum based product can cause the rubber flashing to prematurely deteriorate, thus creating a leak point.

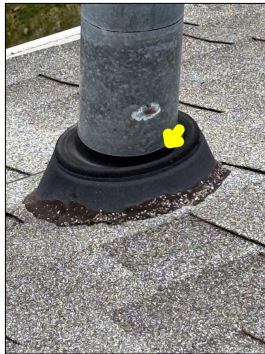
The rubber flashing is concave. This is considered a defect.  
The concave flashing will act as a trap for water and hold water and snow, thus creating a potential leak point.  
Flashing is not designed to hold water, flashing is designed to shed water.

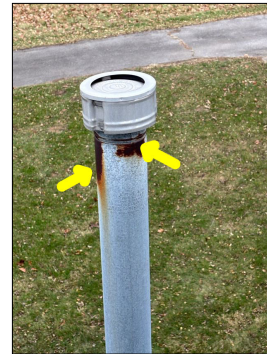
Rust and corrosion along the flue. Rust and corrosion can create holes along the flue, thus creating potential leak points.

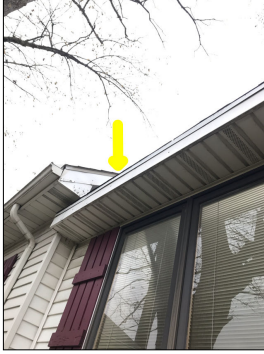
The gutter system is partially missing. The lack of a gutter system can allow excessive water to accumulate around the foundation. Excessive water around the foundation can cause water intrusion into the house and potential foundation problems due to excessive hydrostatic pressure.

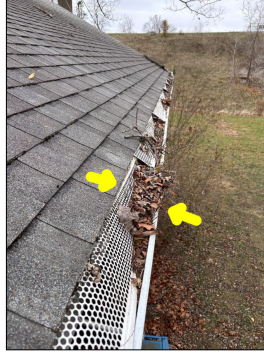
The gutter system is dirty and needs to be cleaned. A dirty gutter system can cause excessive water to accumulate around the house, thus potentially causing water intrusion into the house or potential foundation problems due to excessive hydrostatic pressure. Also, a dirty gutter system can cause excessive water to flow along the siding which could allow water to get behind the siding. An active or intermittent water intrusion source can cause mold growth and property damage.

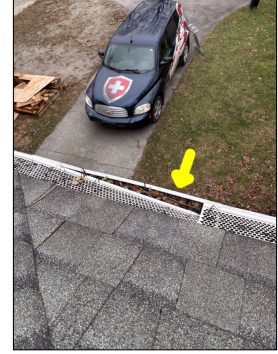
The gutter system is dirty and needs to be cleaned. A dirty gutter system can cause excessive water to accumulate around the house, thus potentially causing water intrusion into the house or potential foundation problems due to excessive hydrostatic pressure. Also, a dirty gutter system can cause excessive water to flow along the siding which could allow water to get behind the siding. An active or intermittent water intrusion source can cause mold growth and property damage.

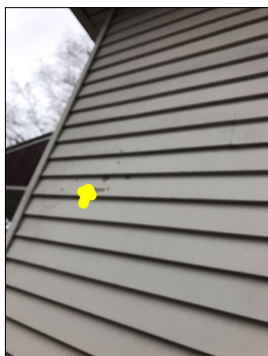
Holes along the siding.

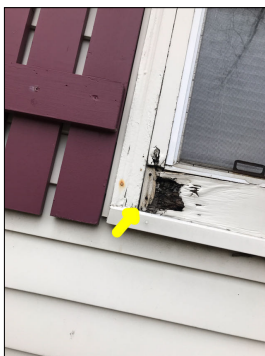
Wood rot damage.

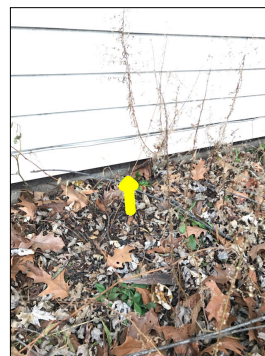
The siding is in proximity to the ground. Siding should have at least 6 to 8 inches of clearance above the ground. Maintaining proper clearances reduces access to wood structures behind the siding and helps preserve the house. The proper clearances help restrict access from wood destroying insects and/or moisture/water that might find its way behind the siding.

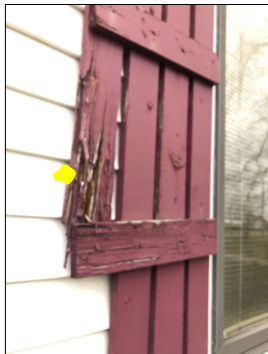
Wood rot damage along the shutters.

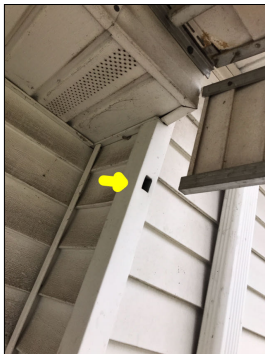
Holes along the siding.

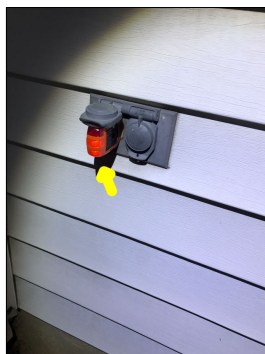
Non **GFCI** protected receptacles.

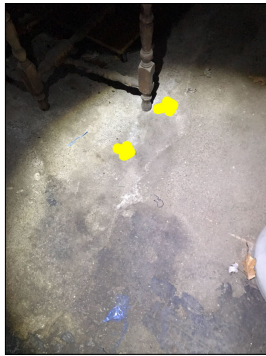
Cracks and deterioration along the floor.

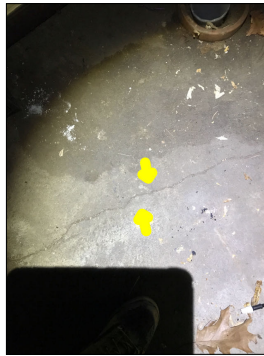
Cracks and deterioration along the floor.

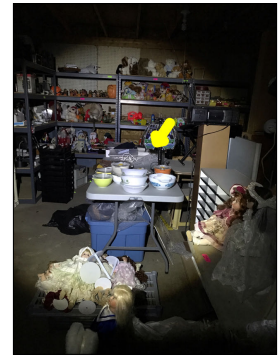
Excessive clutter in the garage. Visibility and accessibility were limited.

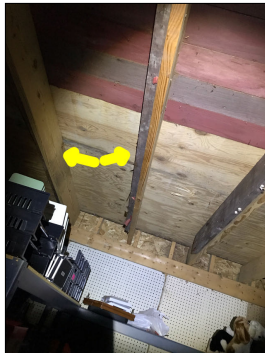
Sistered floor joists observed within the garage. This is an indication of previous structural repairs.

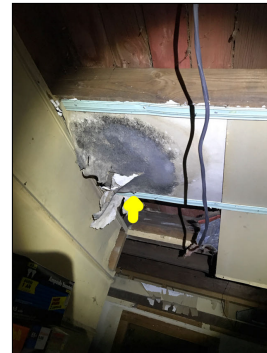
Mold like substance. An active or intermittent water source can cause mold growth and property damage.

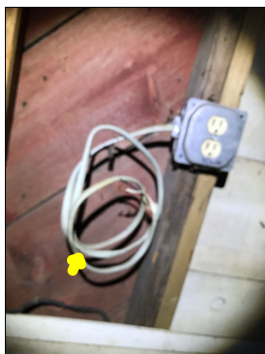
Exposed wires. This is a potential safety hazard.

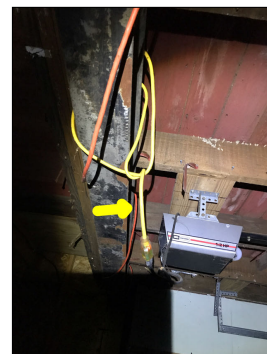
Extension cord observed. Extension cords should not be used as permanent wiring. Extension cords used as permanent wiring is considered a potential safety hazard.

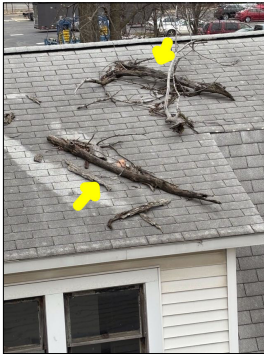
Tree branches observed along the roof.  
Falling tree branches can cause damage to the roof system, thus resulting in water intrusion into the attic/house.

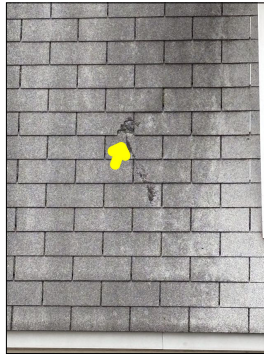
Damaged roof shingles.

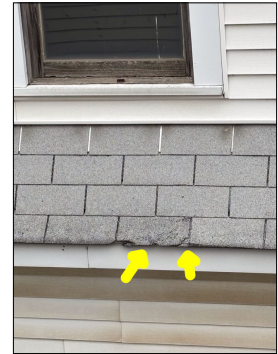
Damaged roof shingles.

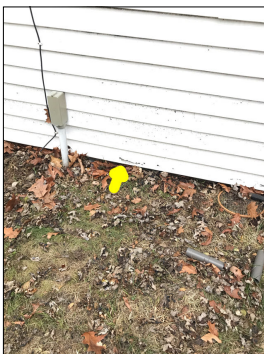
Damaged siding.

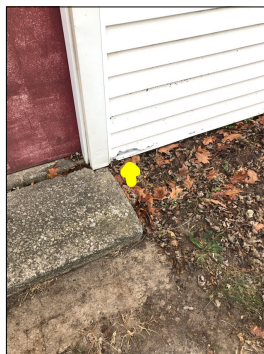
Damaged siding.

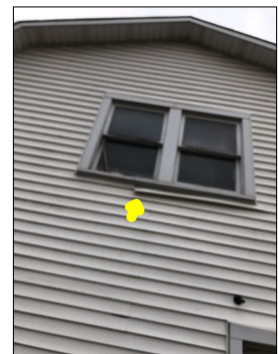
Loose/detached siding.

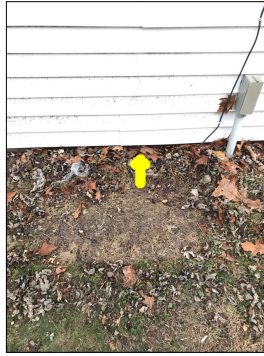
The siding is in proximity to the ground. Siding should have at least 6 to 8 inches of clearance above the ground. Maintaining proper clearances reduces access to wood structures behind the siding and helps preserve the house. The proper clearances help restrict access from wood destroying insects and/or moisture/water that might find its way behind the siding.

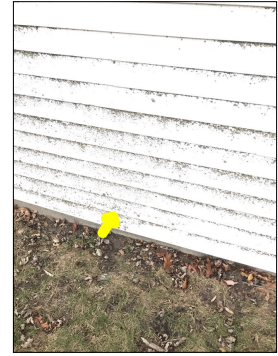
Discoloration along the siding.

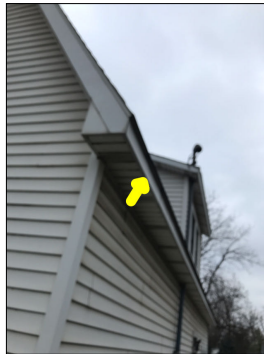
The gutter system is missing. The lack of a gutter system can allow excessive water to accumulate around the foundation. Excessive water around the foundation can cause water intrusion into the house and potential foundation problems due to excessive hydrostatic pressure.

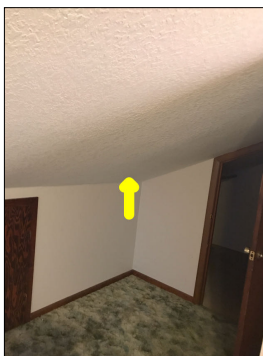
Low overhead clearance. This is a potential safety hazard.

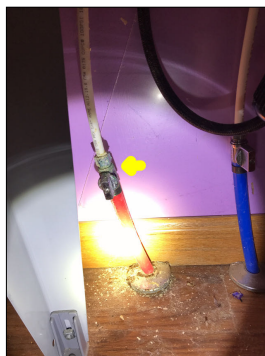
Rust/corrosion along the plumbing pipes.

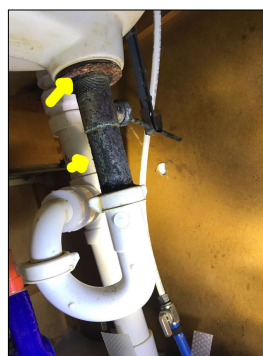
Rust/corrosion along the plumbing pipes.

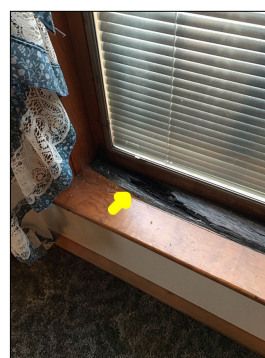
Wood rot damage along the windows.

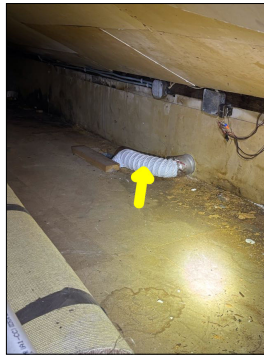
The exhaust ductwork lacks insulation. It is recommended for exhaust ductwork to be insulated in non climate controlled areas, such as an attic. The lack of insulation can cause condensation to form along the ductwork. An active or intermittent water source can cause mold growth and property damage.

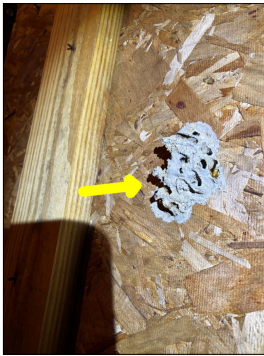
Mud dauber nests observed. Wildlife activity can cause property damage.

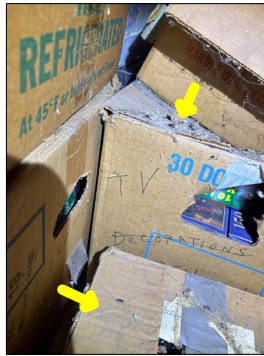
Mice/rodent droppings. Wildlife activity can cause property damage.

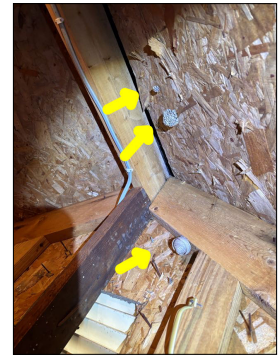
Wasp nest observed. Wildlife activity can cause property damage.

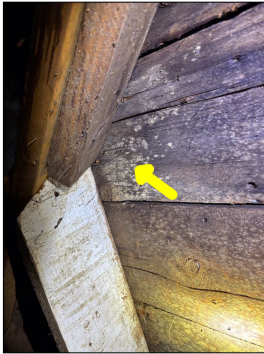
Mold like substance along the sheathing/framing. An active or intermittent water source can cause mold growth and property damage, such as wood rot damage.

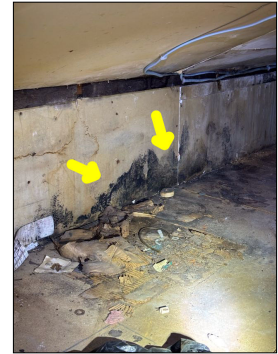
Mold like substance along the sheathing/framing. An active or intermittent water source can cause mold growth and property damage, such as wood rot damage.

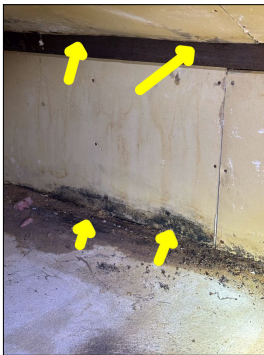
Mold like substance along the sheathing/framing. An active or intermittent water source can cause mold growth and property damage, such as wood rot damage.

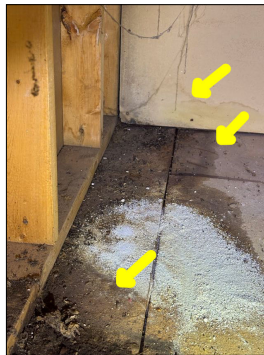
Signs of previous water damage along the sheathing. An active or intermittent water source can cause mold growth and property damage, such as wood rot damage.

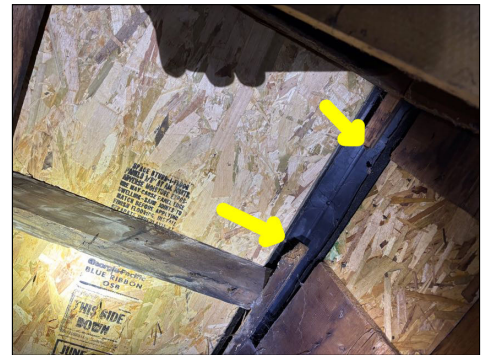
The ridge has unconventionally been cut. This is considered abnormal and a defect.

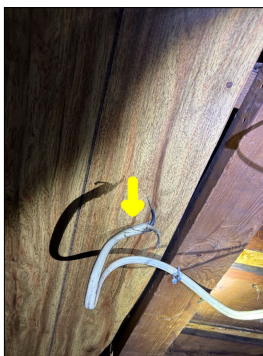
Exposed wires. This is a potential safety hazard.

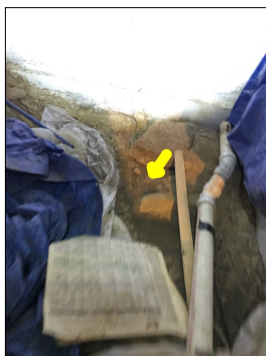
Dirt floor. Dirt floors are not recommended. A dirt floor can allow the intrusion of moisture, insects, wood destroying insects, radon, mice, and rodents. An active or intermittent water source can cause mold growth and property damage, such as wood rot damage. It is recommended that dirt floors be properly encapsulated.

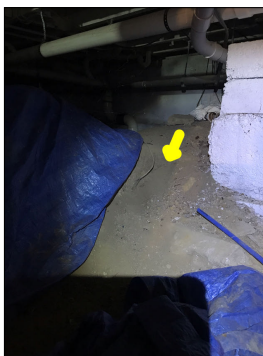
Dirt floor. Dirt floors are not recommended. A dirt floor can allow the intrusion of moisture, insects, wood destroying insects, radon, mice, and rodents. An active or intermittent water source can cause mold growth and property damage, such as wood rot damage. It is recommended that dirt floors be properly encapsulated.

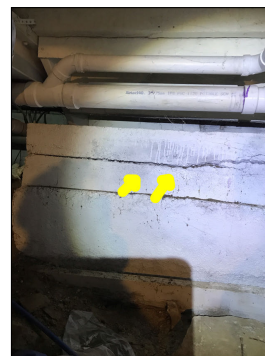
Crack along the foundation. Cracks are considered a defect. Cracks should be repaired/sealed to prevent the intrusion of moisture, insects, wood destroying insects, mice, and radon.

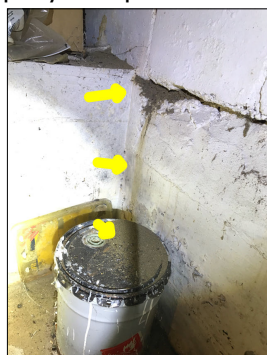
Exposed dirt along the foundation wall. This is considered a defect.

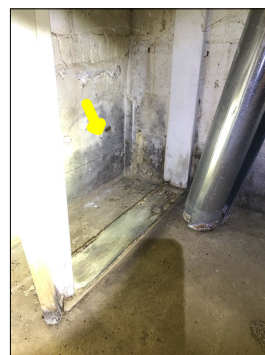
Mold like substance. An active or intermittent water source can cause mold growth and property damage.

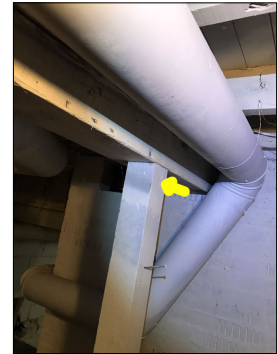
Unconventional alterations and column supports. This is considered amateur craftsmanship. Amateur craftsmanship is prone to failure.

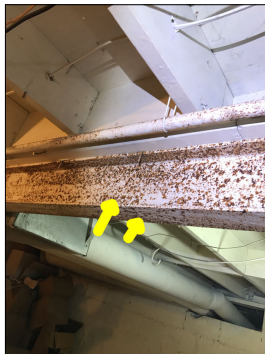
Rust/corrosion along the beams. An active or intermittent water source can cause mold growth and property damage.

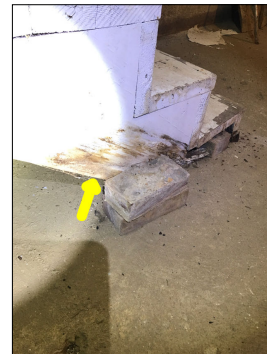
Mold like substance along the stairs. An active or intermittent water source can cause mold growth and property damage.

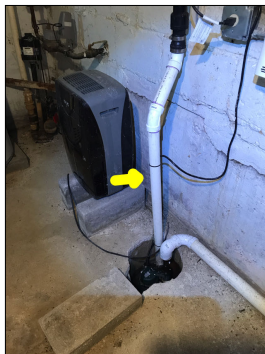
The sump pump discharges into the main drain pipes. This is not a recommended practice and does not meet the industry standard. Sump pumps should discharge to the exterior.

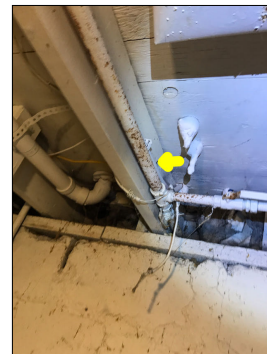
Rust and corrosion along the fuel lines. Rust and corrosion can create holes along the fuel lines, thus creating a fuel leak.

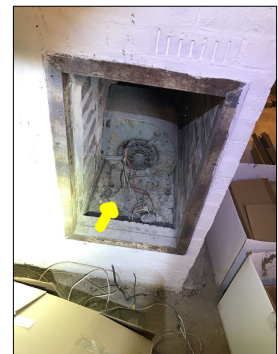
Apparent abandoned blower within the chase located in the basement.

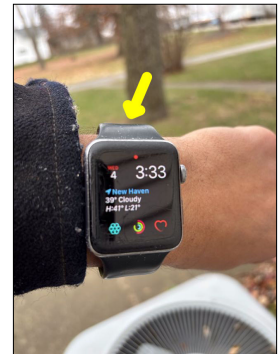
The outdoor temperature during the time of the inspection was approximately 39 degrees Fahrenheit. Due to the cold weather conditions during the time of the inspection. The performance level and working condition of the air conditioner could not be determined.

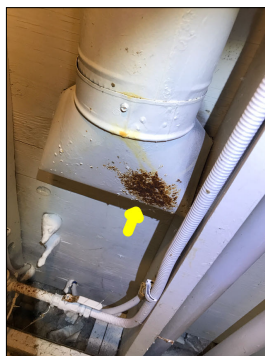
Rust and corrosion along the HVAC ductwork. This is considered a defect. An active or intermittent water source can cause rust and corrosion and property damage. This is in the basement.

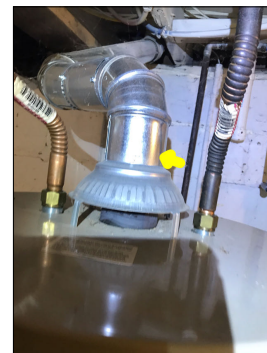
Improper flue. There should be a minimum of twelve inches between the draft hood outlet and the first elbow or connector. The current design of the flue is a potential safety hazard as it could cause the flue to backdraft and release carbon monoxide into the house.

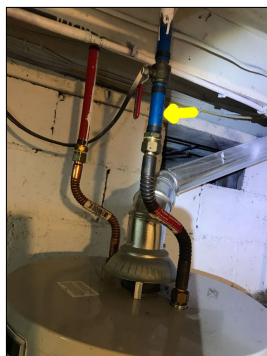
Non-metallic plumbing lines within 18 inches of the water heater. A metallic water supply line, such as copper, should be used for the first 18 inches of water supply lines from the water heater. After the first 18 inches, a transition of plumbing type can be made, such as going from copper to PEX. The rule applies to not only gas water heaters, but also electric, tankless, or closed combustion. Recommend checking with the manufacturer of the water heater to ensure the installation is correct.

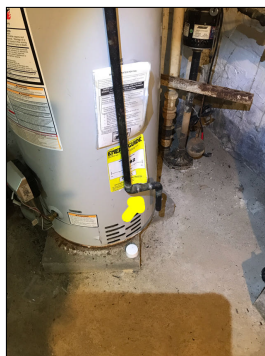
The temperature and pressure relief valve extension has bends along it and is not straight. Temperature and pressure relief valves should be straight and within 6 inches of the floor. The lack of a proper extension is a potential safety hazard.

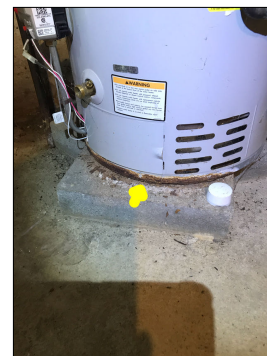
Rust and corrosion along the water heater. This is considered a defect. An active or intermittent water source can cause property damage and mold growth.

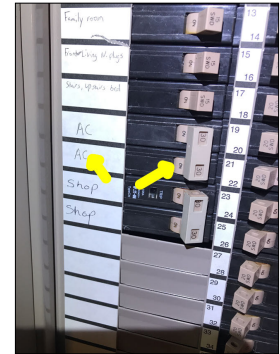
The air conditioning (**AC**) circuit breaker is oversized according to the data plate on the condenser. This is a potential safety hazard. According to the data plate, the maximum size circuit breaker should not exceed 25 amps. The current breaker is 30 amps.

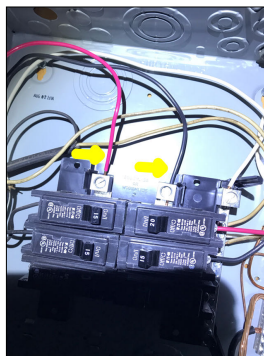
10 gauge wires feeding the sub panel. This is considered abnormal and does not meet the industry standard. These wires are considered too small for supplying electricity to a sub panel.
