# **FAMILYGUARD**

## **HOME INSPECTION REPORT**

**3831 Ironwood Ct. Fort Wayne, IN 46815,**  
**Inspection Prepared For: Seller**

**Date of Inspection: 2/9/2025**  
**Age of House: 52 Years**  
**Weather: Ice & Snow present**

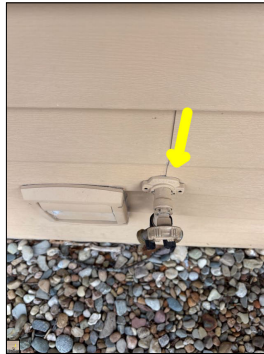
No anti-siphon/frost free valve. The lack of an anti-siphon valve can allow water back flow into the water supply lines, thus contaminating potable water. This is a potential safety hazard. The lack of a frost free valve can allow water to stay within the hose bib, which could potentially freeze during cold months and cause the pipe to rupture. This can cause property damage.

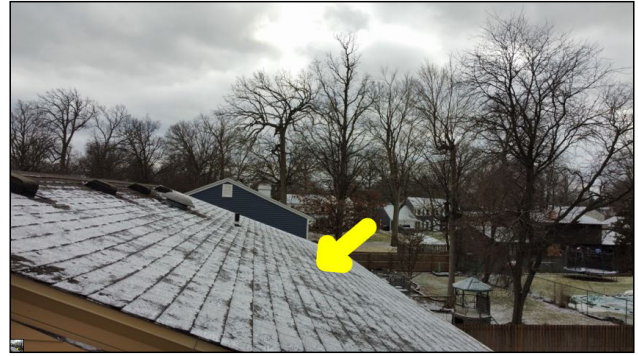
Snow and ice along the roof. Visibility was limited. The roof could not be fully inspected due to the snow and ice.

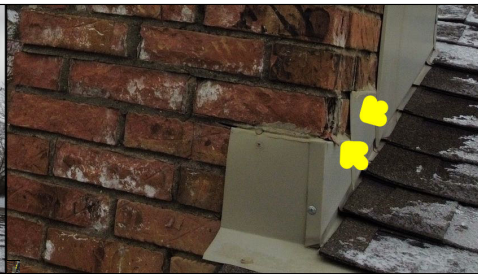
Gaps along the flashing and deterioration along the brick. These types of defects are potential leak points.

- Before using the fireplace, it is recommended that a licensed chimney/fireplace professional further evaluate to ensure the fireplace is in good working condition and is safe for usage.

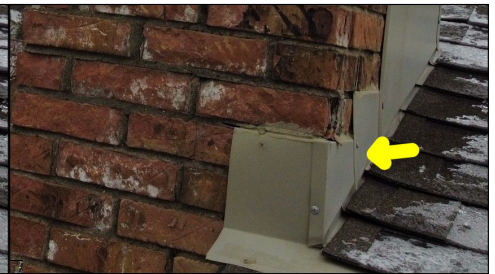
The flashing does not go up at minimum 4 inches along the base of the chimney. 4 inches is the recommended minimum height that flashing should go up around the base of the chimney. The flashing should also be cut into the chimney and sealed to prevent leakage. The current flashing along the chimney is considered subpar and amateur craftsmanship. Amateur craftsmanship is prone to failure and leakage.

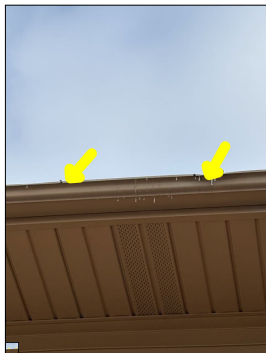
Dents/damage along the gutter system. Dents/damage along the gutter system. Also, loose gutter spikes.

- Recommend general contractor further evaluate and make necessary repairs
- A defective gutter/drainage system can cause excessive water to accumulate around the house, thus potentially causing water intrusion into the house or potential foundation problems due to excessive hydrostatic pressure. Also, a defective gutter/drainage system can cause excessive water to flow along the exterior walls, which could allow water to get behind the siding, soffit and fascia. An active or intermittent water intrusion source can cause mold growth and property damage.

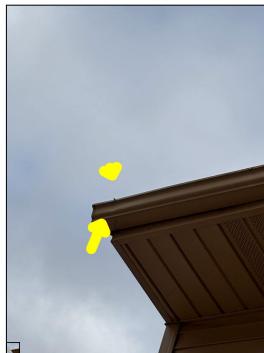
Also, loose gutter spikes.

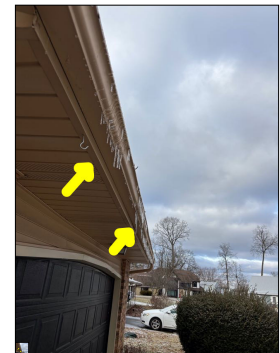
Excessive icicles hanging from the gutter system. This is considered abnormal. This could be an indication of clogged gutters, poor attic ventilation, or poor attic insulation. The excessive icicle accumulation can lead to ice dams and potential water intrusion along the eaves. Ice damming is when snow and ice prevents the roof from properly shedding water, thus allowing water to get underneath the shingles and into the house.

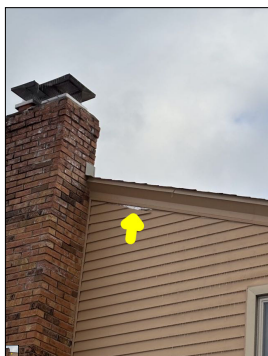
Loose/detached siding.

- Cracks and holes in siding, loose/detached siding, gaps in siding and missing siding have the potential to allow water/moisture, insects, bats, mice, wood destroying insects, pests, and rodents into the framing of a house. The intrusion of water/moisture, insects, bats, mice, wood destroying insects, pests, and rodents has the potential to cause damage to a house, such as wood rot, mold, property damage and structural damage.
- Recommend general contractor further evaluate and make necessary repairs

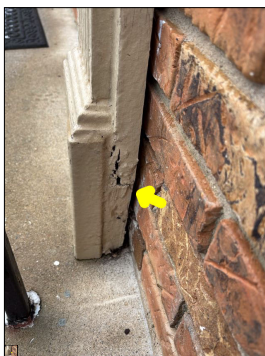
Wood rot damage.

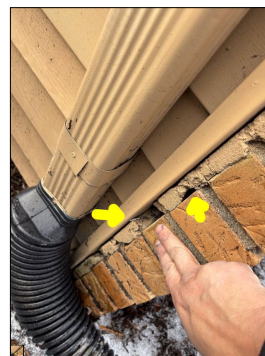
Gaps along the siding.

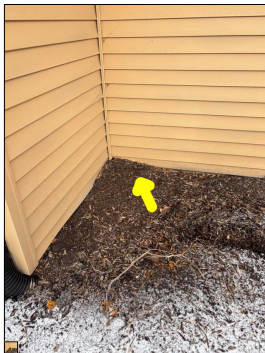
The siding is in proximity to the ground. Siding should have at least 6 to 8 inches of clearance above the ground. Maintaining proper clearances reduces access to wood structures behind the siding and helps preserve the house. The proper clearances help restrict access from wood destroying insects and/or moisture/water that might find its way behind the siding.

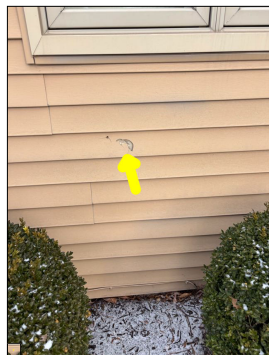
Damaged siding.

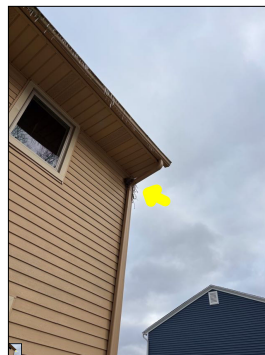
Bird's nest. Wildlife activity can cause property damage.

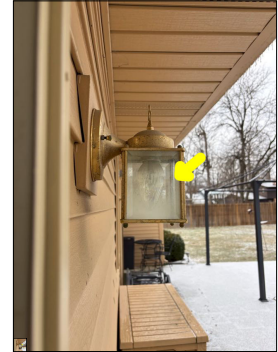
The light is inoperable. Even when covering the daylight sensors, the light would not turn on.

The light is inoperable.

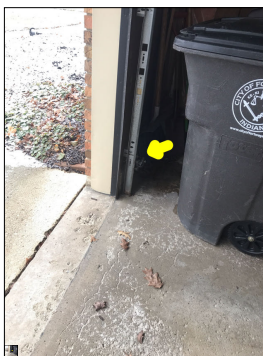
The photo eye sensors are too high. This is a potential safety hazard. The photo eye sensors should be between four and six inches from the floor.

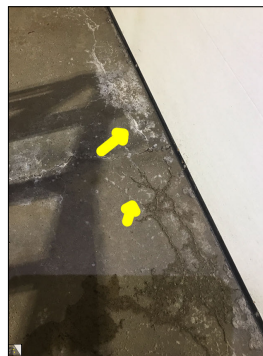
Cracks and deterioration along the floor.

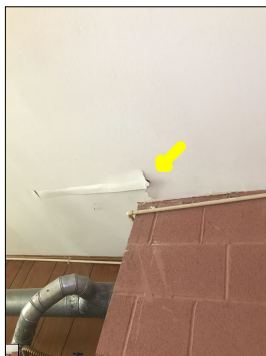
Cracks along the ceiling.

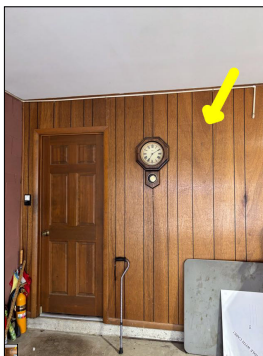
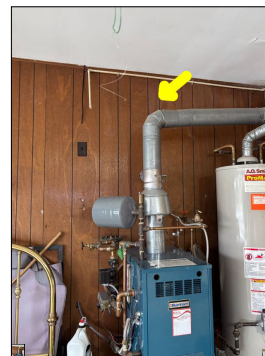
The interior wall that separates the garage from the interior of the house is not covered with gypsum board. The lack of gypsum board is a potential fire hazard. Interior walls between the garage and living areas should be covered with gypsum board.

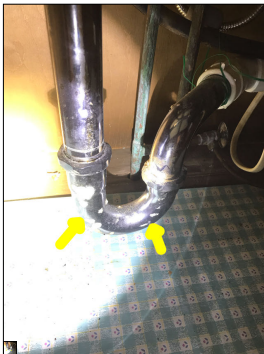
Rust/corrosion along the plumbing pipes.

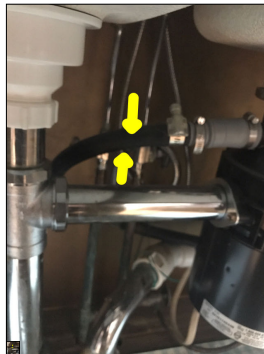
The dishwasher drain line does not have a high loop. A high loop prevents drain water from flowing into the dishwasher and contaminating the clean dishes.

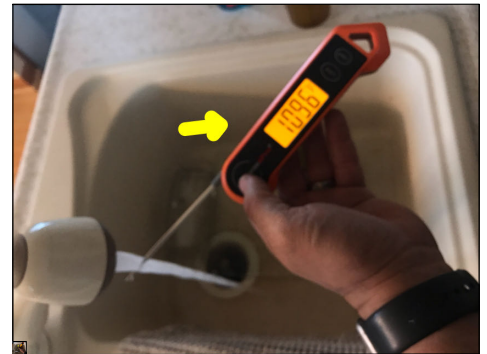
Temperature reading of the hot water during the time of the inspection. The approximate temperature of the hot water was 109 degrees Fahrenheit.

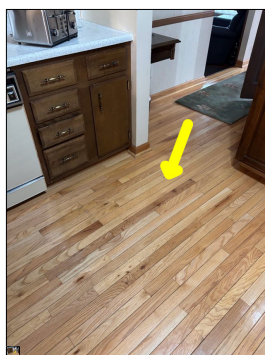
The floor slopes. This is considered abnormal and a defect.

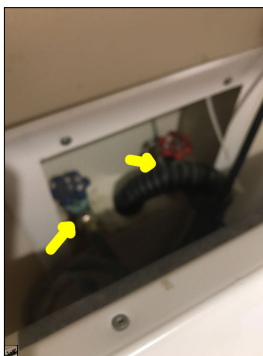
Rust/corrosion along the washer hook up lines.

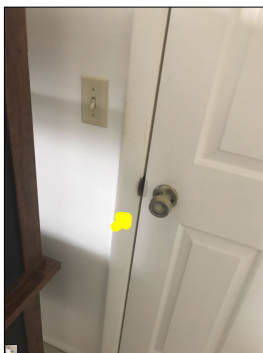
The door does not latch properly.

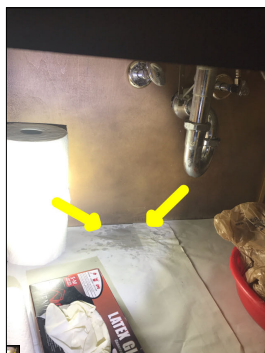
- **Active plumbing leak.** An active or intermittent water source can cause mold growth and property damage.

Active plumbing leak. An active or intermittent water source can cause mold growth and property damage.

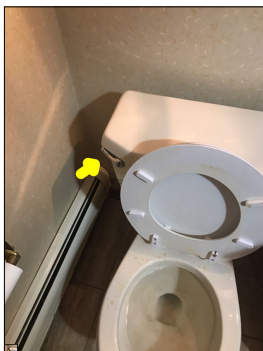
The lever has to be held down for a few seconds for the toilet to flush. This is considered abnormal and a defect. A toilet should properly flush by simply pressing down on the lever and then releasing from the lever.

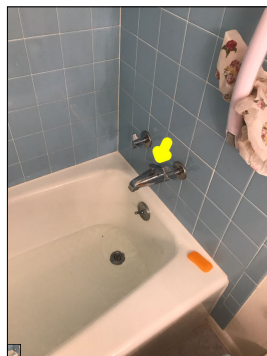
The diverter rod does not drop when the showerhead is turned off. This is considered abnormal and a defect. Unless the diverter rod is manually disengaged when turning the showerhead off, the next person to turn the bathtub faucet on will receive water from the showerhead.

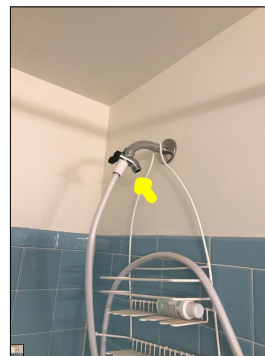
There is no showerhead. There is only a spray hose.

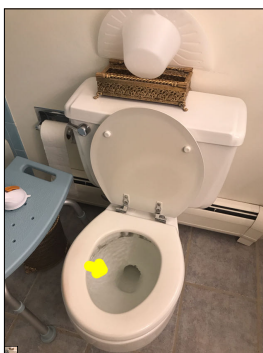
The toilet continuously calls for water. This is considered abnormal and a defect. I was able to adjust the flap within the tank to temporarily fix it.

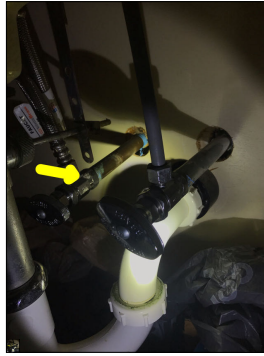
Rust/corrosion along the plumbing pipes.

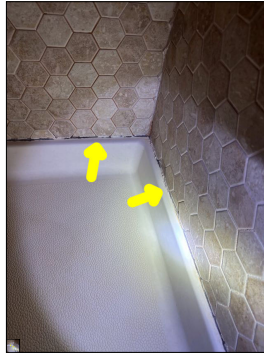
Unconventional beads of caulk along the shower/bath. This is considered amateur craftsmanship. The beads of caulk will discolor and deteriorate with time and potentially mold. The caulk will require regular maintenance to prevent water from getting underneath the caulk and behind the shower/bath wall. A properly installed shower/bath will have edges that overlap and the overlapped edges will properly shed water and create liquid tight seams. Beads of caulk can actually trap water and allow water to get behind the shower/bathtub wall and within the wall cavities, thus causing potential mold growth and property damage.

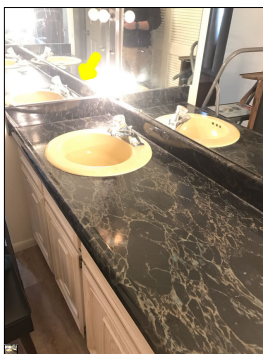
There are no apparent receptacles adjacent to the sinks. This is considered abnormal and a safety hazard.

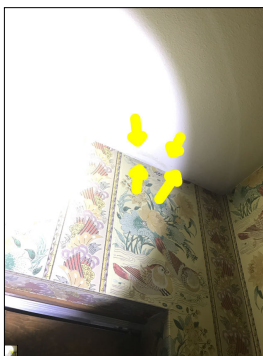
- Discoloration along the ceiling and signs of previous water damage. An active or intermittent water source can cause mold growth and property damage. This is located in the area that has the small sink adjacent to the living room.

Discoloration along the ceiling and signs of previous water damage. An active or intermittent water source can cause mold growth and property damage.

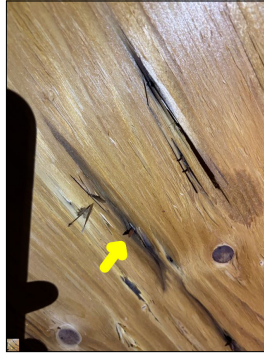
Rust/corrosion along the roofing nails. This is an indication that the attic has an active or intermittent water source. An active or intermittent water source can cause mold growth and property damage, such as wood rot.

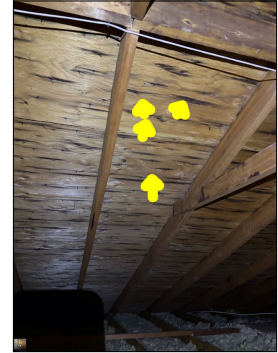
The black discoloration around the roofing nails is a potential mold like substance. This is caused by an active or intermittent water source. In most cases, the discoloration is caused by inadequate attic ventilation. An active or intermittent water source can cause mold growth and property damage.

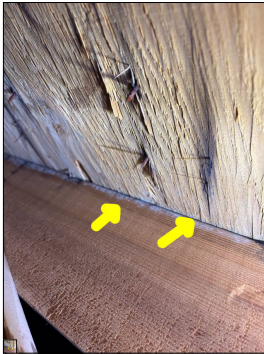
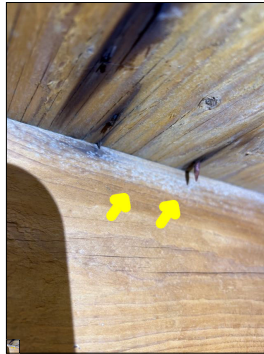
- Mold like substance along the sheathing/framing. An active or intermittent water source can cause mold growth and property damage, such as wood rot damage.

Mold like substance along the sheathing/framing. An active or intermittent water source can cause mold growth and property damage, such as wood rot damage.

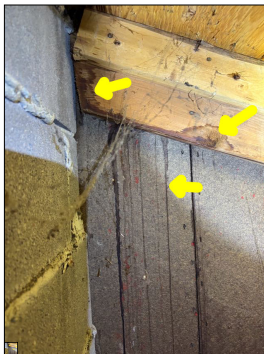
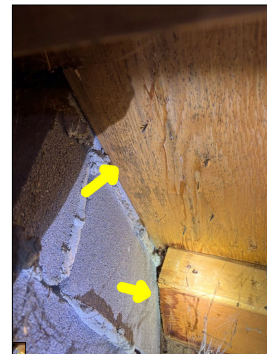
Discoloration along the sheathing/framing. Discoloration can be a potential mold like substance. An active or intermittent water source can cause mold growth and property damage. This is adjacent to the chimney/chase.

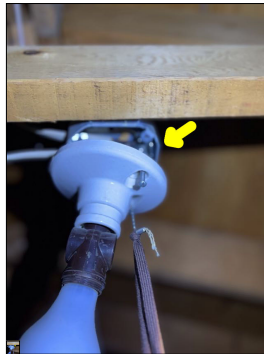
The electrical light is loose.

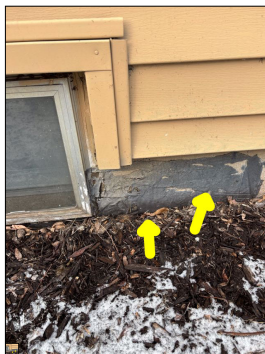
Signs of previous repairs along the foundation.

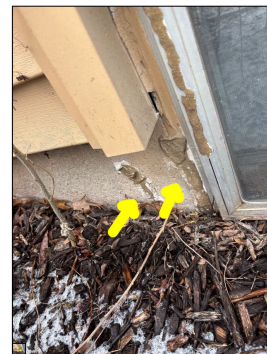
Signs of previous repairs along the foundation and a foreign substance along the foundation. Recommend a general contractor further evaluate and make necessary repairs.

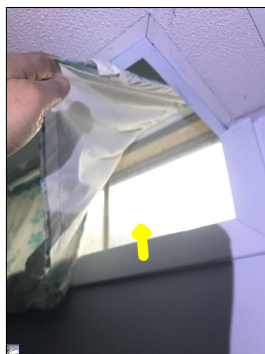
Aged windows.

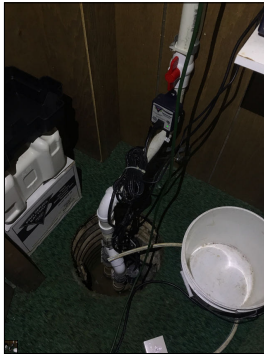
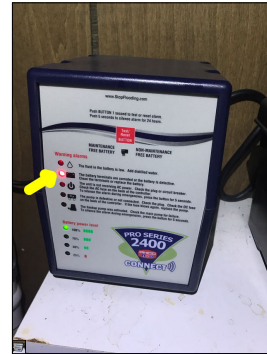
Error code along the sump pump.

The general rule of thumb is that if you do not know how old your sump pump is, it should probably be replaced, or at the very least inspected, cleaned and maintained by a licensed plumber. Most sump pumps should be replaced every five years or according to the manufacturer's suggestion. FamilyGuard always recommends a backup sump pump to the primary sump pump. Sump pumps should always discharge at minimum 25 plus feet from the house. Please note, it is not always possible to locate the discharge location of a sump pump. This is because of several reasons, such as, interior walls/ceilings/drywall blocking the visibility of following the discharge pipe to the exterior of the house, a low water table underneath the house which means the sump pump is not in periodic operation during the inspection, buried sump pump discharge pipe along the exterior, etc. Failure to properly discharge water away from the house can cause excessive hydrostatic pressure against the foundation walls and an elevated water table underneath the house, thus causing excessive wear and tear on the sump pump, potential foundation issues and possible water intrusion into the house.

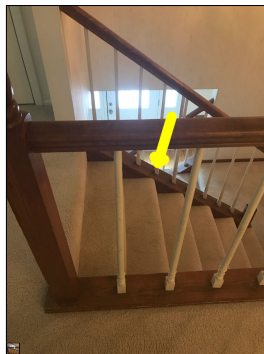
The spacing between the railing exceeds four inches. Four inches is the recommended maximum distance between balusters. Spacing between the balusters that exceeds four inches is considered a safety hazard as a small child or pet could fall between the balusters.

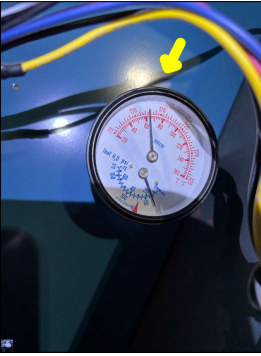
General photo of the temperature and pressure gauge. The water temperature was approximately 150+ degrees during operation. This is sufficient and expected for a boiler in working condition.

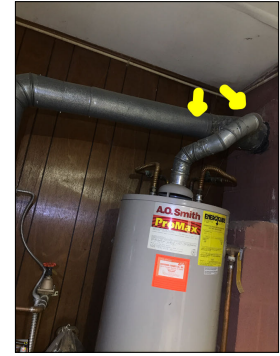
The boiler vents into the chimney. This is a potential safety hazard as the chimney might not be properly equipped for proper drafting for appliances. Improper drafting can release carbon monoxide into the house and can potentially cause a fire. Recommend a licensed HVAC technician further evaluate, perform a combustion test on the chimney and make necessary repairs.

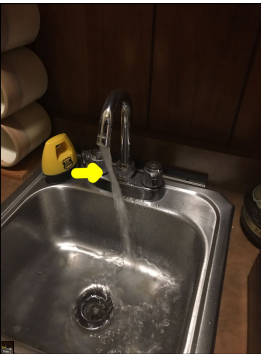
The water flow/pressure is spraying along the countertop. This is considered abnormal. This is located at the sink adjacent to the living room.

- Limited visibility
- Rust/Corrosion
- Leaks
- Hot water present
- Please review entire report
- Recommend licensed plumber further evaluate and make necessary repairs.

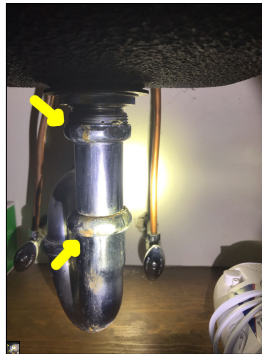
Rust and corrosion along the plumbing pipes. This is located underneath the sink adjacent to the living room.

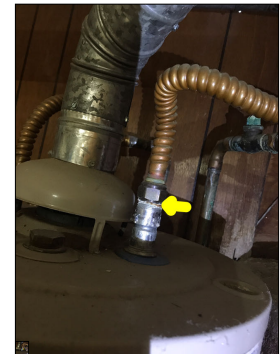
Corrosion along the water supply lines.

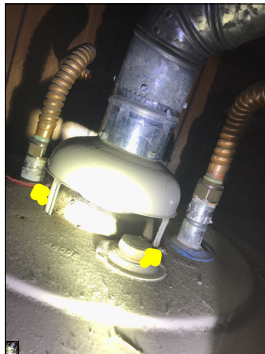
The plastic rings adjacent to the water heater flue are melted. This is an indication that the water heater is backdrafting. This is a potential safety hazard as it can release carbon monoxide into the house.

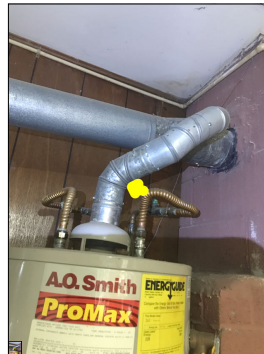
Improper flue. There should be a minimum of twelve inches between the draft hood outlet and the first elbow or connector. The current design of the flue is a potential safety hazard as it could cause the flue to backdraft and release carbon monoxide into the house.

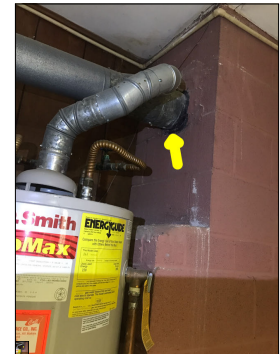
The water heater vents into the chimney. This is a potential safety hazard as the chimney might not be properly equipped for proper drafting for appliances. Improper drafting can release carbon monoxide into the house and can potentially cause a fire. Recommend a licensed HVAC technician further evaluate, perform a combustion test on the chimney and make necessary repairs.

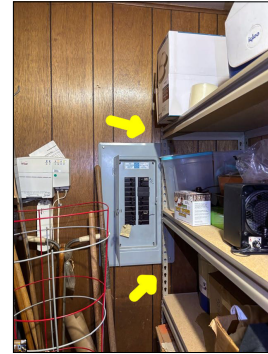
The circuit breaker panel is inaccessible due to personal items, clutter, etc. It is beyond the scope of a general home inspection to move personal property. Doing so could potentially cause property damage. Electrical systems, wire type, electrical components, etc. behind the panel cover could not be inspected.
