# **FAMILYGUARD**

## **HOME INSPECTION REPORT**

**110 S. Grant St. Kendallville, IN 46755**  
**Inspection Prepared For: Seller**

**Date of Inspection: 8/9/2023**  
**Age of House: 100+ Years**  
**Weather: Clear**

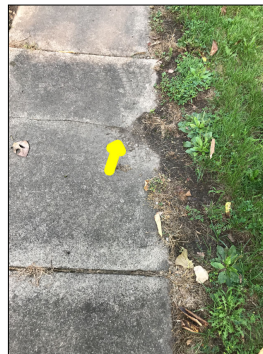
Cracks and deterioration along the service walks.

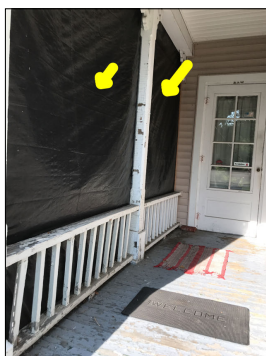
Unconventional tarp along the porch.  
This is considered abnormal.

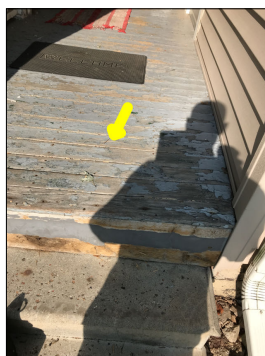
Flaking and peeling along the porch.

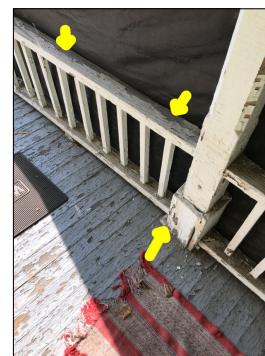
Flaking and peeling along the porch.

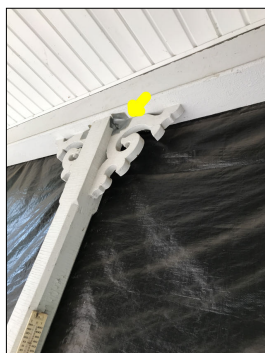
Unconventional tape along the porch.

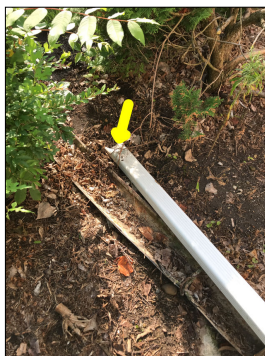
Smashed gutter extension.

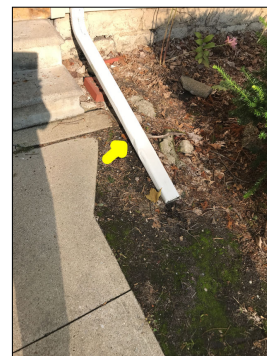
Dents along the gutter system.

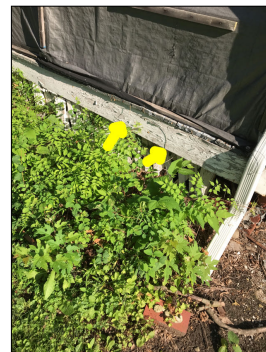
Flaking and peeling along the exterior.

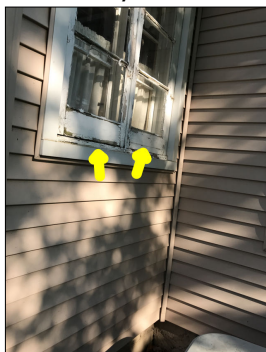
Flaking and peeling along the exterior.

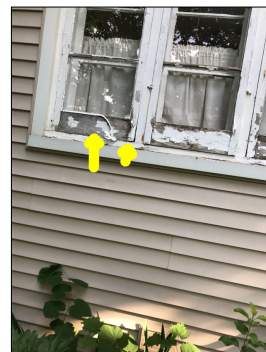
Flaking and peeling along the exterior.

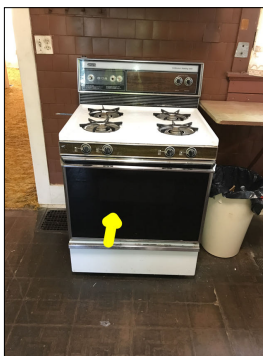
Aged range. The range is inoperable.

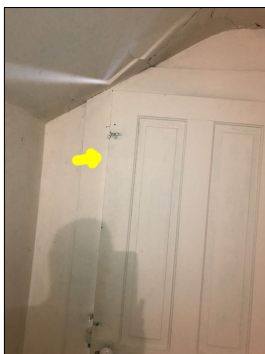
The door does not latch properly.

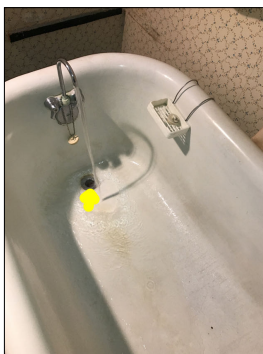
Missing original drain stopper.

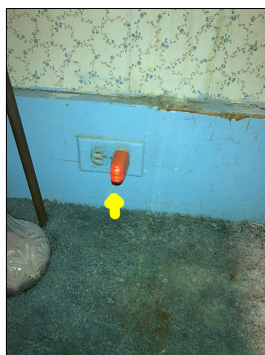
Non GFCI protected receptacles.

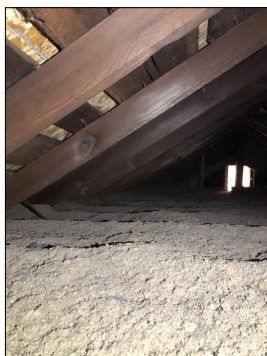
General photo of the attic.

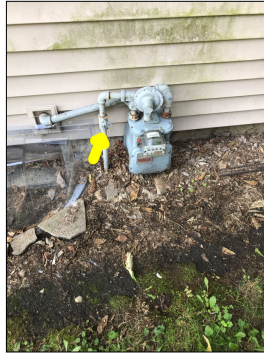
Main fuel shut off valve.
