# **FAMILYGUARD**

## **HOME INSPECTION REPORT**

**5715 W. 1200 N.-35 South Whitley, IN 46787**  
**Inspection Prepared For: Seller**

**Date of Inspection: 7/8/2024**  
**Age of House: 165 Years**  
**Weather: Clear**

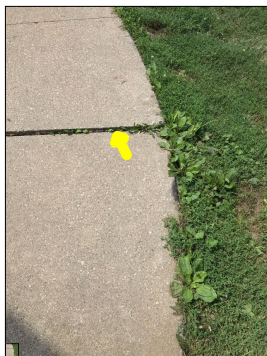
Uneven surfaces along the service walks.

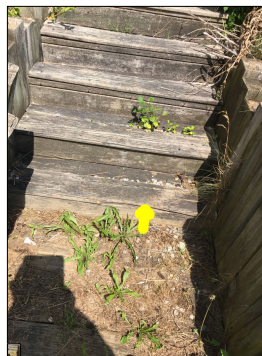
Deterioration along the service walks.

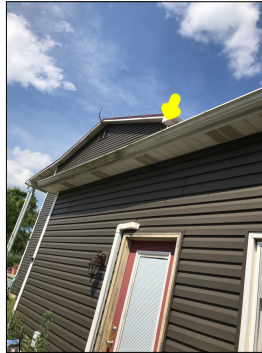
Loose gutter spikes.

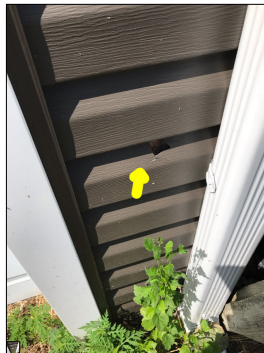
Holes along the siding.

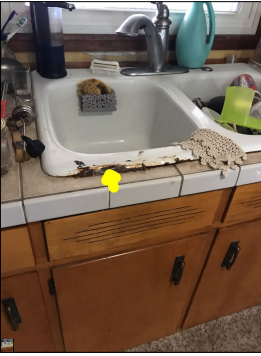
Rust and corrosion along the sink.

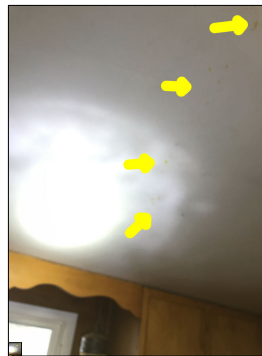
Discoloration along the ceiling.

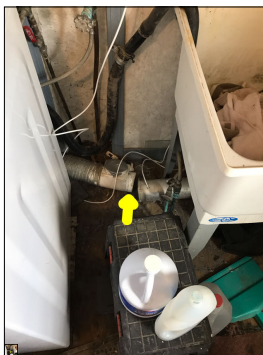
The ductwork is disconnected.

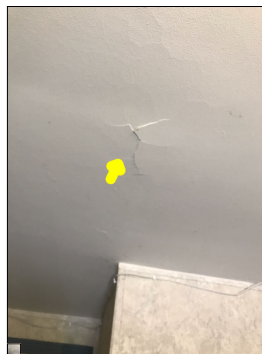
Cracks along the ceiling.

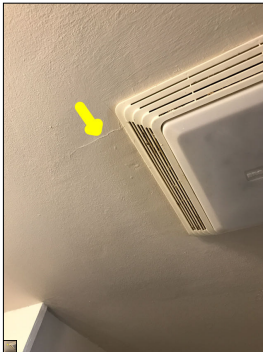
Cracks along the ceiling.

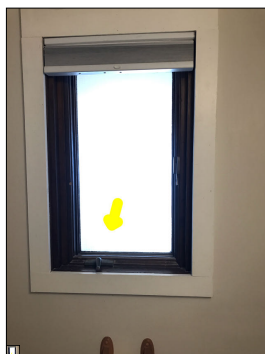
Aged and inoperable window.

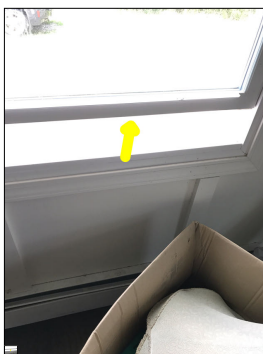
Missing window screens.

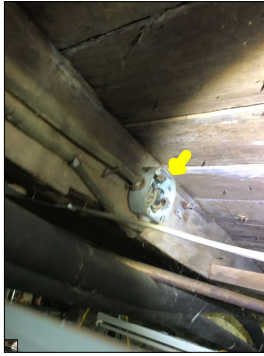
Open junction boxes.
