# **FAMILYGUARD**

## **HOME INSPECTION REPORT**

**110 S. Grant St. Kendallville, IN 46755**  
**Inspection Prepared For: Seller**

**Date of Inspection: 8/9/2023**  
**Age of House: 100+ Years**  
**Weather: Clear**

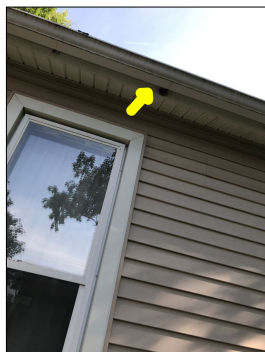
Wasp nest.

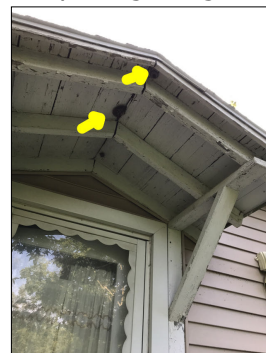
Wasp nest.

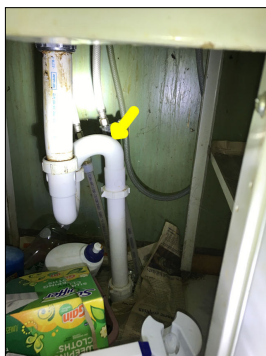
S-trap underneath the sink. S-traps no longer meet modern day plumbing standards. S-traps have the potential to siphon and become dry, thus creating the potential to allow sewer gases into the house. S-traps have the potential to make a knocking/gurgling sound when draining.

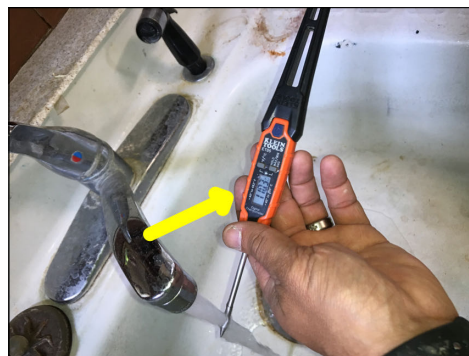
Temperature reading of the hot water during the time of the inspection. The approximate temperature of the hot water was 110 degrees Fahrenheit.

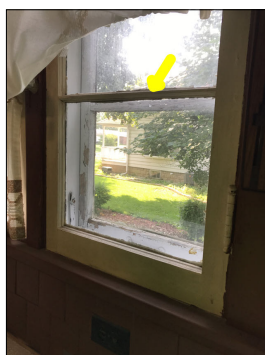
Aged windows.

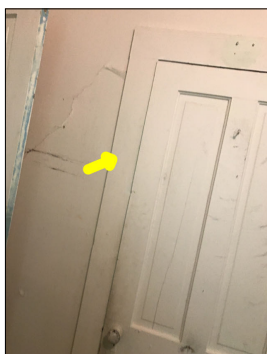
The door does not close/latch properly.

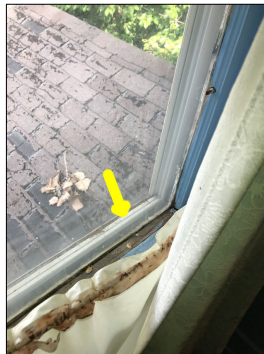
Aged windows.

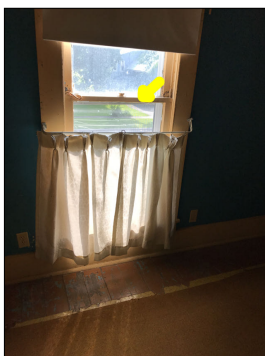
Aged windows.

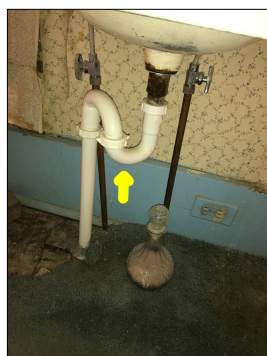
S-trap underneath the sink. S-traps no longer meet modern day plumbing standards. S-traps have the potential to siphon and become dry, thus creating the potential to allow sewer gases into the house. S-traps have the potential to make a knocking/gurgling sound when draining.

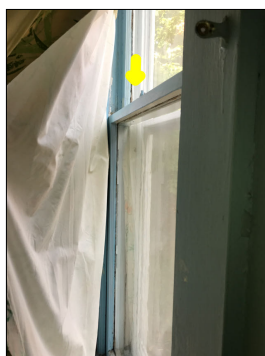
Aged window.

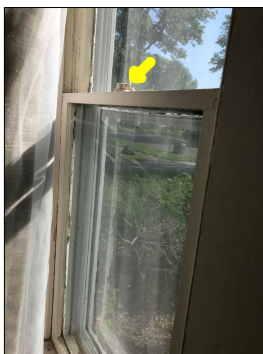
Aged windows.

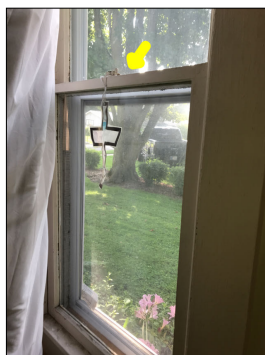
Aged windows.

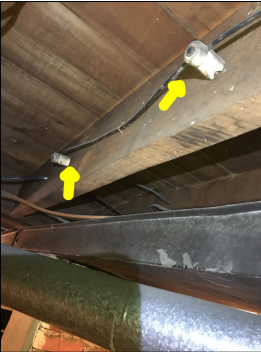
Traces of knob and tube. No voltage detected in this area. Knob and tube wiring is a potential safety hazard and does not meet modern day electrical standards. Please note, additional knob and tube wiring can be concealed behind walls, ceilings, etc.  
Recommended licensed electrician further evaluate and make necessary repairs.

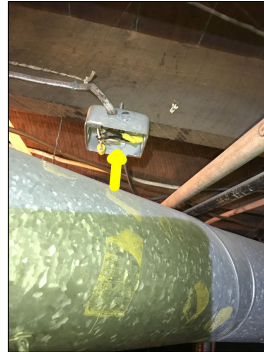
Exposed wires. This is a potential safety hazard.

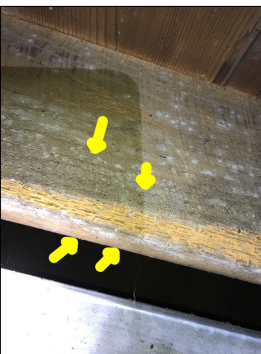
Exit holes observed. Exit holes are an indication of an infestation of powderpost beetles. Powderpost beetles are a wood destroying insect and can cause structural damage and property damage.

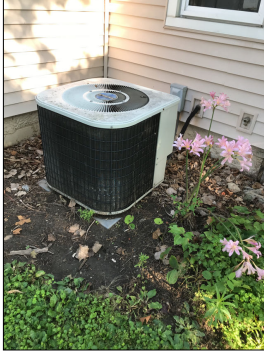
Condenser.

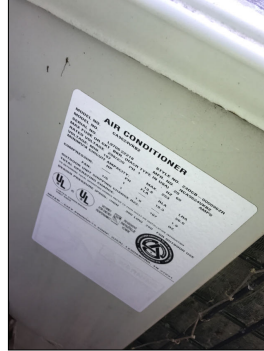
Condenser data plate.

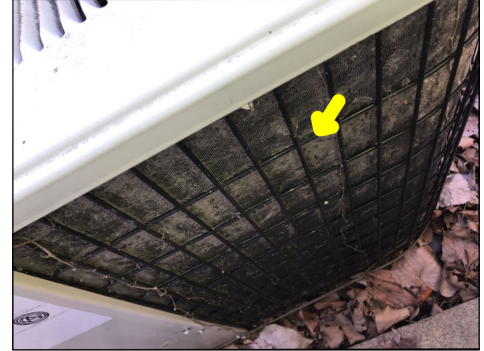
The condenser is dirty and needs cleaning. A dirty condenser can restrict proper airflow along the condenser, thus causing the condenser to work harder, which can shorten the lifespan of the condenser.

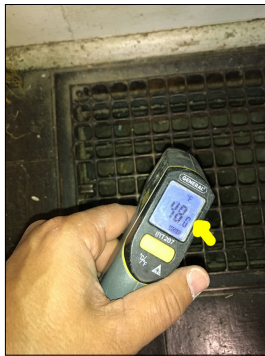
The photo identifies the temperature of the supply air while the air conditioner was in operation. The approximate temperature of the supply air was 48 degrees Fahrenheit.

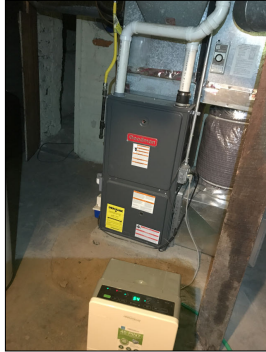
Furnace.

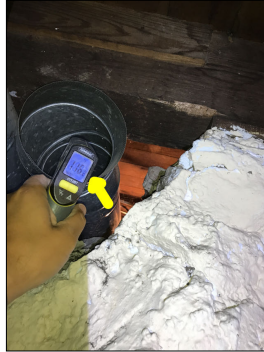
The photo identifies the temperature of the supply air while the furnace was in operation. The approximate temperature of the supply air was 116 degrees Fahrenheit.

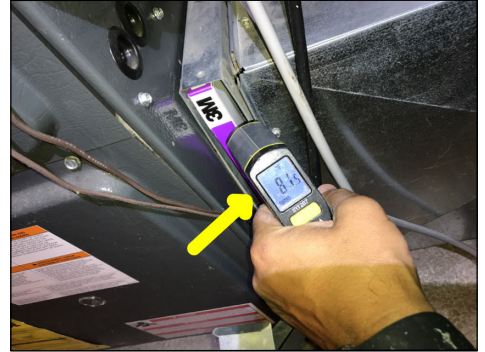
The photo identifies the temperature of the return air while the furnace was in operation. The approximate temperature of the return air was 81 degrees Fahrenheit.

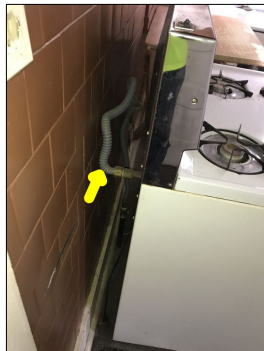
Coated brass fuel line. Coated brass no longer meets modern day plumbing standards and is considered a safety hazard. Recommend upgrading the fuel line to a modern day plumbing material, such as **CSSI** or black iron.

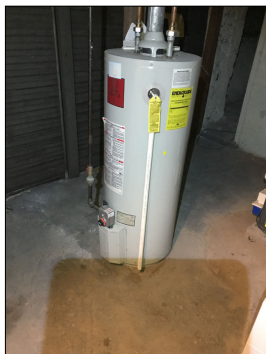
Water heater.
