FAMILYGUARD

HOME INSPECTION REPORT

3633 W. State Blvd. Fort Wayne, IN 46808
Inspection Prepared For: Seller

Date of Inspection: 4/25/2024
Age of House: 57 Years
Weather: Clear

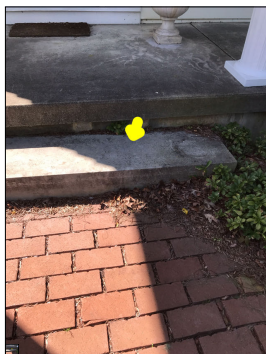
The step is sloped.

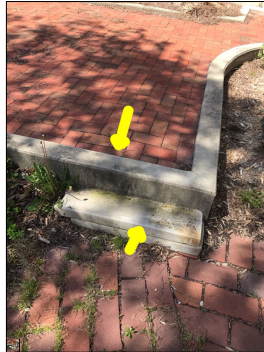
Uneven surfaces along the patio.

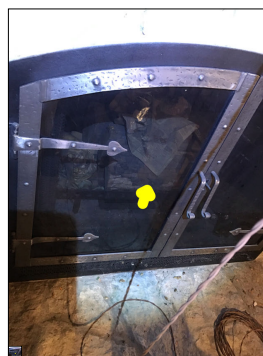
The fireplace is dirty and needs cleaning/serviced.

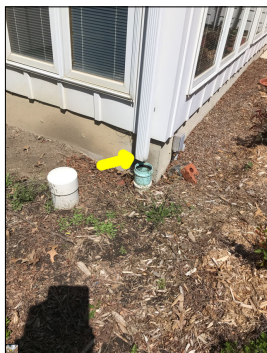
The downspout is off center from the drain tile.

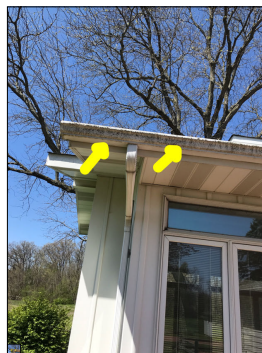
Discoloration along the gutter system.

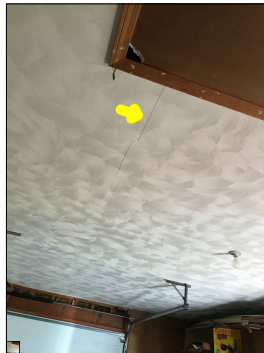
Cracks along the ceiling.

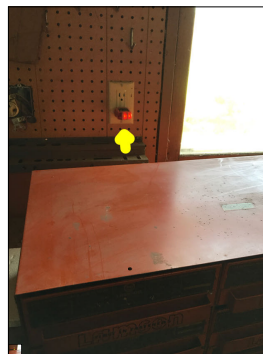
Non GFCI protected receptacles.

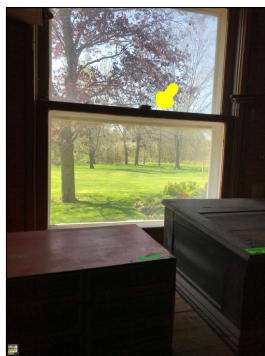
Aged windows.

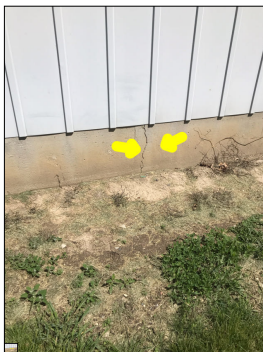
Crack along the slab. Cracks are considered a defect. Cracks should be repaired/sealed to prevent the intrusion of moisture, insects, radon, wood destroying insects, mice, etc.

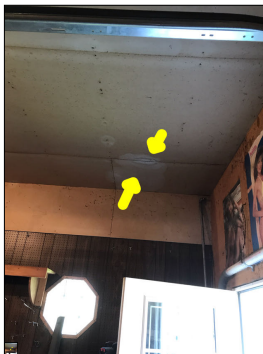
Discoloration along the ceiling.

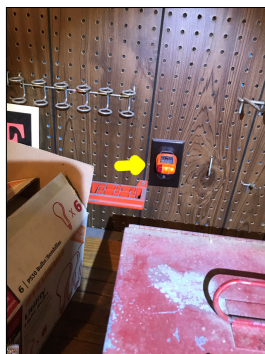
Non GFCI protected receptacles.

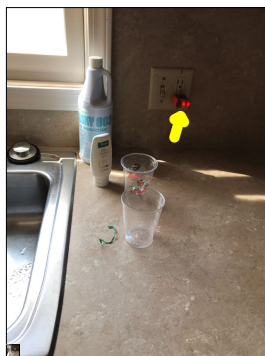
Non GFCI protected receptacles.

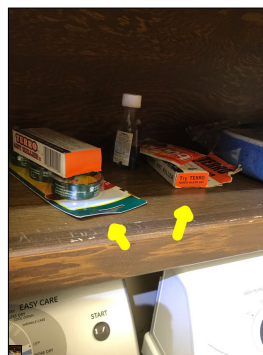
Pest control observed.

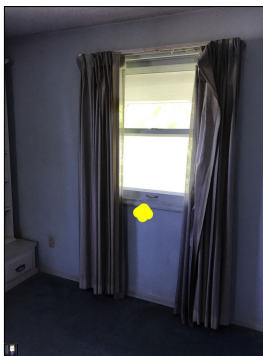
Aged windows.

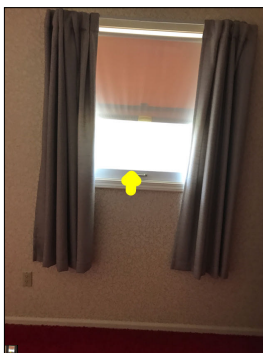
Aged windows.

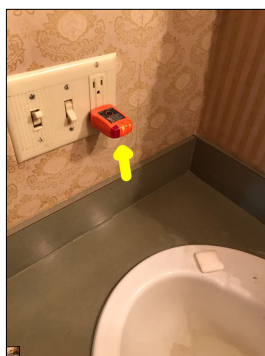
Non GFCI protected receptacles.

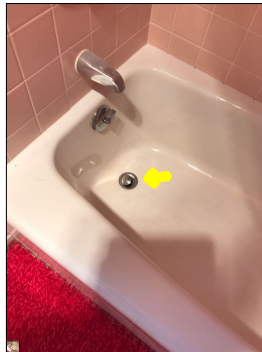
Inoperable drain stopper.

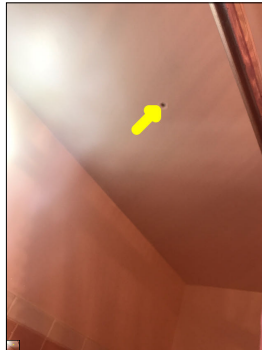
Damage along the ceiling.

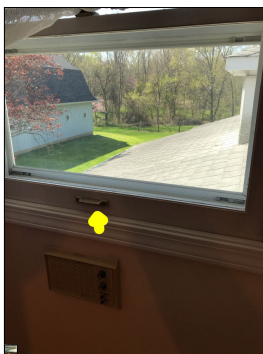
Aged window.

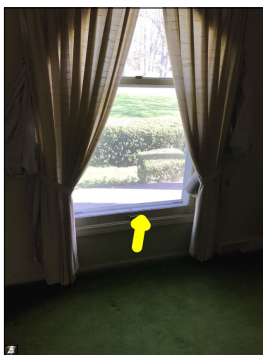
Aged windows.

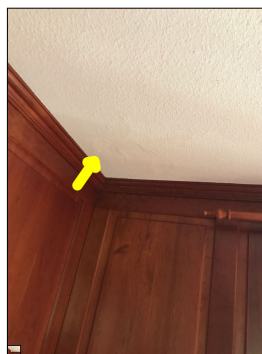
Discoloration along the ceiling.

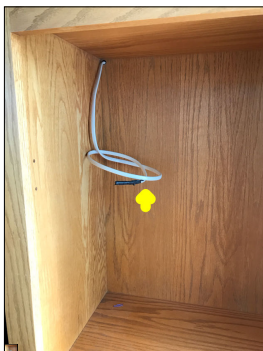
Exposed wires. This is a potential safety hazard.

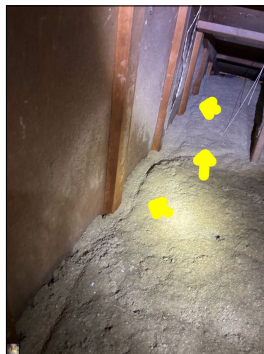
Mice/rodent tracks along the insulation. Wildlife activity can cause property damage.

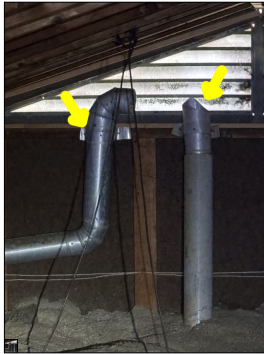
The bathroom exhaust fan vents into the attic. This is not a recommended practice. Exhaust fans venting into the attic can cause mold growth. An active or intermittent water source can cause mold growth. Exhaust fans should vent to the exterior. Exhaust fans should have their own termination and not share a termination with an attic vent, such as a roof vent or soffit. Also, the ductwork for the fan should be properly insulated so condensation does not form along it, thus potentially causing mold growth.

The exhaust ductwork lacks insulation. It is recommended for exhaust ductwork to be insulated in non climate controlled areas, such as an attic. The lack of insulation can cause condensation to form along the ductwork. An active or intermittent water source can cause mold growth and property damage.

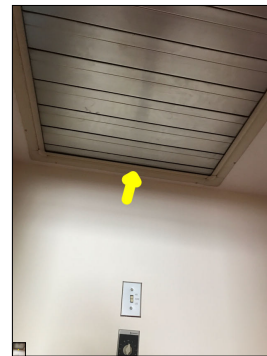
Inoperable whole house fan.

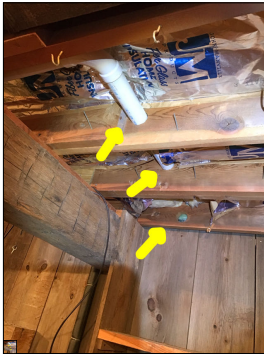
Unconventional plumbing pipes routed through the floor joists. This is not a recommended practice. Plumbing pipes normally are not routed through floor joists, unless the house is built with floor trusses, in this case, the house does not have floor trusses. The unconventional alterations and holes to the floor joists can compromise the structural integrity of the floor joists, thus resulting in squeaky floors, sloped floors, cracks along walls and ceilings, doors and windows not properly closing and opening, etc.

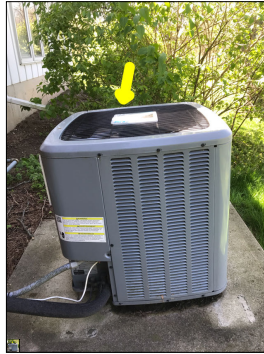
The condenser is not level. Refrigerant within an air conditioner also acts as a lubricant. When the condenser is leaning, some internal components may not get properly lubricated, thus shortening the lifespan of the condenser.

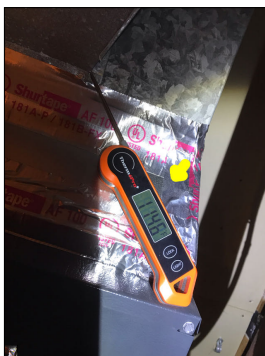
The photo identifies the temperature of the supply air while the furnace was in operation. The approximate temperature of the supply air was 114 degrees Fahrenheit.

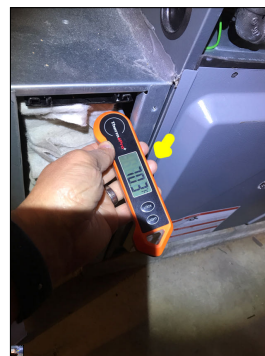
The photo identifies the temperature of the return air while the furnace was in operation. The approximate temperature of the return air was 70 degrees Fahrenheit.

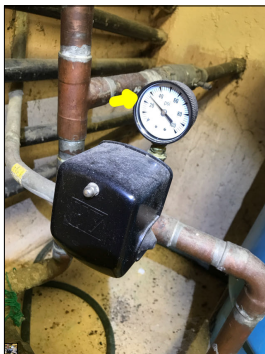
The well pressure was approximately 28 PSI during the inspection.

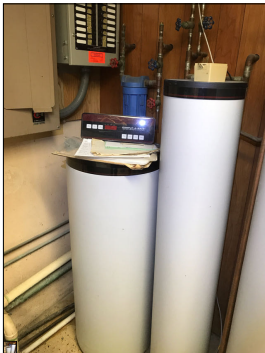
Water softener. Please note, the softener is not in service.

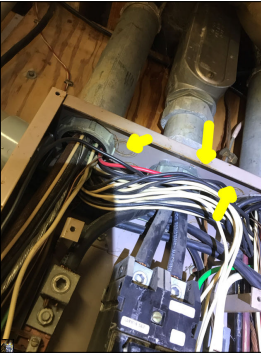
Rust and corrosion within the circuit breaker panel. This is considered abnormal and a potential safety hazard. An active or intermittent water source can cause rust and corrosion.

Rusted/corroded terminals and connections increase resistance in the circuit that can cause overheating, thus causing arcing, spark and/or fire.

Some areas of rust and corrosion may not be visible and could be concealed behind breakers, wires, etc.
