# **FAMILYGUARD**

## **HOME INSPECTION REPORT**

**5715 W. 1200 N.-35 South Whitley, IN 46787**  
**Inspection Prepared For: Seller**

**Date of Inspection: 7/8/2024**  
**Age of House: 165 Years**  
**Weather: Clear**

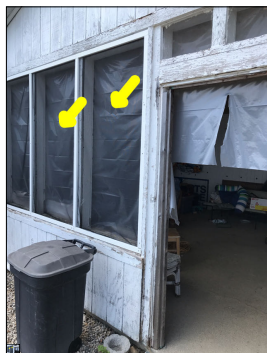
Unconventional plastic along the windows. This is considered abnormal.

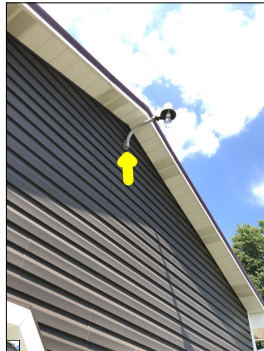
The wires are not wrapped in conduit. This is considered abnormal, amateur craftsmanship and a potential safety hazard. Wires should be wrapped in conduit to protect both humans and the electrical wiring. Wires that lack conduit can potentially get pulled, become loose, or damaged, thus creating shock hazards and/or fire hazards. Also, the sheathing around the wires is not rated for exterior use. The lack of proper sheathing can allow rain, snow, sunlight, wildlife, etc. to damage the wires, thus causing shock hazards, spark, arcing and/or fire.

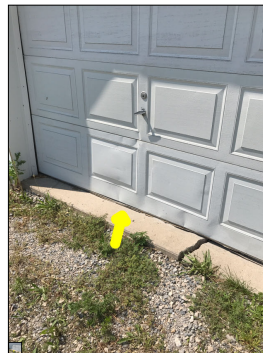
The weatherstrip is partially torn/missing along the overhead garage door. The lack of a proper weatherstrip can allow the intrusion of moisture, insects, wood destroying insects, mice and rodents into the property.

Dents/damage along the overhead garage door.

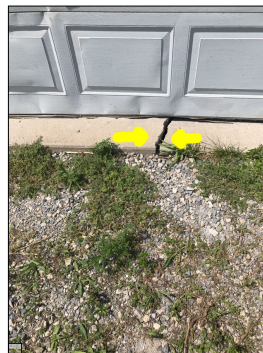
Cracks and deterioration along the floor.

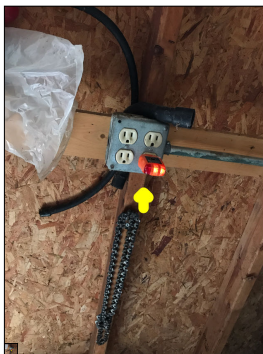
Non GFCI protected receptacles.

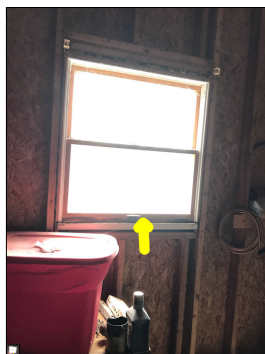
Aged windows.

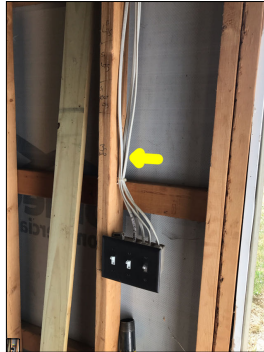
The wires are not wrapped in conduit. This is considered abnormal, amateur craftsmanship and a potential safety hazard. Wires should be wrapped in conduit to protect both humans and the electrical wiring. Wires that lack conduit can potentially get pulled, become loose, or damaged, thus creating shock hazards and/or fire hazards.

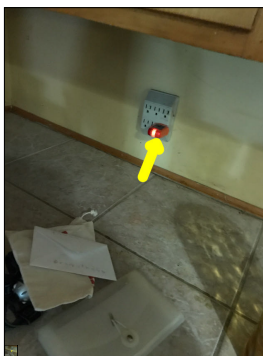
Open ground receptacles.

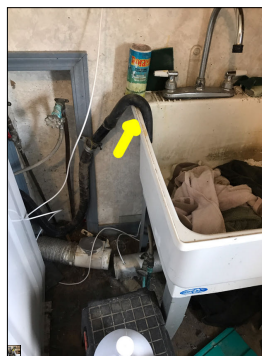
The washing machine unconventionally discharges into the sink. This is not a recommended practice and does not meet the industry standard. The washing machine should discharge into the main drain pipes. Recommend licensed plumber further evaluate and make necessary repairs.

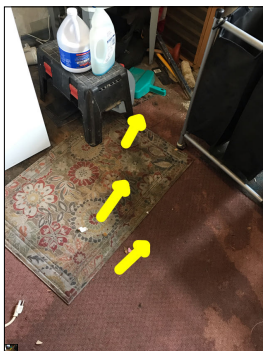
The floor and carpet are wet. An active or intermittent water source can cause property damage and mold growth.

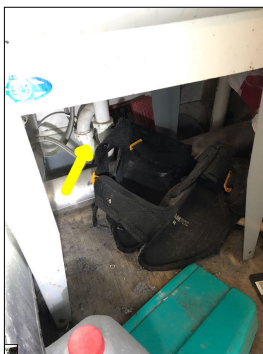
S-trap underneath the sink. S-trap no longer meet modern day plumbing standards. S-traps have the potential to siphon and become dry, thus creating the potential to allow sewer gases into the house. S-traps have the potential to make a knocking/gurgling sound when draining.

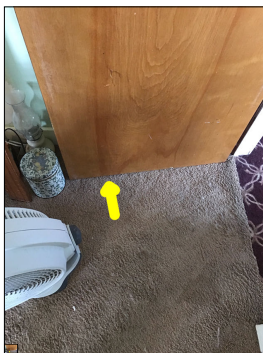
The door drags the floor during operation.

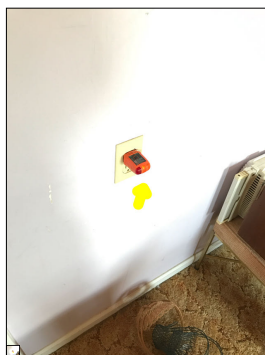
Open ground receptacles.

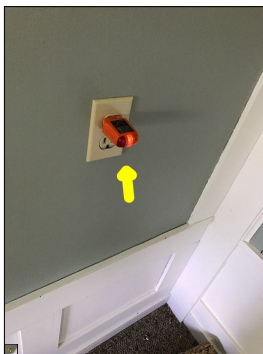
Open ground receptacles.

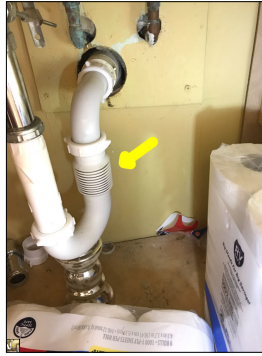
Flexible accordion drain pipe underneath the sink. Flexible accordion drain pipe is intended for temporary use. The problem with accordion drain pipe is the collection of grime, hair, dirt, debris and other small items that may fall into a drain. The design of the pipes allows for debris to easily collect in the drain line, thus eventually creating poor drainage and potential blockage. Flexible drain pipe is considered amateur craftsmanship and does not meet the industry standard.

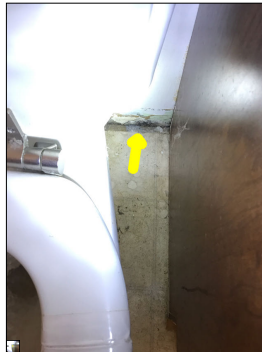
Discoloration along the wall and signs of previous water damage. An active or intermittent water source can cause mold growth and property damage.

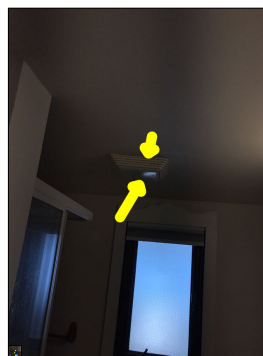
I was unable to find the wall switch for the exhaust fan and ceiling light.

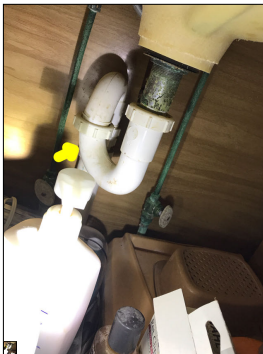
S-trap underneath the sink. S-traps no longer meet modern day plumbing standards. S-traps have the potential to siphon and become dry, thus creating the potential to allow sewer gases into the house. S-traps have the potential to make a knocking/gurgling sound when draining.

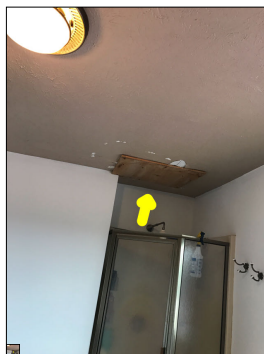
Unconventional board along the ceiling.

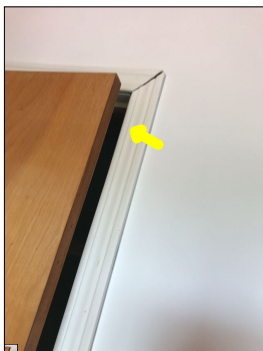
The door rubs the frame during operation.

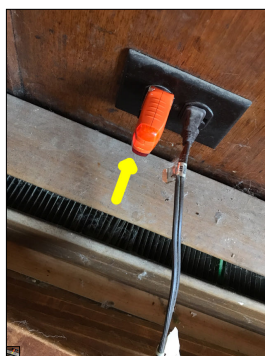
Open ground receptacles.

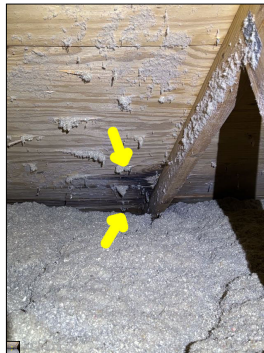
Mold like substance along the sheathing/framing. An active or intermittent water source can cause mold growth and property damage, such as wood rot damage.

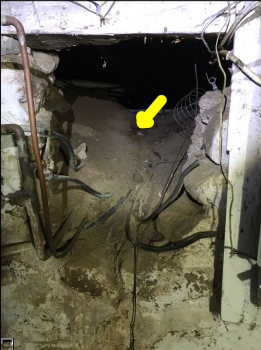
Dirt floor. Dirt floors are not recommended. A dirt floor can allow the intrusion of moisture, insects, wood destroying insects, radon, mice, and rodents. An active or intermittent water source can cause mold growth and property damage, such as wood rot damage. It is recommended that dirt floors be properly encapsulated.

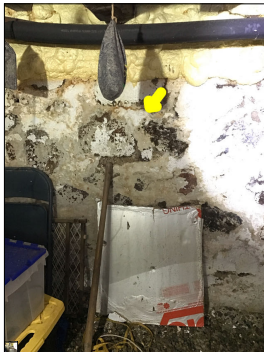
Aged field stone foundation.

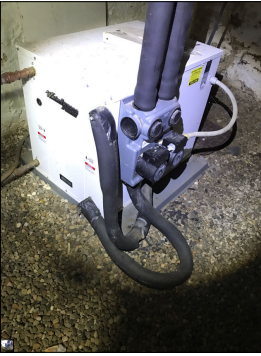
- No current service record
- Service recommended
- Please note, there is no indication that the geothermal has experienced annual routine preventative maintenance. It is recommended that appliances have annual maintenance to prolong the life of the appliance, ensure the appliances are operating at optimal performance, keep warranties valid and help avoid unexpected/costly repairs.

Geothermal. Please note, the geothermal is hooked up to heating elements that use water, similar to a boiler. Most of the heating elements throughout the house are supplied by the geothermal. However, there are a few rooms in the house that have electric baseboard heat. Also, even though a geothermal can provide cooling. This geothermal cannot because it is not equipped to create forced air.

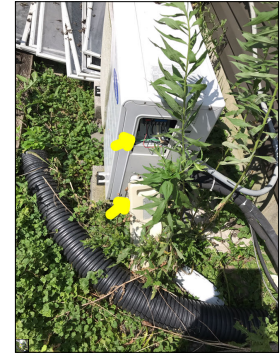
Exposed wires along the mini split and the cover is detached. The approximate manufacturer date of the mini split is 2011. I was unable to locate the remote to the mini split. Check with a licensed HVAC technician or current homeowner to ensure the mini split is operable.

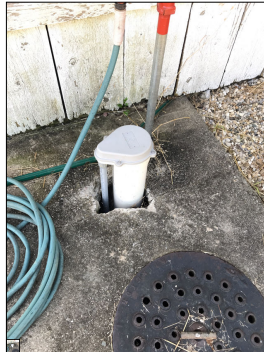
General photo of the wellhead. Please note, there was no apparent pressure tank observed on the property. The benefit of a pressure tank is a pressure tank takes the workload off of the well pump, thus extending the life of the well pump. Also, it is normally less expensive to replace a pressure tank than a well pump.

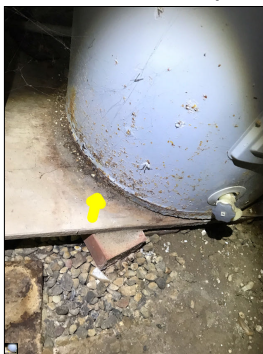
Rust and corrosion along the water heater. This is considered a defect. An active or intermittent water source can cause property damage and mold growth.

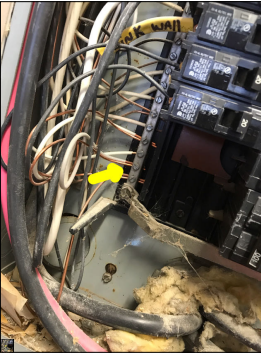
Double tapped neutral wires. Neutral wires should not share a terminal with any other wires, including ground wires. Double tapped neutrals are considered a safety hazard. Double tapped neutral wires do not allow the circuit to be isolated if the circuit needs to be worked on. Also, double tapped neutral wires under the same terminal can become loose, which could lead to arcing, overheating, spark and/or fire.
