FAMILYGUARD

HOME INSPECTION REPORT

623 Stratton Rd. Fort Wayne, IN 46825
Inspection Prepared For: Seller

Date of Inspection: 9/11/2024
Age of House: 41 Years
Weather: Clear

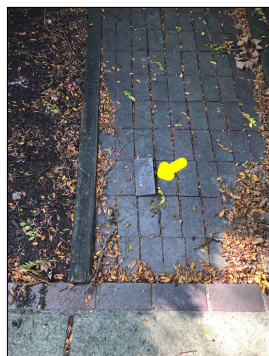
Uneven surfaces along the service walks.

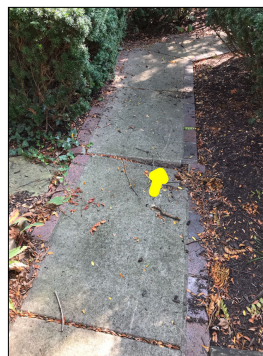
Uneven surfaces along the service walks.

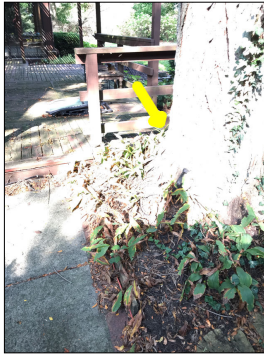
Tree adjacent to the house. Tree roots can cause foundation problems and can create structural damage to the foundation. Also, trees that are next to the house can potentially fall on the house, potentially causing bodily harm and damage to the house.

- Trim back trees/shrubberies
- Remove wood/leaves/debris from around house

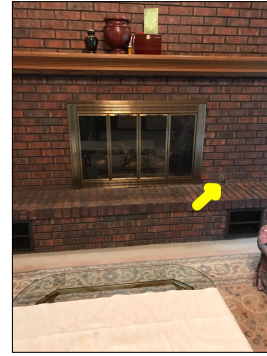
The fireplace is a gas fireplace. There is no apparent electronic ignition. It is beyond the scope of a general home inspection to light fuel burning appliances. Doing so could cause property damage. Recommend a licensed chimney/fireplace professional further evaluate to make sure the fireplace is in good working condition and safe to use.

- Needs cleaning/serviced
- Before using the fireplace, it is recommended that a licensed chimney/fireplace professional further evaluate to ensure the fireplace is in good working condition and is safe for usage.

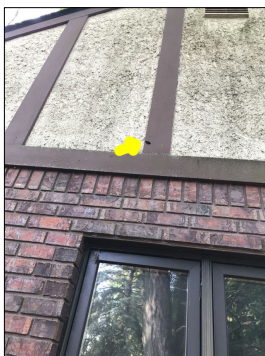
Holes along the siding.

- Recommend general contractor further evaluate and make necessary repairs

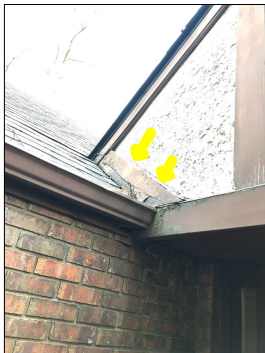
Unconventional application of caulk along the siding. This is considered abnormal and amateur craftsmanship.

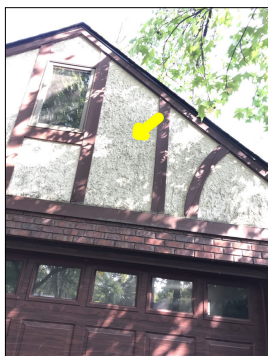
The house has stucco siding in some areas. Please note, stucco siding is prone to absorbing moisture. An active or intermittent water source can cause mold and property damage.

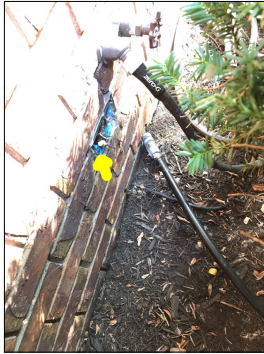
Exposed wires. This is a potential safety hazard.

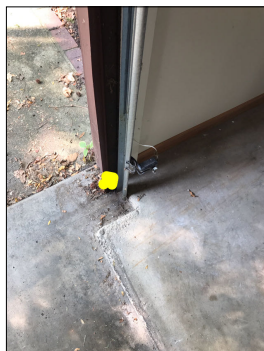
The photo eye sensors are too high. This is a potential safety hazard. The photo eye sensors should be between four and six inches from the floor.

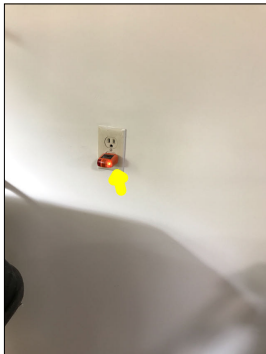
Open neutral receptacle.

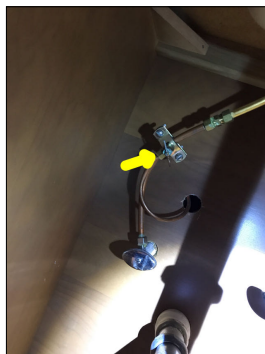
Rust/corrosion along the plumbing pipes/saddle valve. This is underneath the sink in the living room.

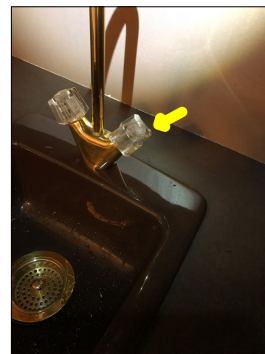
The handle for the cold water is inoperable. The handle will not move. The handle might move with excessive force.

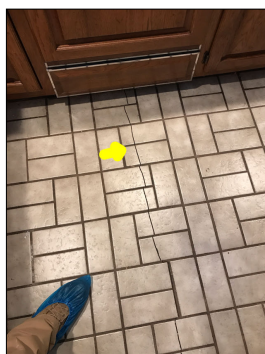
Cracked floor tiles.

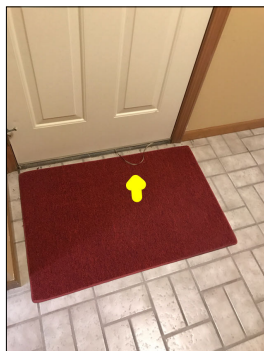
Torn weatherstrip along the door.

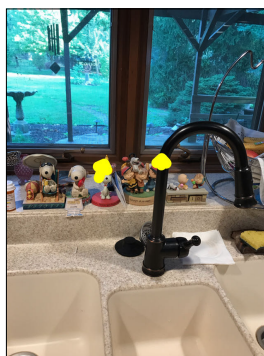
Aged windows.

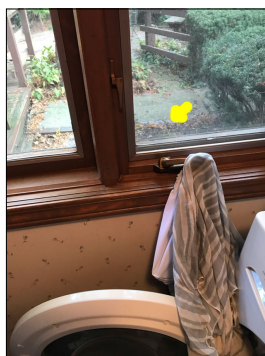
Aged windows.

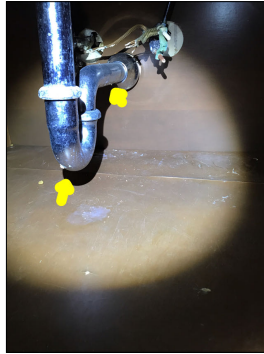
Rust/corrosion along the plumbing pipes.

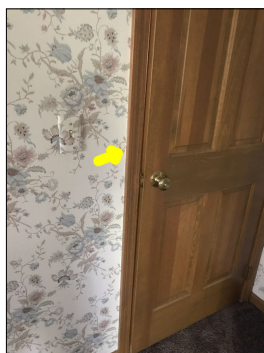
The door rubs the frame during operation.

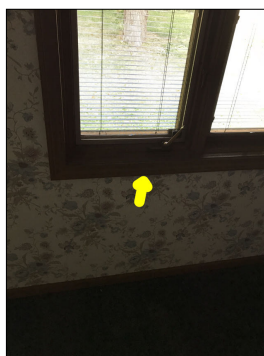
Inoperable window. The window might open with excessive force. Please note, a properly functioning window should be able to easily open.

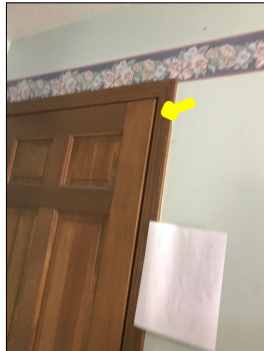
The door rubs the frame during operation.

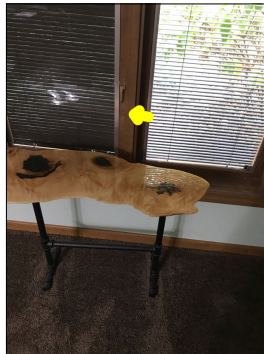
Aged windows.

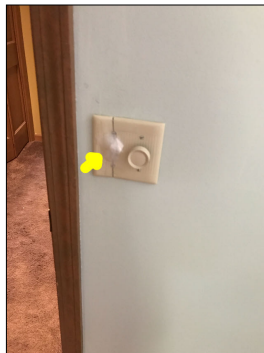
Unconventional tape along the switch and the cover is cracked.

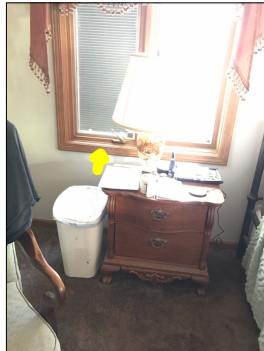
Aged windows.

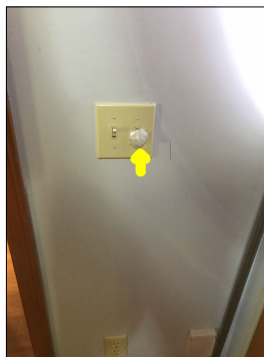
Unconventional tape along the switch. This is considered abnormal and amateur craftsmanship.

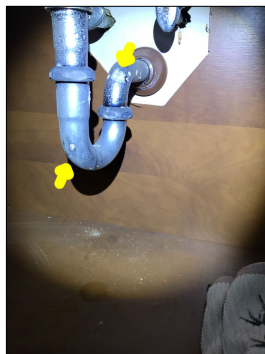
Rust/corrosion along the plumbing pipes.

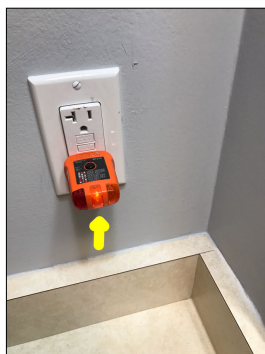
Open ground receptacles

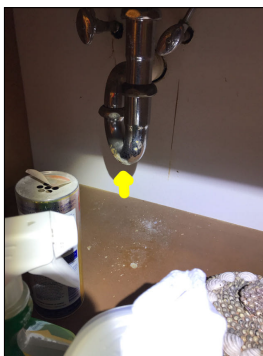
Rust/corrosion along the plumbing pipes.

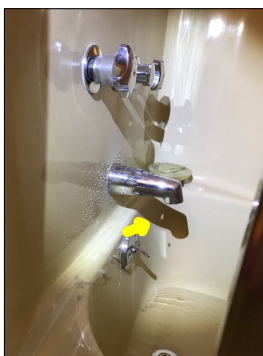
The bathtub faucet leaks while the showerhead is in operation. This is considered a defect. A properly functioning diverter will not allow any water through the bathtub faucet while the showerhead is in operation.

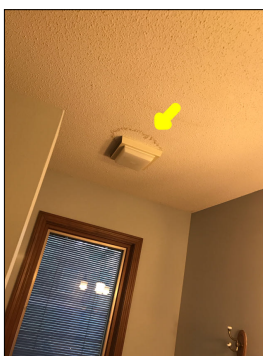
Discoloration along the ceiling and signs of previous water damage. An active or intermittent water source can cause mold growth and property damage.

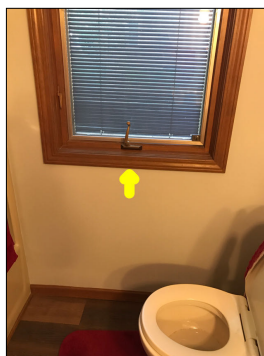
Aged window.

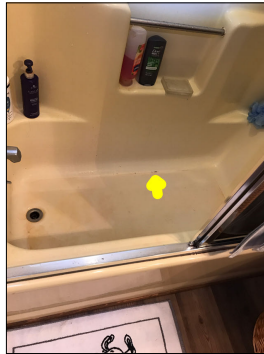
Chips along the bathtub. Chips are considered defects and are potential leak points.

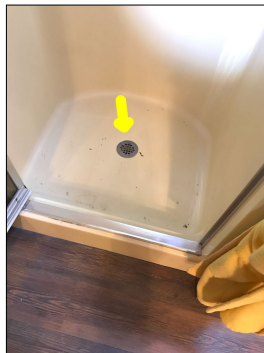
The drain is noisy when the other shower is in operation. This is considered abnormal.

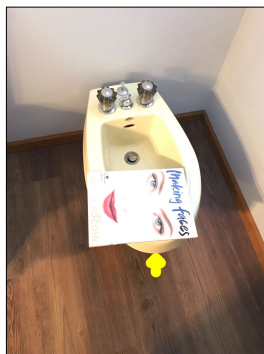
The bidet toilet is loose. The toilet rocks from side to side. A toilet should not have any movement and be fully anchored and secured to the floor.

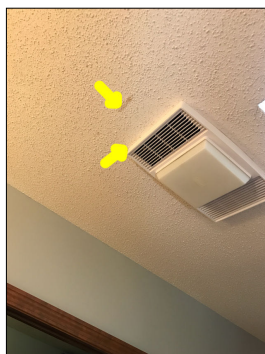
Discoloration along the ceiling and signs of previous water damage. An active or intermittent water source can cause mold growth and property damage.

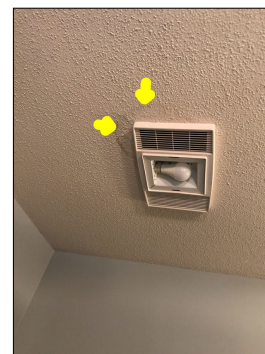
Discoloration along the ceiling and signs of previous water damage. An active or intermittent water source can cause mold growth and property damage.

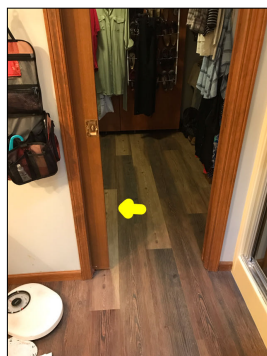
The pocket door is difficult to operate.

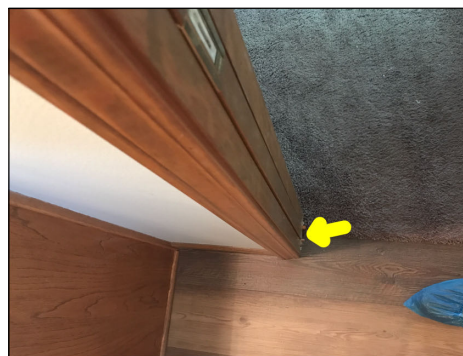
Inoperable door. The door might move with excessive force.

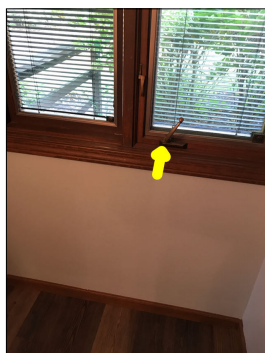
Aged window.

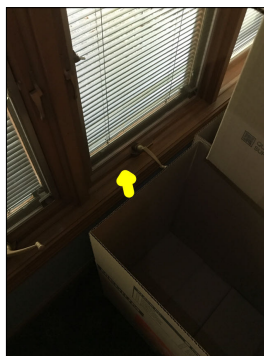
Inoperable window. The window might open with excessive force. Please note, a properly functioning window should be able to easily open.

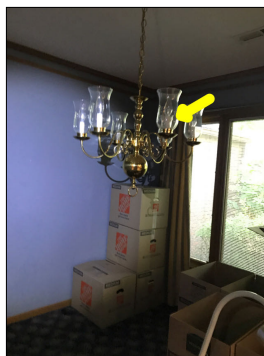
The light is inoperable. The wall switch appears to be inoperable.

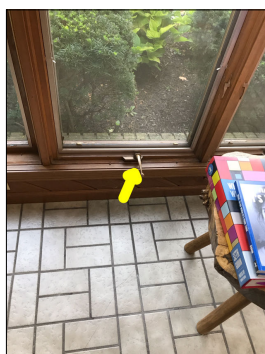
Inoperable window. The window might open with excessive force. Please note, a properly functioning window should be able to easily open.

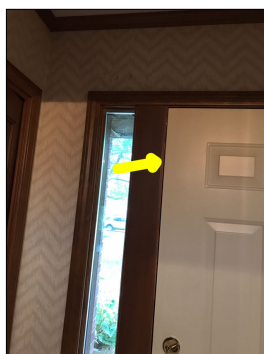
The door rubs the frame during operation.

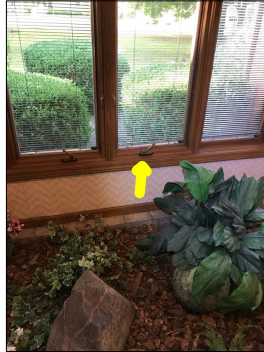
Inoperable window.

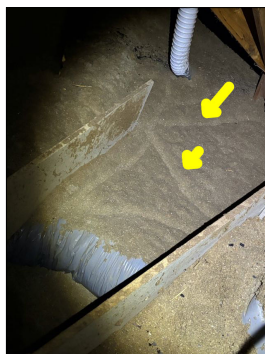
Mice/rodent tracks along the insulation. Wildlife activity can cause property damage.

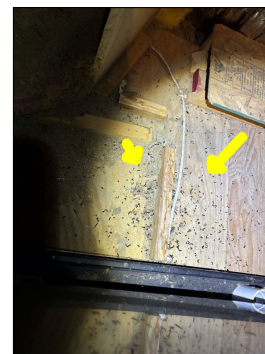
Mice/rodent droppings. Wildlife activity can cause property damage.

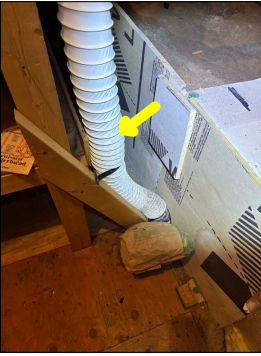
The exhaust ductwork lacks insulation.

It is recommended for exhaust ductwork to be insulated in non climate controlled areas, such as an attic. The lack of insulation can cause condensation to form along the ductwork. An active or intermittent water source can cause mold growth and property damage.

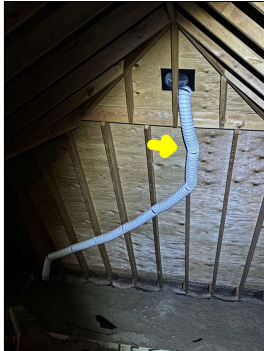
The bathroom exhaust fan vents into the attic. This is not a recommended practice. Exhaust fans venting into the attic can cause mold growth. An active or intermittent water source can cause mold growth. Exhaust fans should vent to the exterior. Exhaust fans should have their own termination and not share a termination with an attic vent, such as a roof vent or soffit. Also, the ductwork for the fan should be properly insulated so condensation does not form along it, thus potentially causing mold growth.

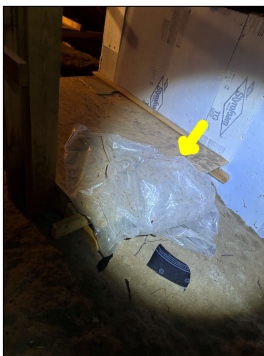
Debris and clutter within the attic. Visibility and accessibility were limited.

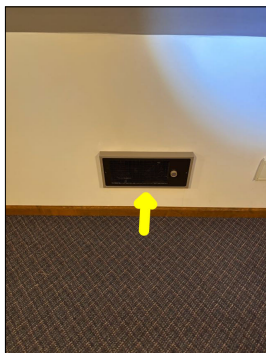
The heating element is inoperable.

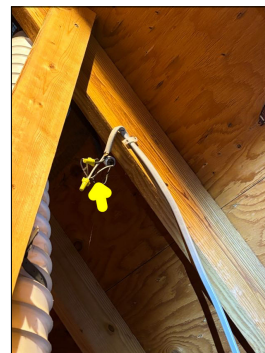
Exposed wires. This is a potential safety hazard.

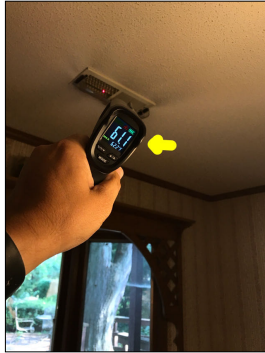
The photo identifies the temperature of the supply air while the air conditioner was in operation. The approximate temperature of the supply air was 61 degrees Fahrenheit.

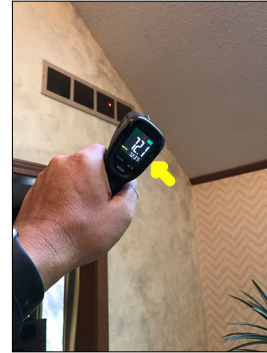
The photo identifies the temperature of the return air while the air conditioner was in operation. The approximate temperature of the return air was 72 degrees Fahrenheit.

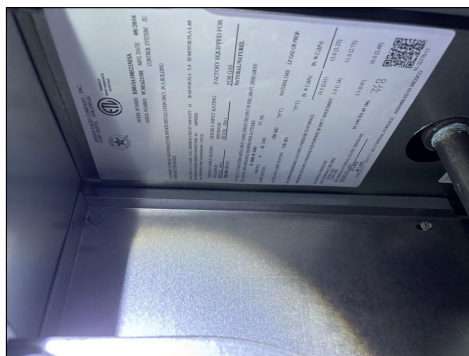
Furnace data plate.

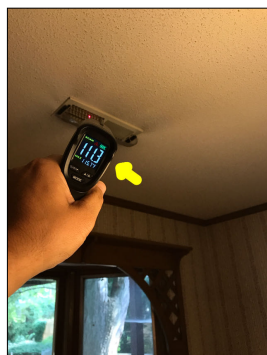
The photo identifies the temperature of the supply air while the furnace was in operation. The approximate temperature of the supply air was 111 degrees Fahrenheit.

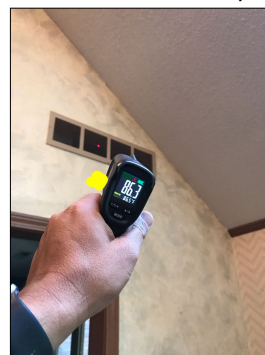
The photo identifies the temperature of the return air while the furnace was in operation. The approximate temperature of the return air was 86 degrees Fahrenheit.

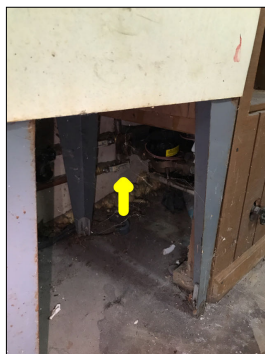
Apparent main water shut-off valve.

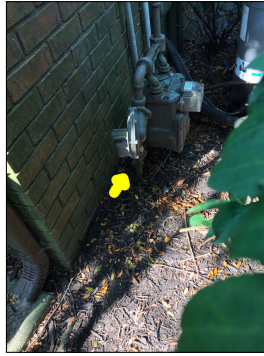
Main fuel shut off valve.

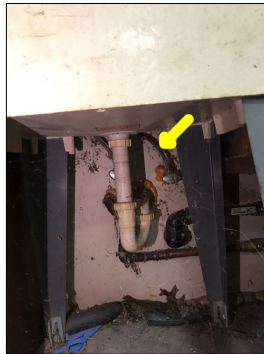
Polybutylene plumbing lines. Polybutylene pipes are prone to failure and no longer meet modern day plumbing standards. Recommend upgrading from polybutylene pipes to modern day plumbing materials, such as PEX or copper. Please note, polybutylene pipes can be concealed behind walls, ceilings, etc. This is located underneath the sink in the garage.

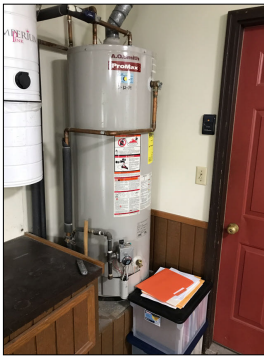
Water heater.

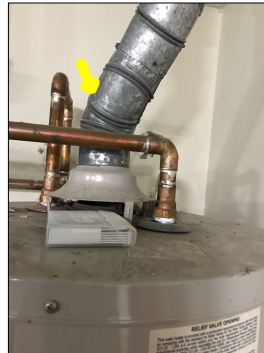
Improper flue. There should be a minimum of twelve inches between the draft hood outlet and the first elbow or connector. The current design of the flue is a potential safety hazard as it could cause the flue to backdraft and release carbon monoxide into the house.
