FAMILYGUARD

HOME INSPECTION REPORT

305 E. Highland St. Albion, IN 46701
Inspection Prepared For: Seller

Date of Inspection: 9/17/2025
Age of House: 175 Years
Weather: Clear

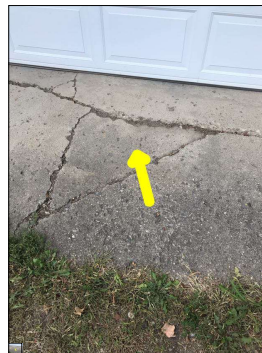
Cracks and deterioration along the driveway.

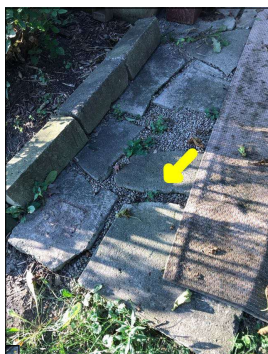
Uneven surfaces along the service walks.

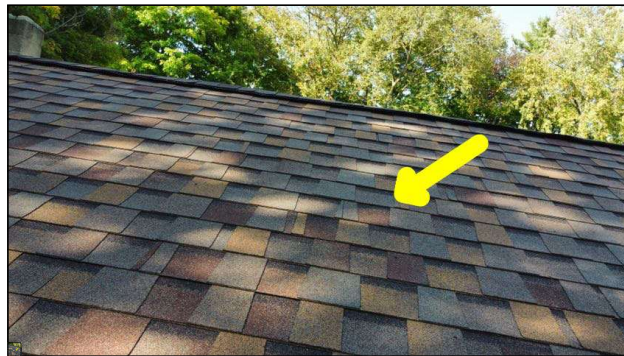
General photo of the roof the shingles.

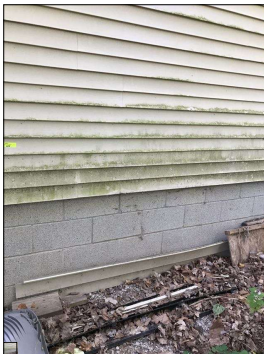
Discoloration along the siding.

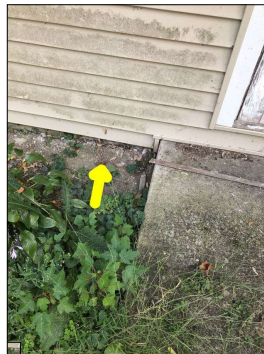
The siding is in proximity to the ground. Siding should have at least 6 to 8 inches of clearance above the ground. Maintaining proper clearances reduces access to wood structures behind the siding and helps preserve the house. The proper clearances help restrict access from wood destroying insects and/or moisture/water that might find its way behind the siding.

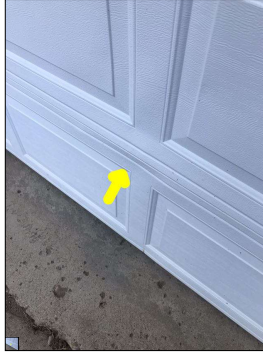
Dents/damage along the overhead garage door.

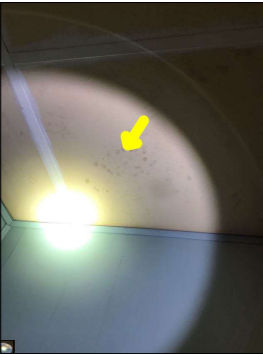
Discoloration along the ceiling tiles.

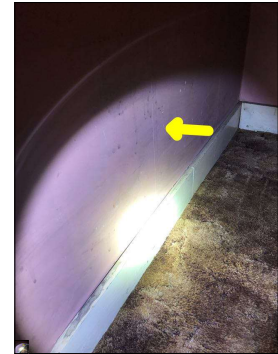
Discoloration along the walls.

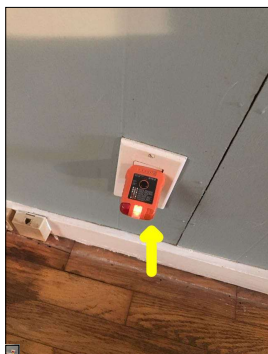
Open ground receptacles.

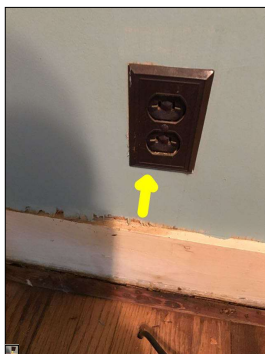
Two prong receptacles. Two prong receptacles are not grounded.

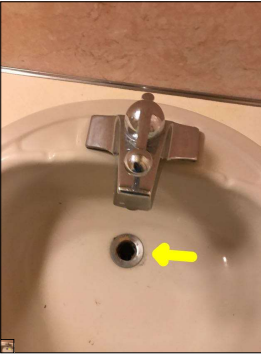
Missing drain stopper.

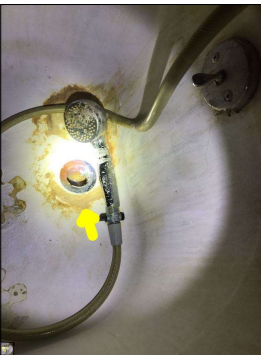
Missing drain stopper.

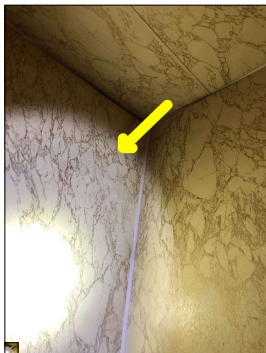
Unconventional flex and movement along the walls.

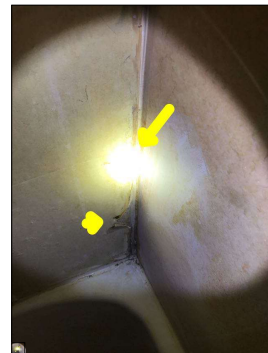
Flaking and peeling along the walls. Also, mold like substance as mentioned in the bathtub section.

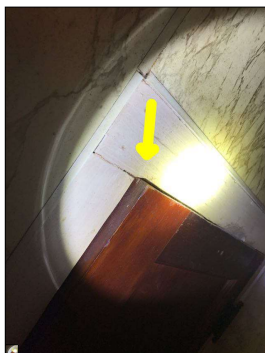
The door does not close properly.

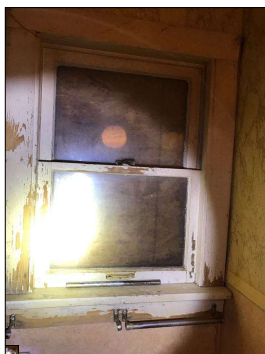
Aged window. That has a board over it.

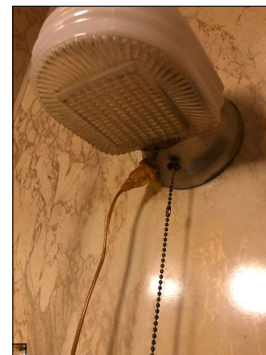
Open ground receptacles

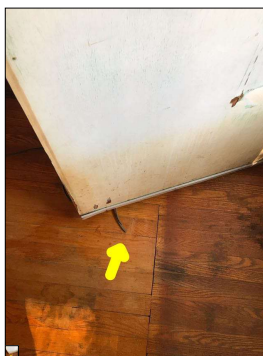
Torn weatherstrip along the door.

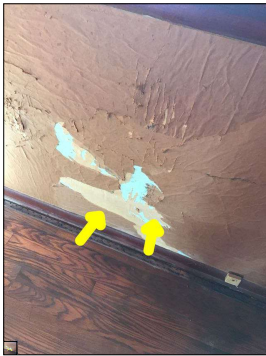
Flaking and peeling along the walls.

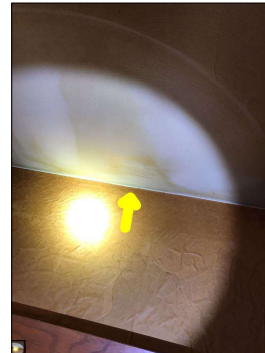
Discoloration along the ceiling. Discoloration along the ceiling is considered abnormal and a defect. An active or intermittent water source can cause discoloration, mold growth and property damage.

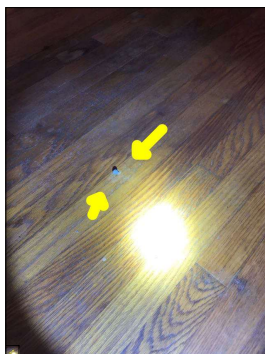
Unconventional nails sticking out from the floor.

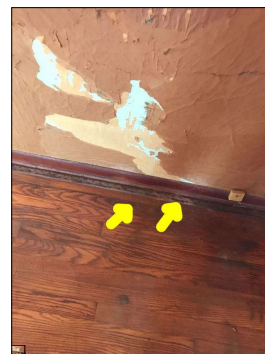
Exposed tack strips.

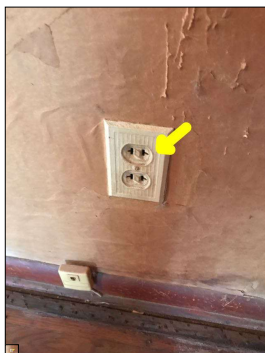
Two prong receptacles. Two prong receptacles are not grounded.

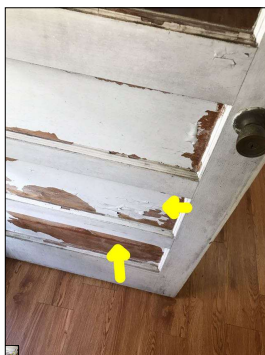
Flaking and peeling along the doors.

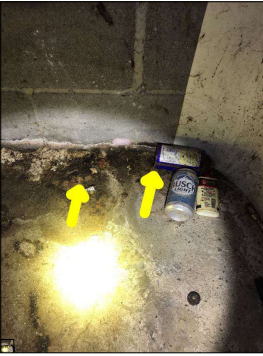
Moisture/dampness observed. This is considered a defect. An active or intermittent water source can cause mold growth and property damage.

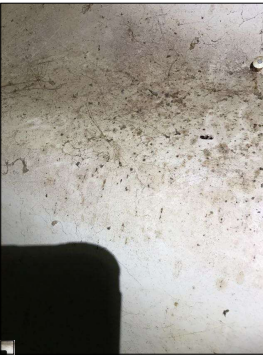
Mold like substance. An active or intermittent water source can cause mold growth and property damage.

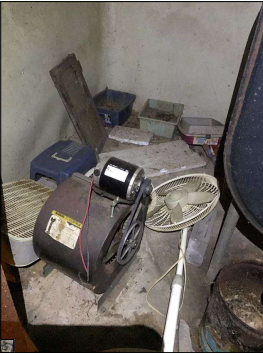
Excessive debris and clutter observed in the basement. Visibility and accessibility were limited.

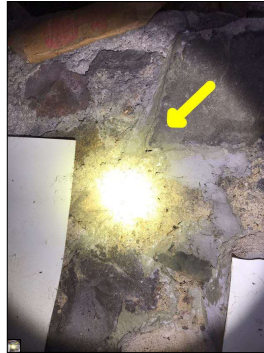
Deterioration along the field stone foundation.

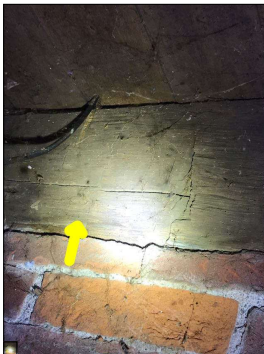
Exit holes observed. Exit holes are an indication of an infestation of powderpost beetles. Powderpost beetles are a wood destroying insect and can cause structural damage and property damage.

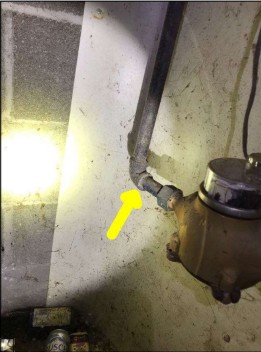
Aged galvanized water lines/pipes. Galvanized pipes no longer meet modern day plumbing standards. Galvanized pipes are prone to corroding from the inside out. Galvanized pipes are towards the end of their life expectancy. Repairs or replacement to galvanized pipes should be anticipated.

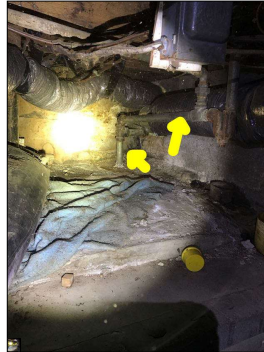
Aged galvanized water lines/pipes. Galvanized pipes no longer meet modern day plumbing standards. Galvanized pipes are prone to corroding from the inside out. Galvanized pipes are towards the end of their life expectancy. Repairs or replacement to galvanized pipes should be anticipated.

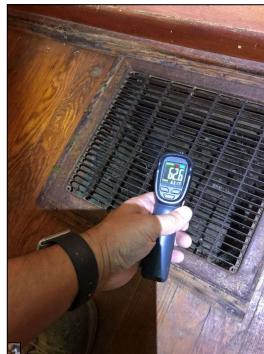
The photo identifies the temperature of the return air while the air conditioner was in operation. The approximate temperature of the return air was 62 degrees Fahrenheit.

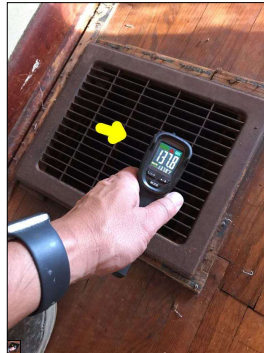
The photo identifies the temperature of the supply air while the furnace was in operation. The approximate temperature of the supply air was 137 degrees Fahrenheit.

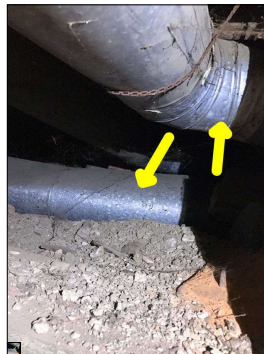
The HVAC ductwork lacks insulation. This is not a recommended practice. The lack of insulation along the ductwork can allow moisture and condensation to form along the ductwork. An active or intermittent water source can cause the ductwork to rust and corrode. A water source can also cause mold growth and property damage. This is located in the crawl space.

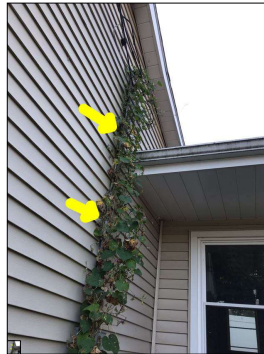
Unconventional vegetation along the service wires. This is considered abnormal. Excessive vegetation can cause property damage.
